# Spencer Dam Failure Investigation Report

*In the early morning hours of March 14, 2019, Spencer Dam on the Niobrara River in northern Nebraska failed during a major flood and ice run on the river. An independent investigative panel was formed to examine the failure.*

*April 2020*

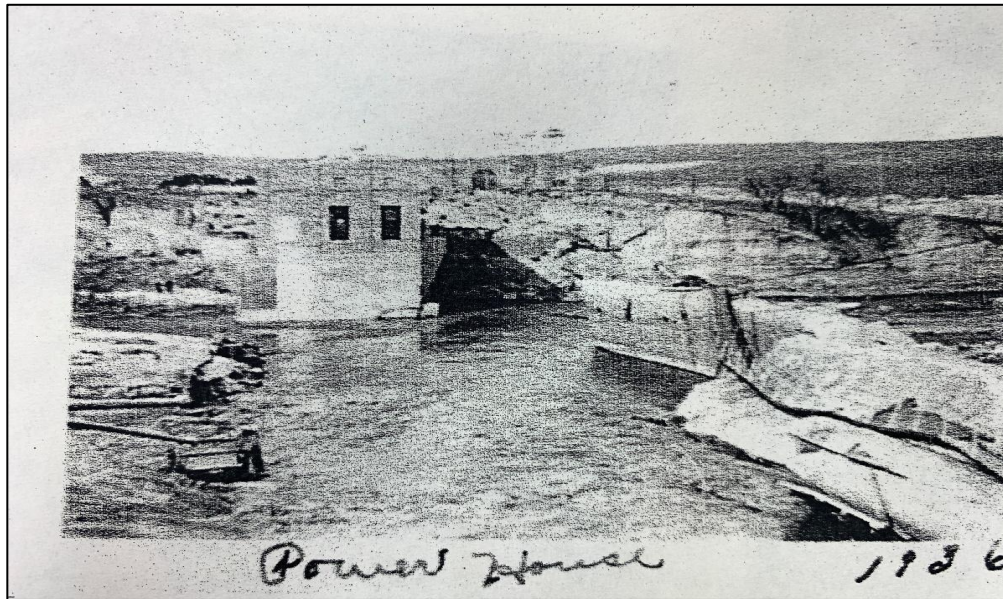
As the result of a high pool elevation, high water pressures developed within the foundation, and the entire spillway structure detached from its shale foundation and slid 30 to 50 feet downstream (Figure 2.8). The spillway was reconstructed in 1940 with foundation keys and anchors to prevent sliding.

*Figure 2.10 - 1936 Spencer Dam failure due to the concrete spillway sliding 50 feet downstream – NPPD photo.*

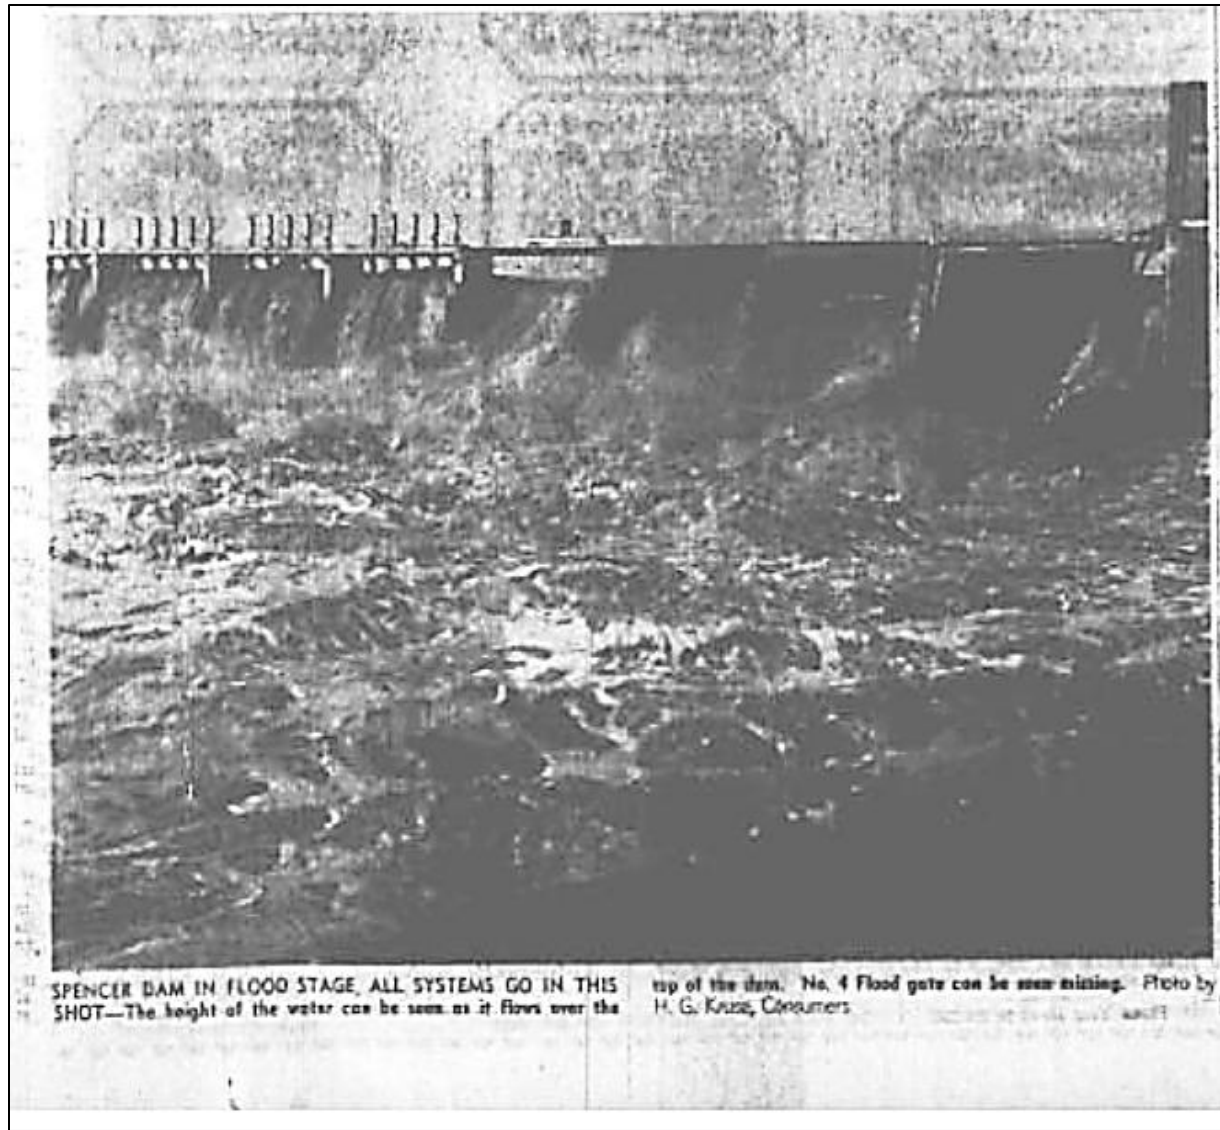
Figure 2.11 - Caption: "SPENCER DAM IN FLOOD STAGE, ALL SYSTEMS GO IN THIS SHOT" - The height of the water can be seen as it flows over the top of the dam. No. 4 flood gate can be seen missing. Photo credit Holt County Independent March 17, 1966, page 4. Research source: History Nebraska.

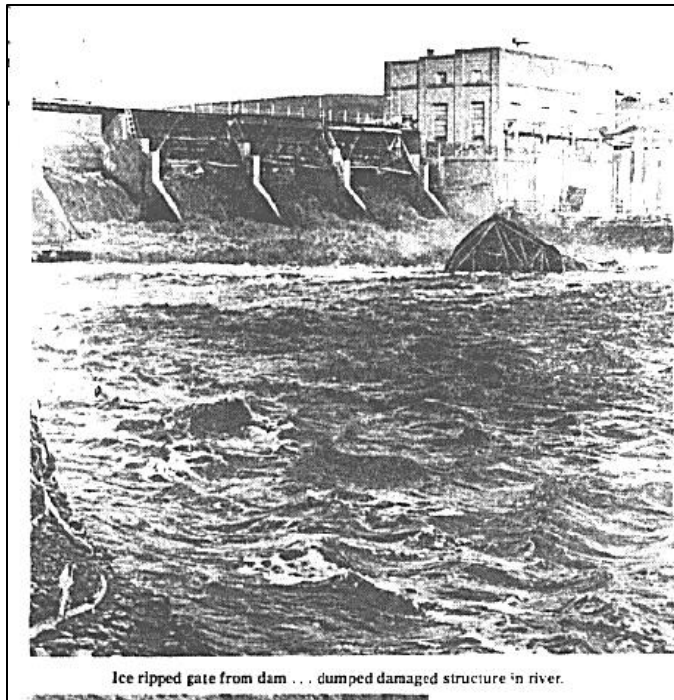
Figure 2.12 - Caption: "Ice ripped gate from dam. Dumped damaged structure in river."  
[Photo: Omaha World Herald March 15, 1966, page 11]. Research source: History Nebraska.

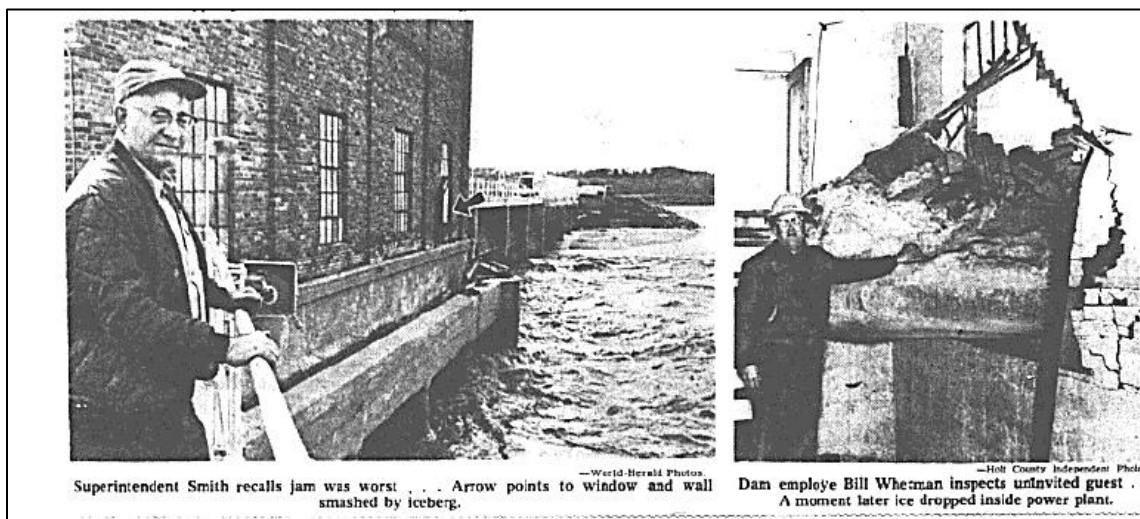
Figure 2.13 - Damaged window and ice – Photo: Omaha World Herald March 15, 1966, page 10.  
Research source: History Nebraska.

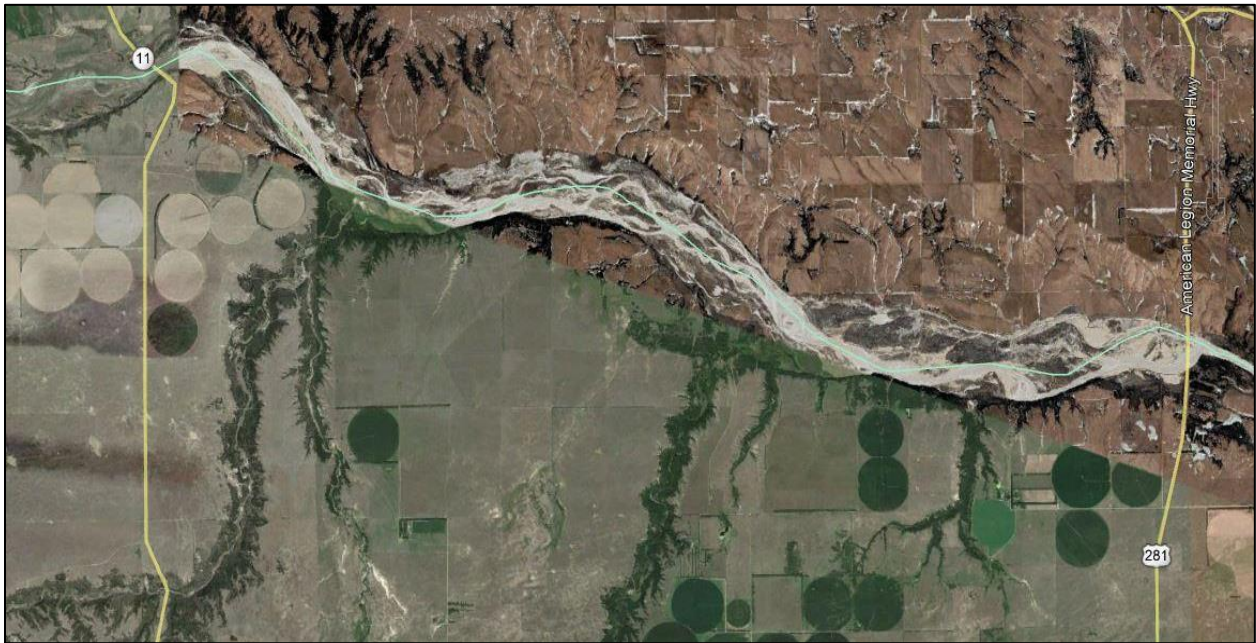
Figure 4.2 - Niobrara River between the Highway 11 Bridge (upstream) and the Highway 281 Bridge (downstream from the dam) after failure. From Google Earth (3/2019).

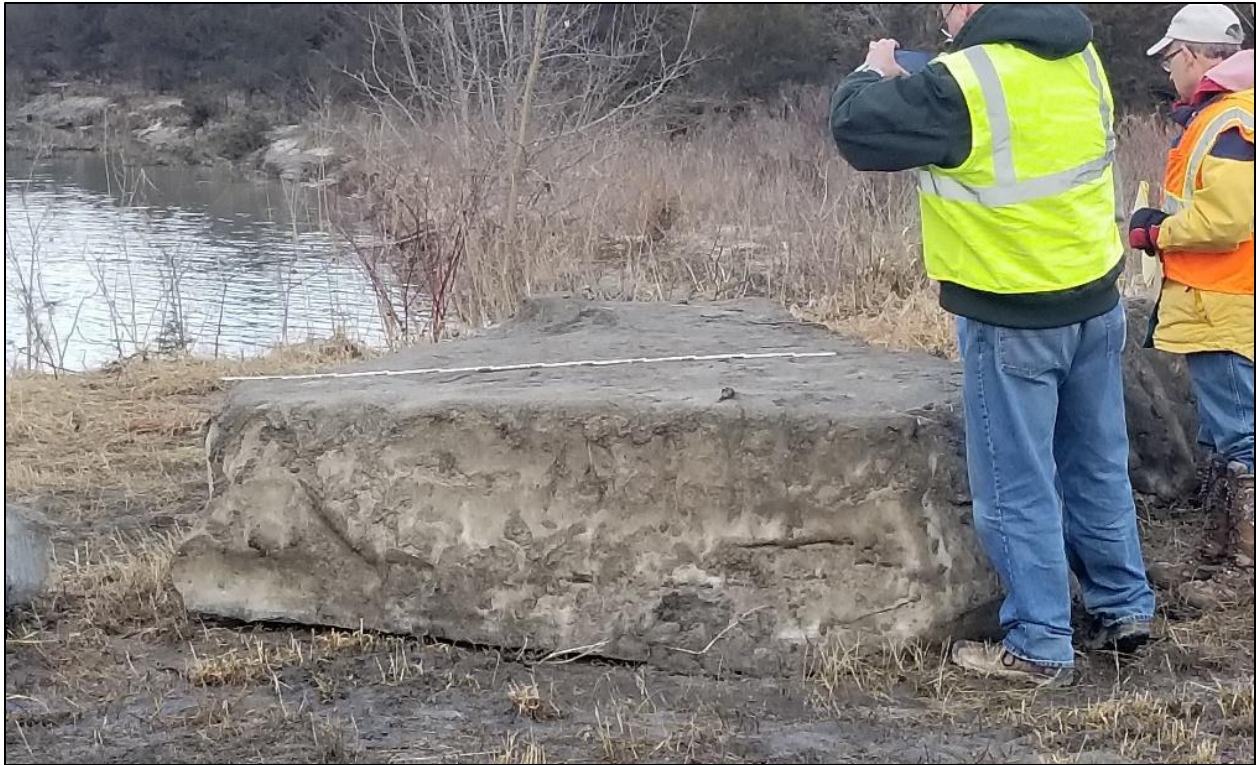
*Figure 4.3 - 2-foot thick ice block (NPPD photo, March 2019).*

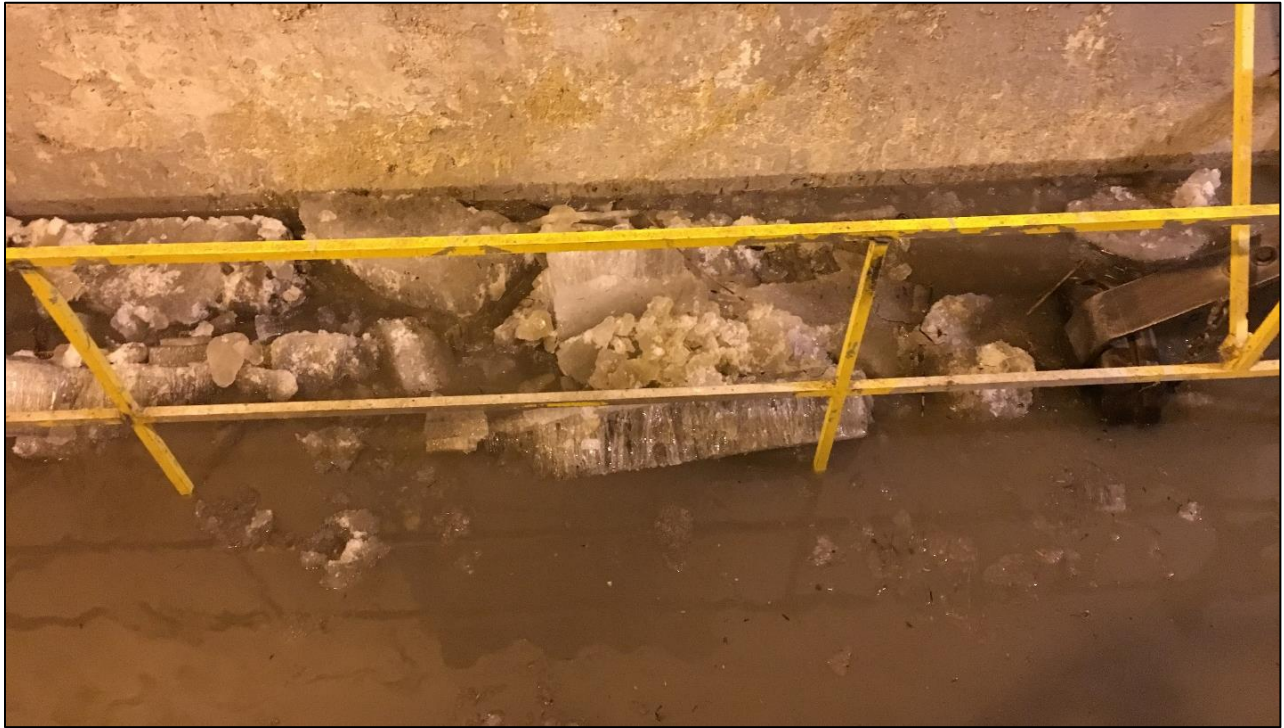
*Figure 4.4 – Water and ice entering the trash-rake room at 4:38 AM on March 14. The trashrack slots are behind (upstream from) the railing (NPPD photo).*

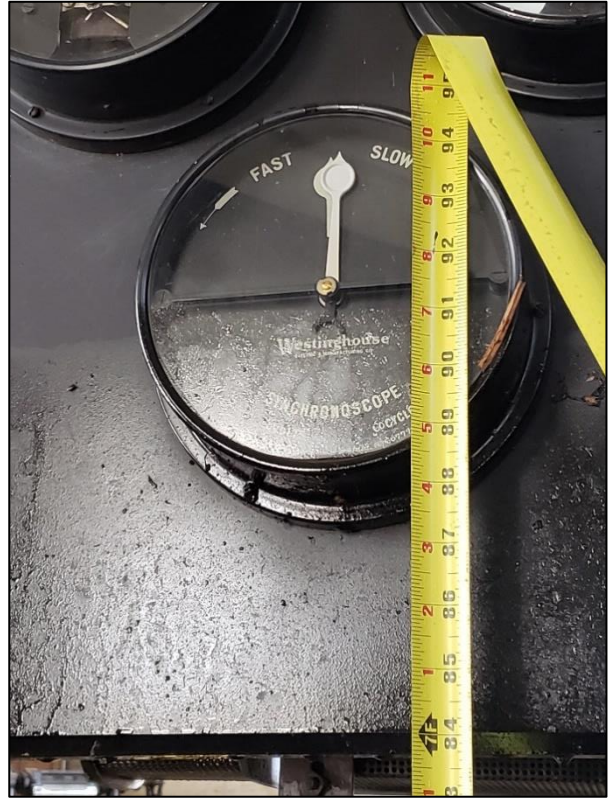
Figure 4.5 – High water mark in the generator room – note that the water stain on the cabinet is the same elevation as the water in the gage (NPPD photo).

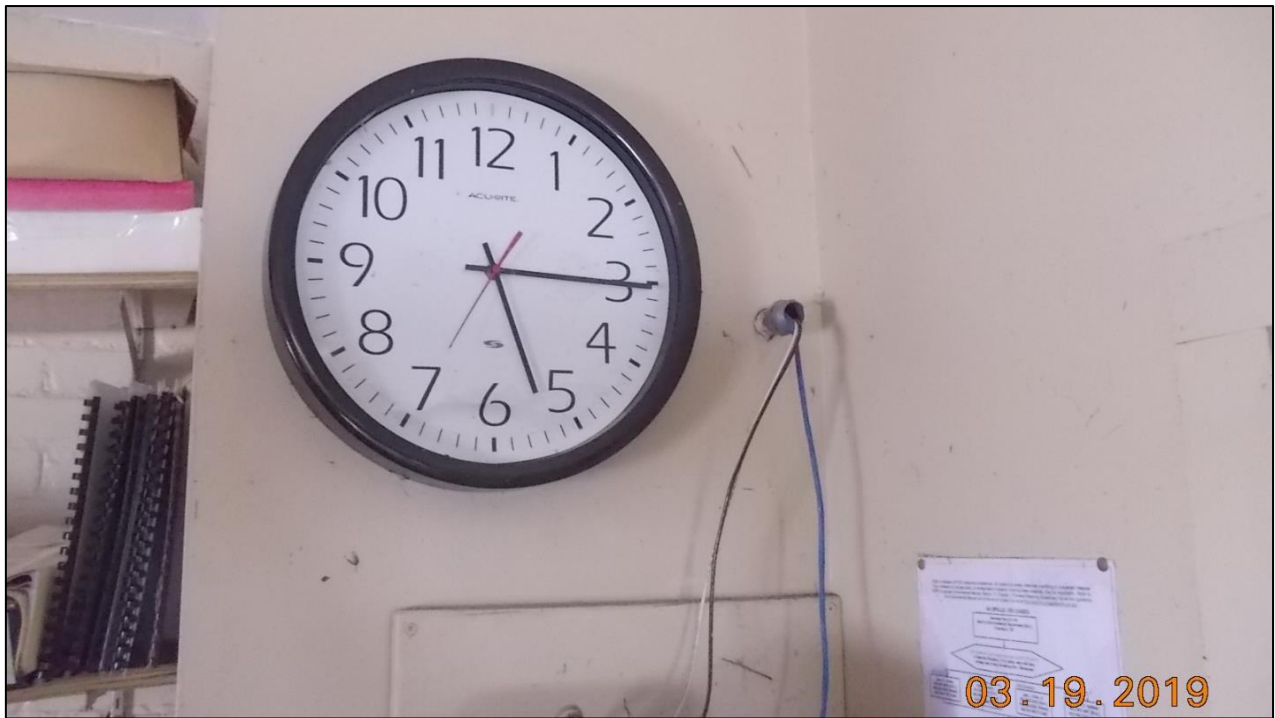
Figure 4.6 - Stopped clock in the powerhouse office (NPPD photo).

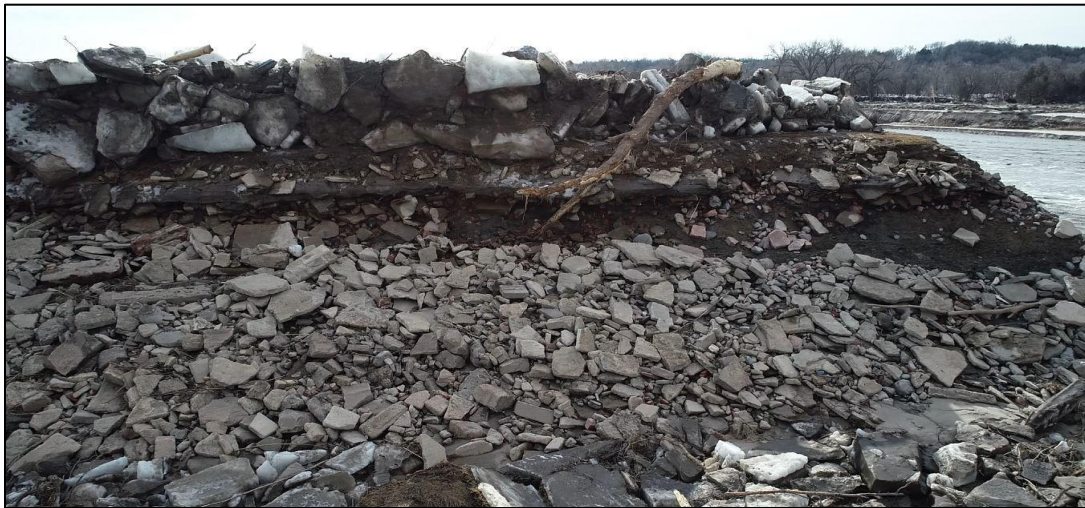
Since the physical evidence indicates that ice rubble, and not necessarily water was approximately 4.5 feet above the dike's crest (Figure 4.7), the water level itself may not have been this high. The high-water mark measured in the downstream generator room of the powerhouse was 7-feet 7.5-inches above the floor at elevation 1505.36 (Figure 4.5). This observation puts the water level at elevation 1513.0 (about two feet above the dike). The discrepancy between water level and ice level could be explained if the surge pushed, rather than floated the ice over the dike. Floating ice would only be several inches above the water surface. As the ice was being forced over the dike and through the powerhouse wall to a height of 4.5 feet above the dam, the reservoir water surface may have only risen to a height of two feet above the dam.

*Figure 4.7 – Ice stacked on the north end of the south breach. The elevation of ice measured in the reservoir rim upstream from the powerhouse was about 4.5 feet above the design top of dam elevation (from NPPD video).*

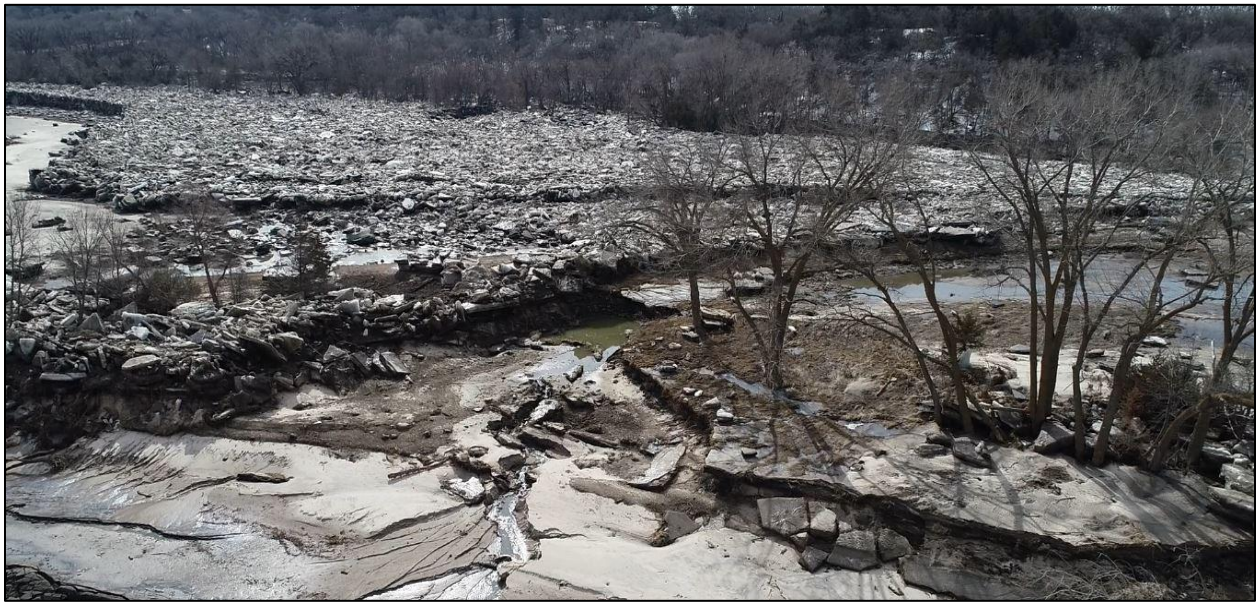
*Figure 4.12 – South end of the dike looking downstream. The dike is at roughly mid-height in the figure. Thick ice fields can be seen downstream (MPPD video).*

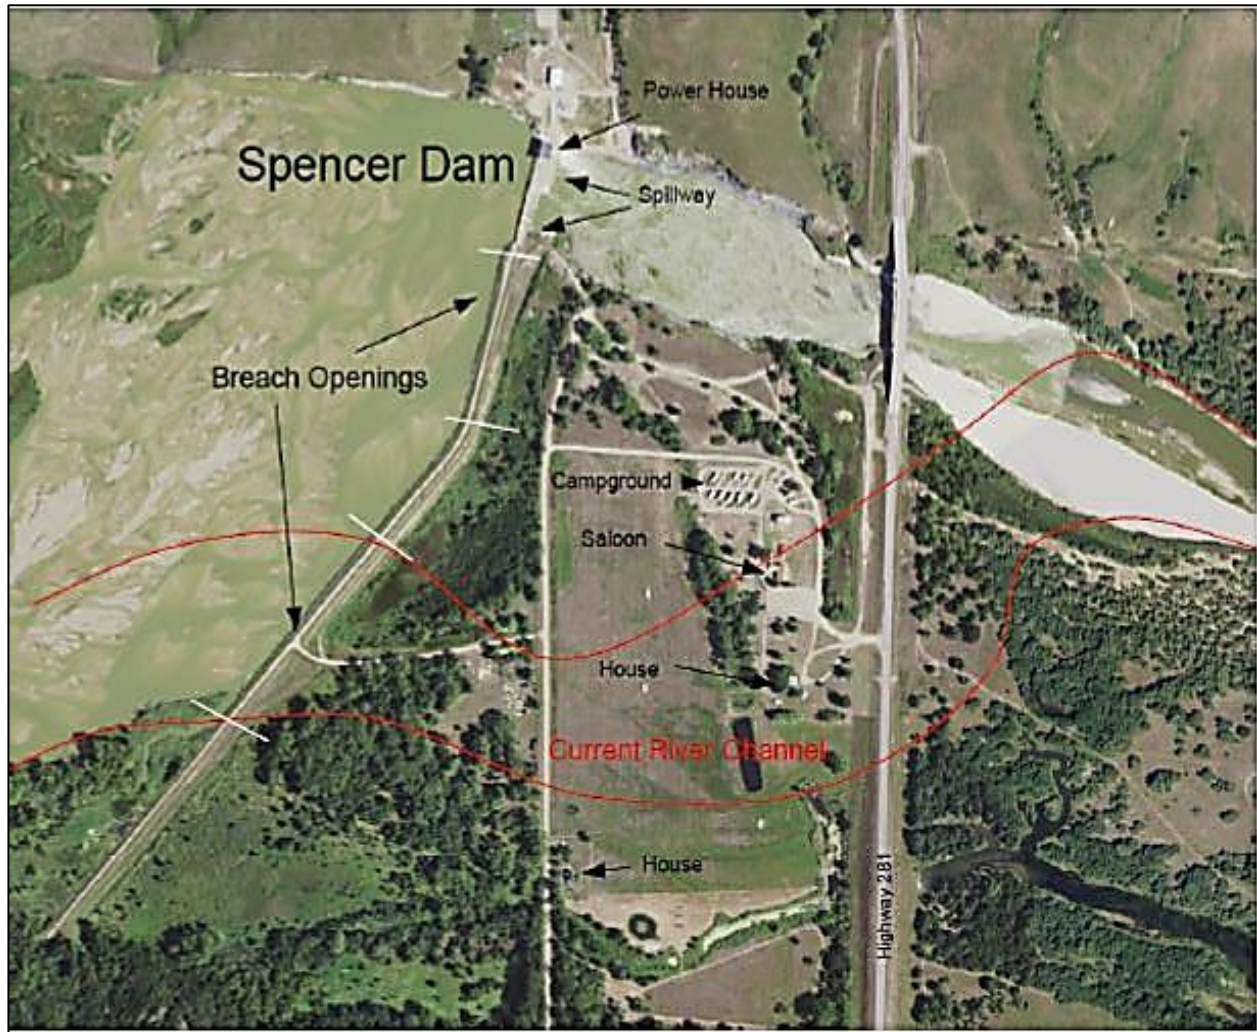
Figure 4.13 – Details of dam and area downstream showing dike breach locations and location of the river channel following the event (NPPD figure).

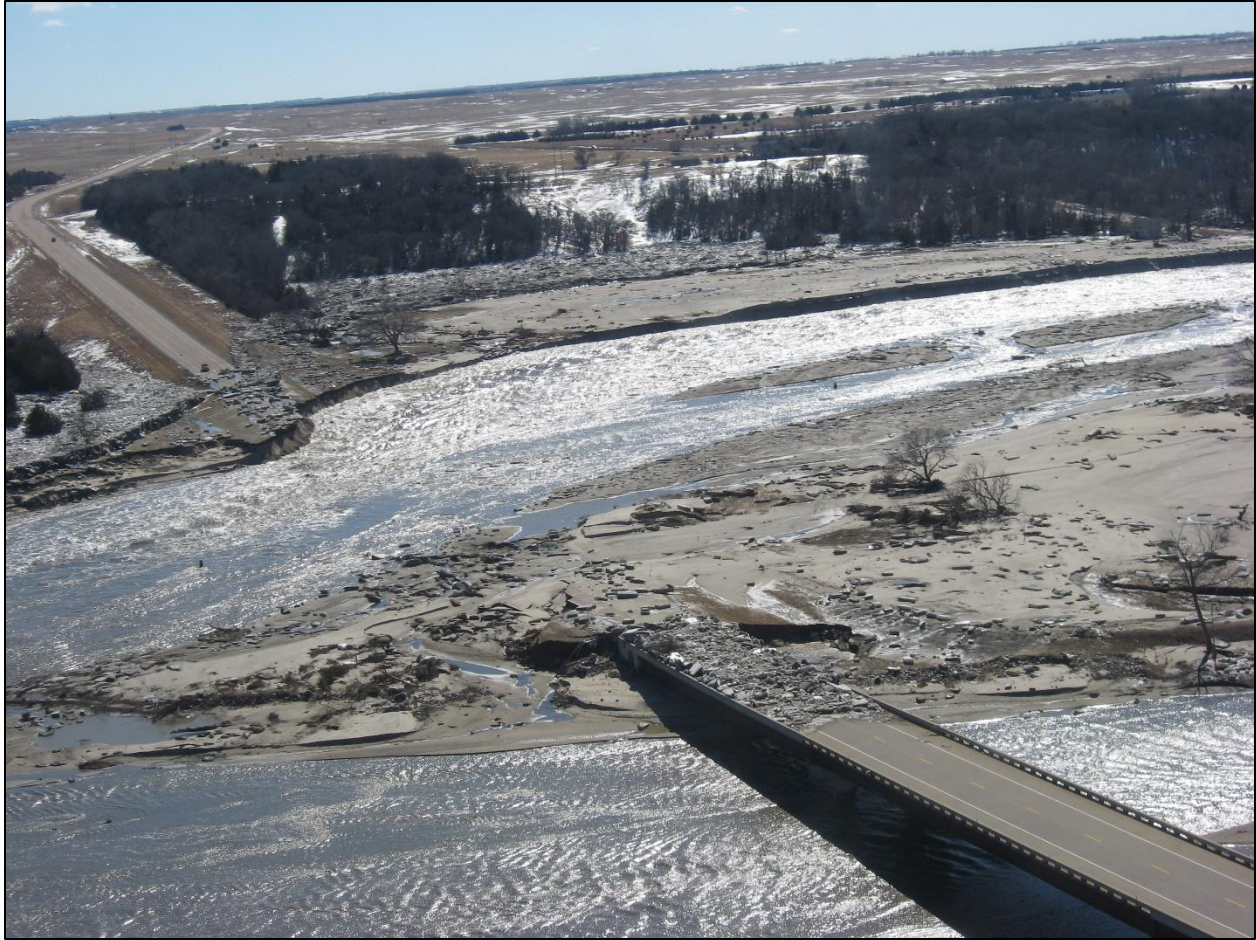
*Figure 4.14 – View of washed-out Highway 281 approach ramp (looking south). Note the ice fields upstream and downstream from the road on the south bank (NPPD photo).*

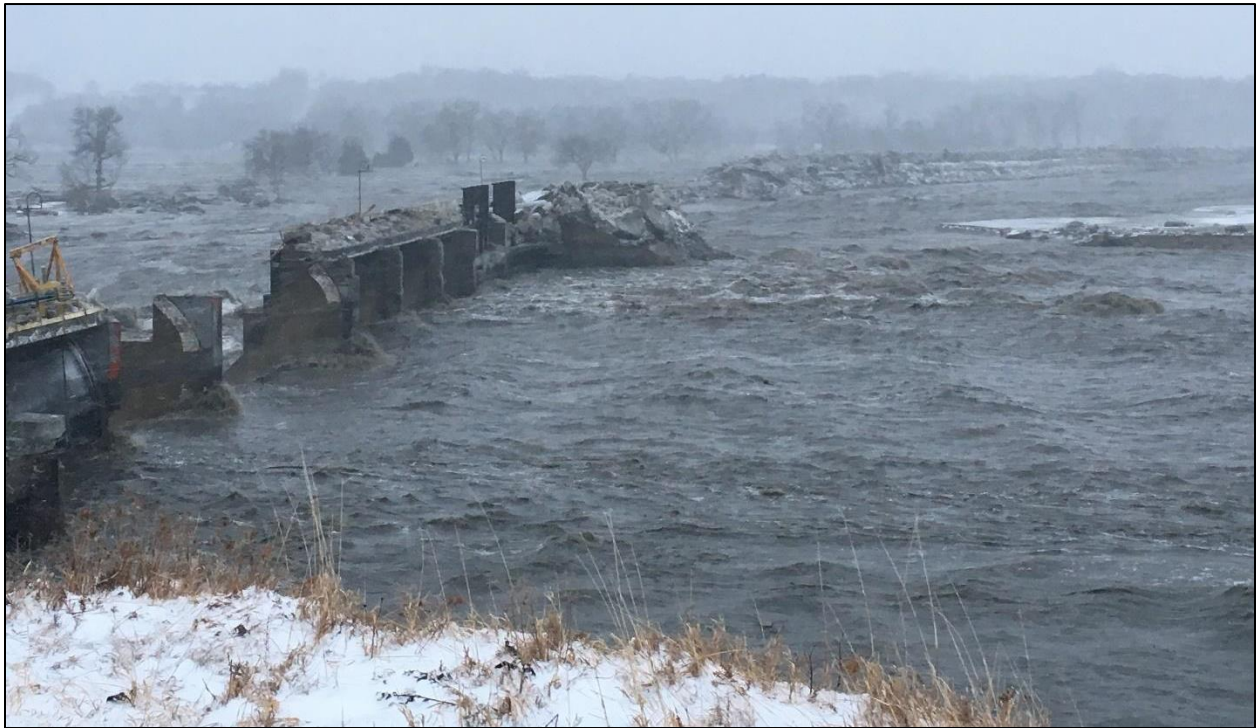
*Figure 4.17 – Photo of Spencer Dam taken at 8:04 AM on March 14, 2019 (NPPD photo).*
