# Spencer Dam Failure Investigation Report

*In the early morning hours of March 14, 2019, Spencer Dam on the Niobrara River in northern Nebraska failed during a major flood and ice run on the river. An independent investigative panel was formed to examine the failure.*

*April 2020*

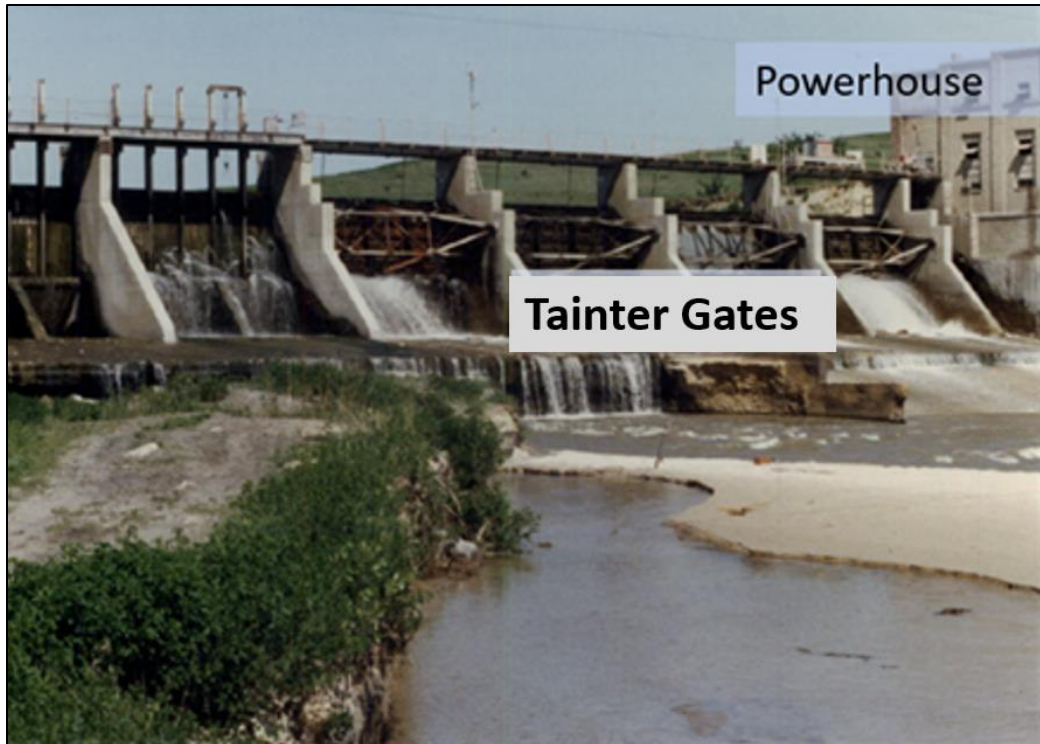
Figure 2.3 - Tainter (radial) gates - NebDSP photo

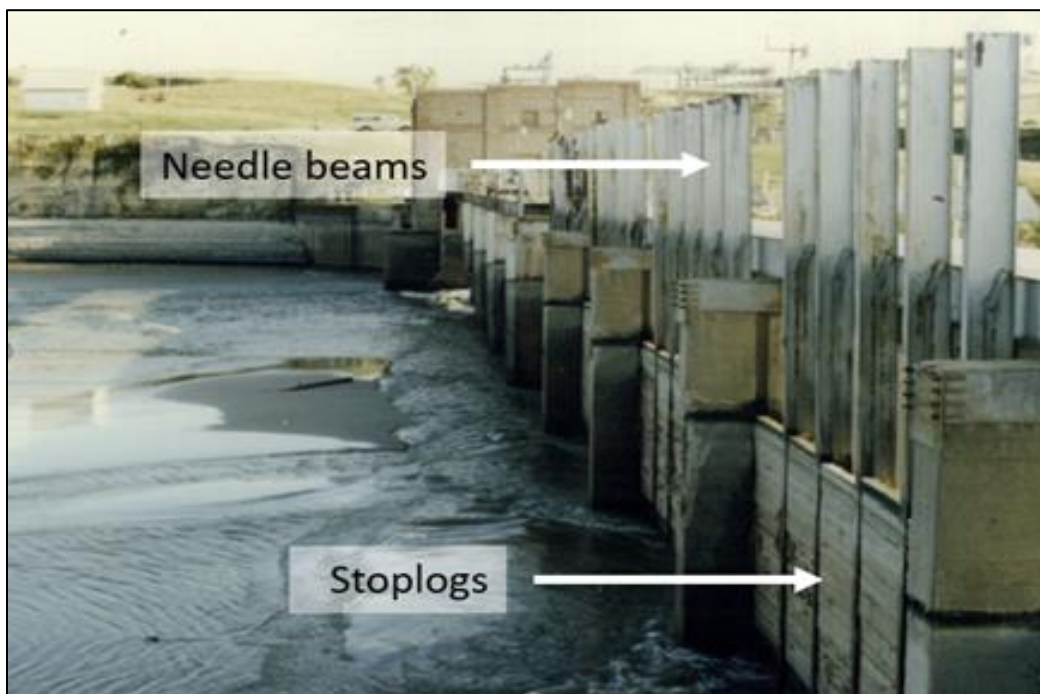
Figure 2.4 - Needle beams and stoplogs - NebDSP photo

The last five bays had six stacks of stoplogs each (Figure 2.4). These wood timbers were held in place by five vertical, steel I-beams (Figure 2.5). These “needle beams” could be lifted by a portable jack to release the beams from a pocket in the spillway crest. As the needle beams were released, they swung downstream, releasing the stoplogs on either side. Each bay had a crest at elevation 1491.14 feet. Figures 2.8 and 2.9 describe the needle beams and their operation.

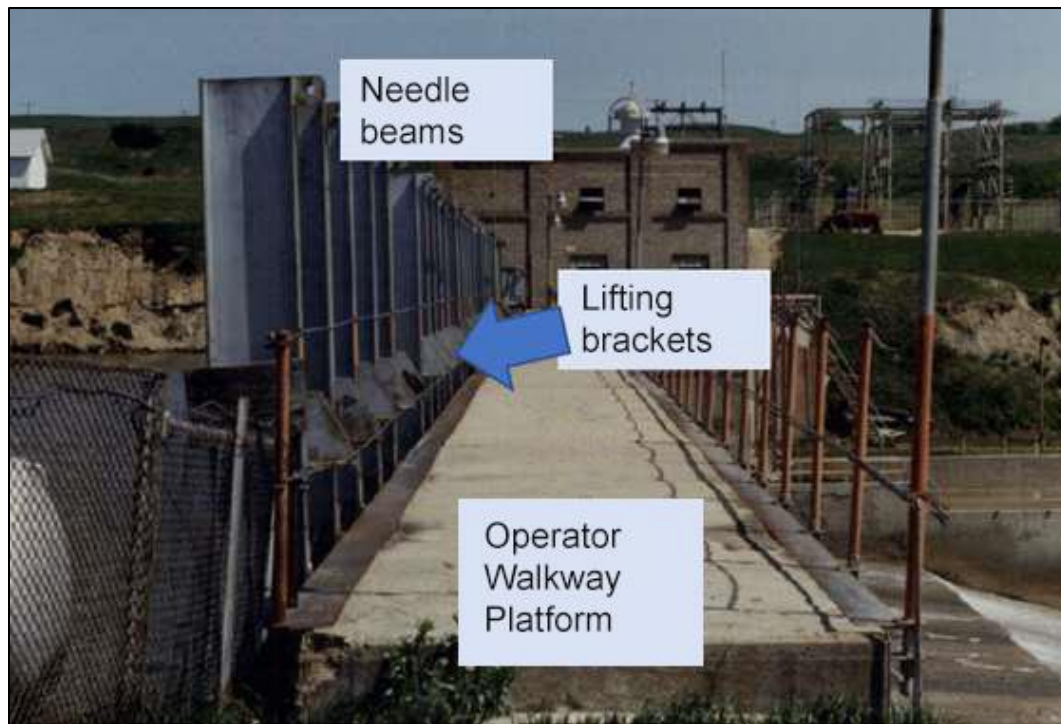
Figure 2.5 - Stoplog bays and needle beams at south end of spillway. NebDSP photo

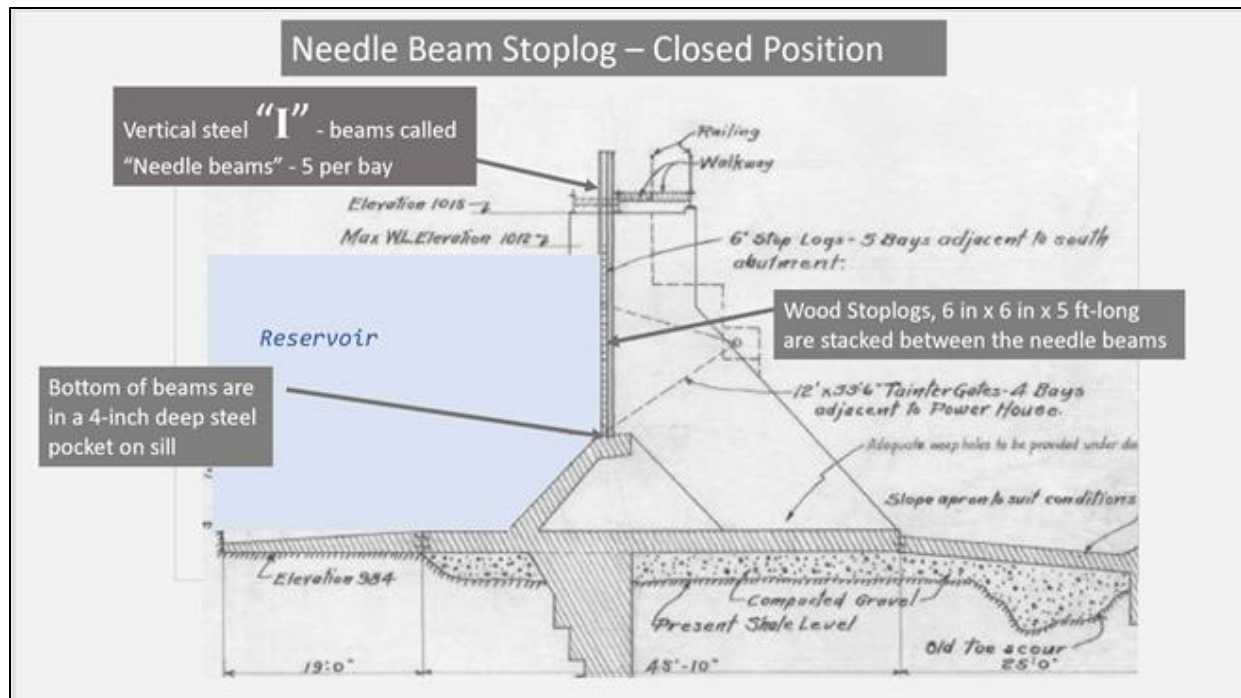
The spillway gates, hoists, and stoplog needle beams were all apparently in good operating condition before the March 2019 event. However, during the event the needle beams and stoplogs in the last two bays (Bays 8 and 9) were frozen in place by ice that had formed (See Appendix K). Also, Gate 3 shut partway through the event due to a broken lifting chain. The closure of these three bays (two stoplog bays and one Tainter (radial) gate reduced the discharge capacity of the spillway.

Figure 2.8 Needle Beam Stoplog - Closed Position - Source 1939 Spencer Spillway design drawing and Panel annotations.

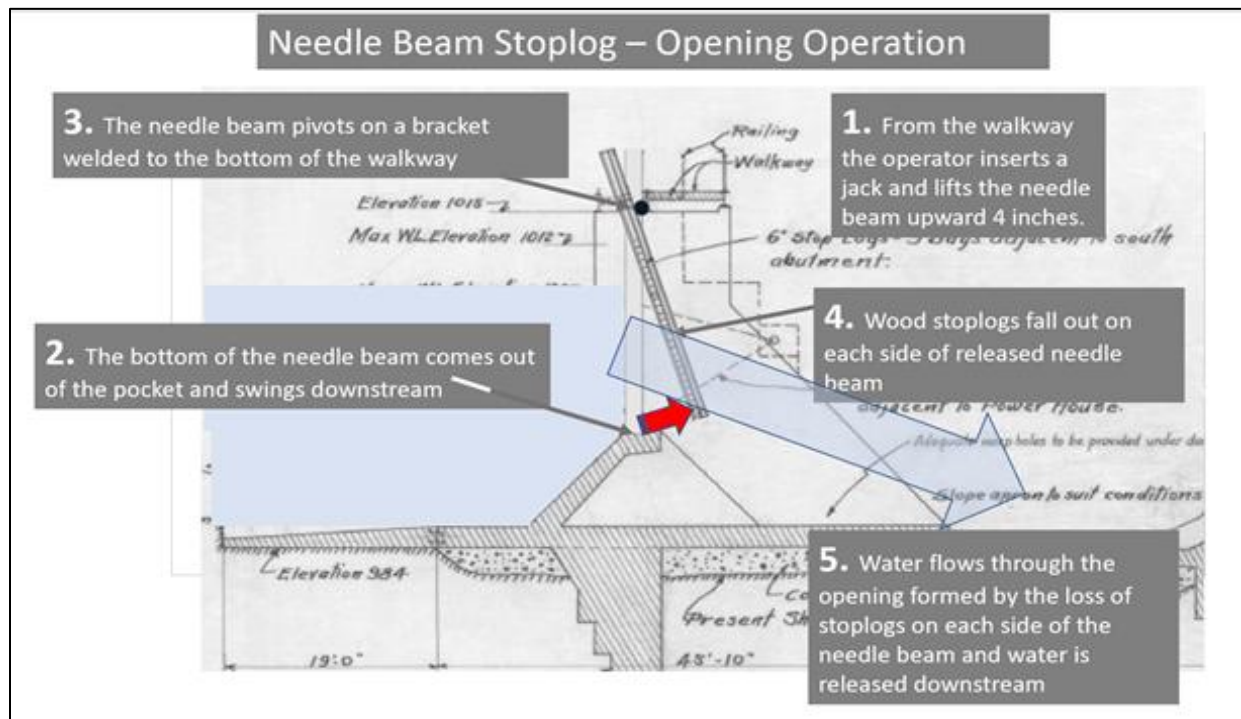
Figure 2.9 Needle Beam Stoplog - Opening Operation Sequence - Source 1939 Spencer Spillway design drawing and Panel annotations.

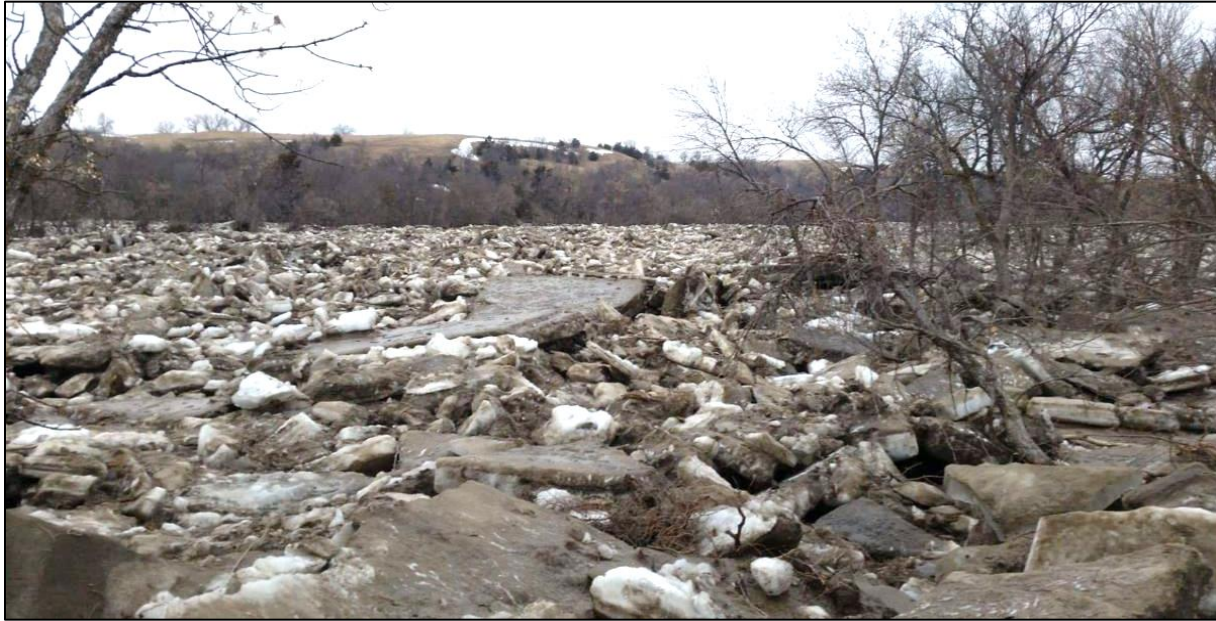
Figure 3.8 shows ice rubble jammed in a reach of the Niobrara River. Though no photographs show such jamming upstream of Spencer Dam during the event, this photograph gives an impression of jam development along the river.

*Figure 3.8. Ice rubble jamming on the Niobrara River during March 2019. The jam shoves rubble into a jumbled mass and pushes rubble over the channel's banks.*

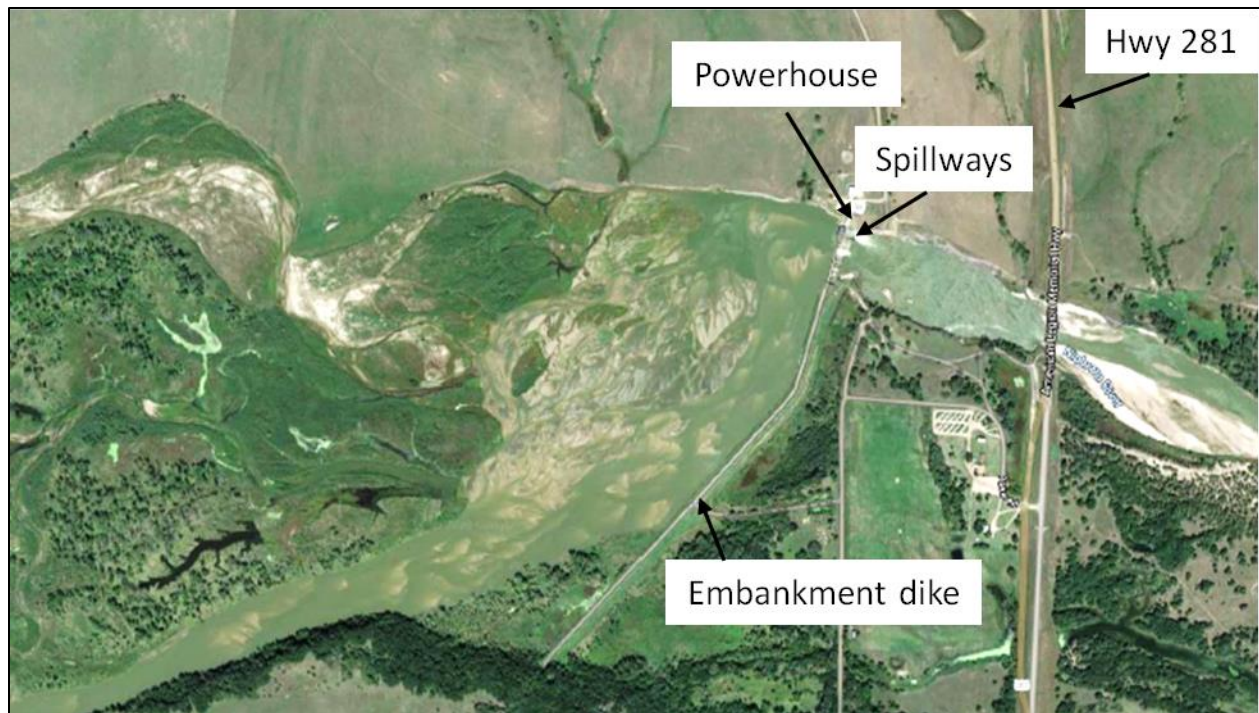
Spencer Dam extended across the full width of the Niobrara River. Figure 3.9 is an aerial view of the dam before its failure. This view depicts the river a short distance downstream of the view in Figure 3.3 and shows that water flow, sediment and ice arriving at the dam had to pass through the dam's gated spillway and two hydropower turbines.

The spillway also included a narrow trough (10 feet wide) designated as an ice chute. Such chutes are common for navigation dams on the Mississippi, Ohio and Illinois Rivers, and can be used to pass small quantities of ice (such as ice blocks cut upstream of the gates at Spencer Dam) but are considered essentially useless during major runs of ice. The layout lacked an ice bypass sluice or spillway.

Figure 3.9. The layout of Spencer Dam on the Niobrara River. North is up. The west end of this view is about 0.5 mile downstream of the east end of the view shown in Figure 3.3 (Google Earth Image).

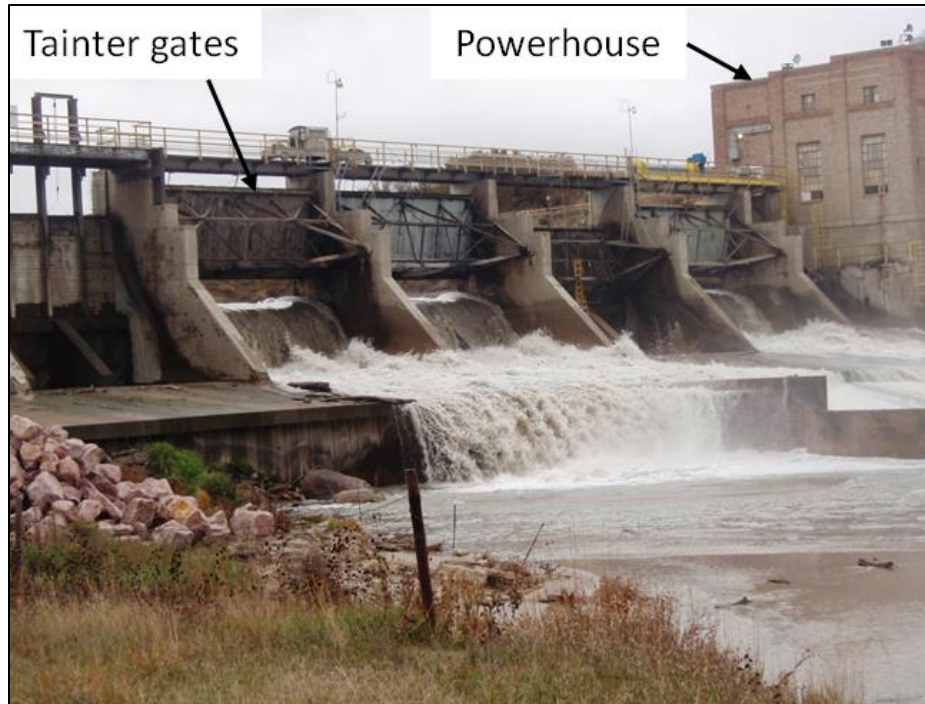
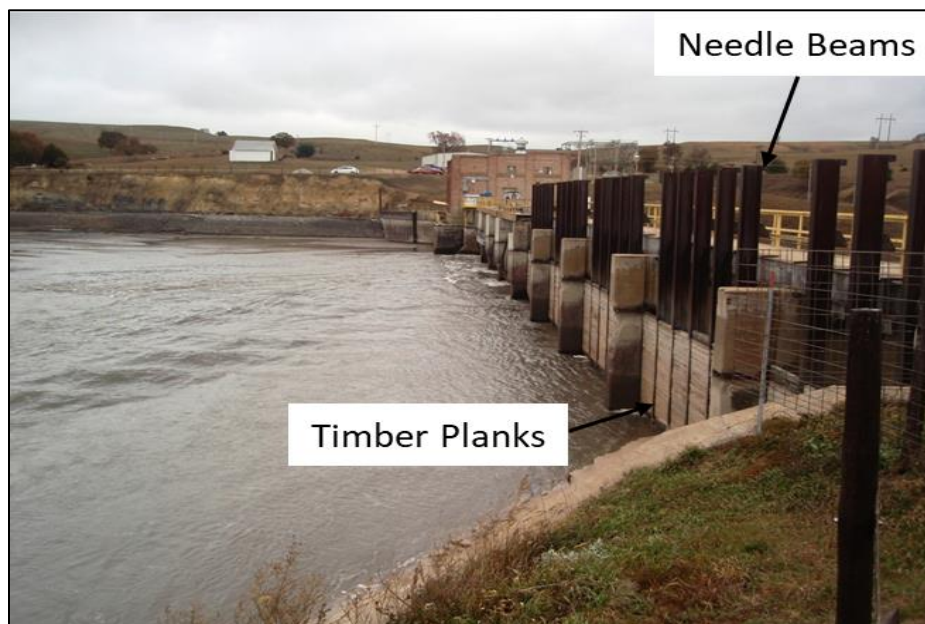
Figure 3.10. Two views of the spillway of Spencer Dam during sediment flushing: (a) the four Tainter (radial) gates; and, (b) the five stoplog bays with five needle beams and stacks of timber planks.

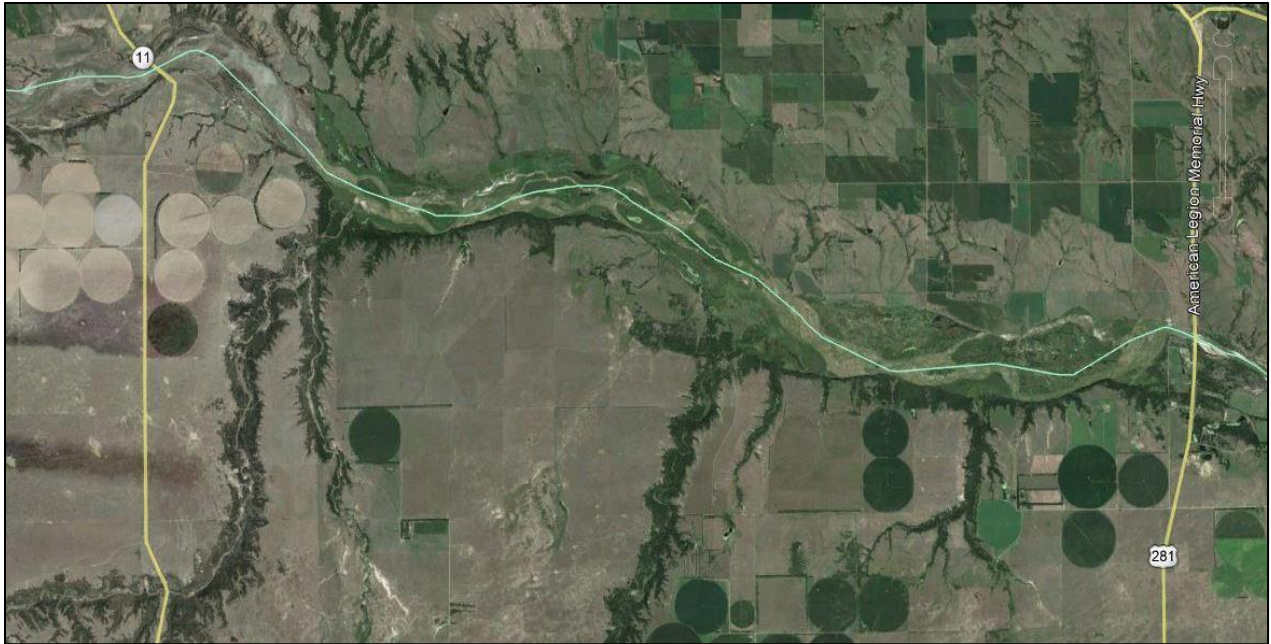
showed pieces of ice that appear to be even thicker. Figure 4.1 shows how the channel would have looked before the March 2019 flood. The channel averaged about 1,000 feet wide. The after-flood image, Figure 4.2, indicates the flood flow averaged about 3,000 feet wide.

Figure 4.1 – Niobrara River between the Highway 11 Bridge (upstream) and the Highway 281 Bridge (downstream from the dam) before failure. From Google Earth (6/2018).

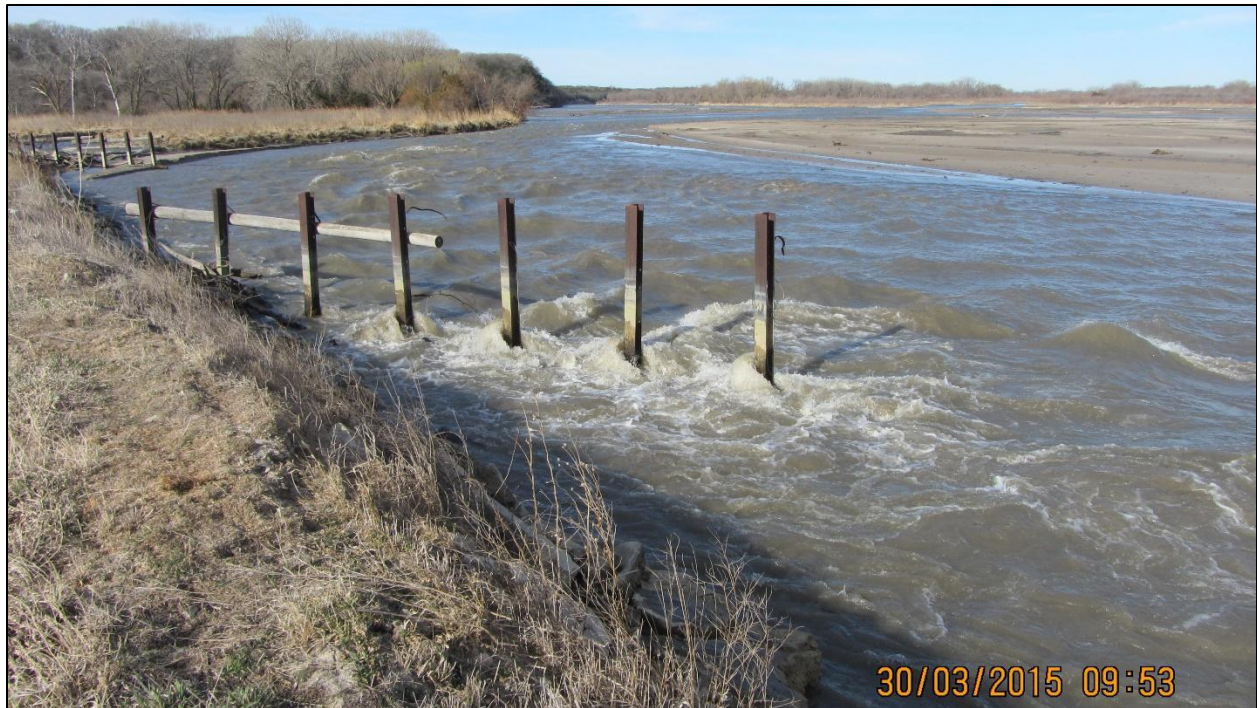
The embankment breached in two locations that the Panel has identified as the north (adjacent to the spillway) and south (near the access ramp) breaches. In past flooding, the dike failed or suffered erosion damage near the location of the 2019 south breach. It is believed that flow from the south channel, that is directed towards the dike, caused erosion of the dike in this location (Figure 4.10). The momentum of the ice-laden flow in 2019, which was much higher than the flow in the figure, likely caused run-up of ice and water onto the embankment, making this location the most likely spot for erosion damage and overtopping.

Figure 4.10 – Flow from south channel changing direction at the dike. (Corps of Engineers photo, 2015).

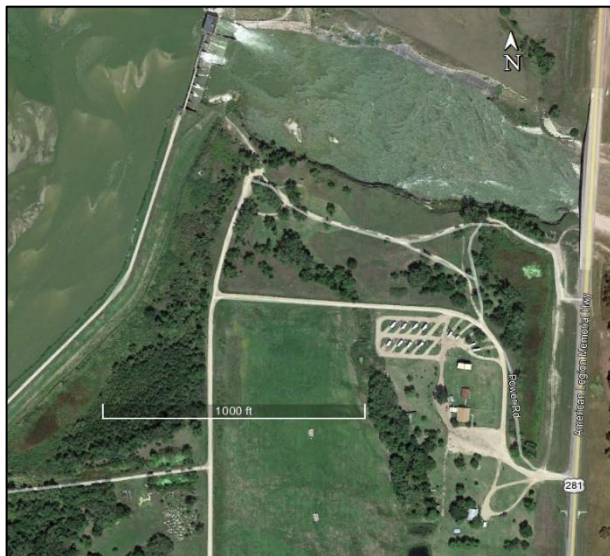
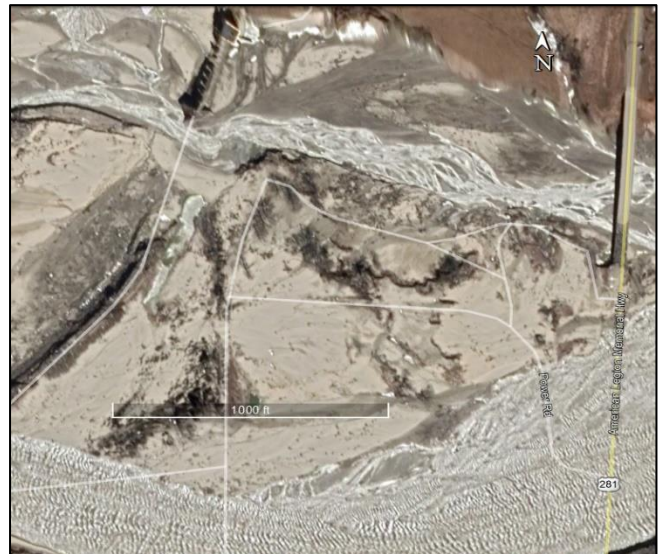
This section describes consequences “immediately downstream” of the dam which includes the toe of the dam and property and structures just downstream, including the Highway 281 embankment and bridge crossing, about 1,500 to 3,000 feet downstream of the dike. This area is shown in Figure 5.1. As can be seen in the photographs in Figure 5.1 (a) and (b), all structures immediately below the dam were washed away.

In addition, the new flow path created by the southern breach (at the bottom of the photograph in Figure 5.1b) destroyed the highway embankment leading to the bridge. The bridge itself was left intact. Two new flow paths from the northern and southern breaches of the dam created channels evident in the photograph. However, it is also evident that the area between the two main flow paths was impacted by ice and water as it was swept clean of buildings, vegetation, and most other features. The extensive deposition of sand, and the patterns of deposition themselves, indicate flow paths and sand fans over the area and show that flow spread over the area as well as cutting into deposits to form new channels (Figure 5.1).

Figure 5.1. Vicinity of Spencer Dam (a) Before (June 2018) and (b) After (March 2019) Failure (Google Earth)
