Dam Ownership Fact Sheet

TOPIC: COMMON PROBLEMS FOR SMALL DAMS WITH CONCRETE CHANNEL SPILLWAYS

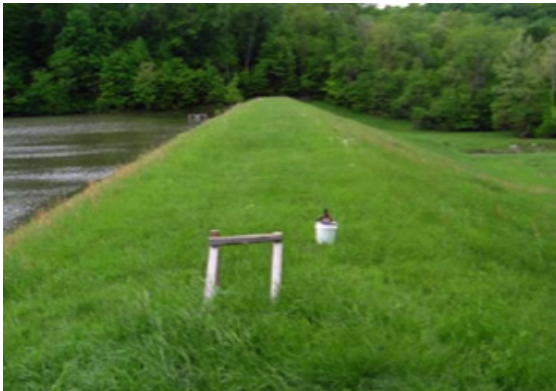
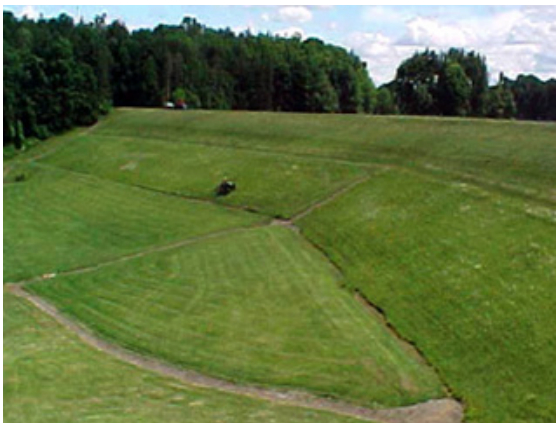
An excellent grass cover will reduce erosion and is easily maintained.

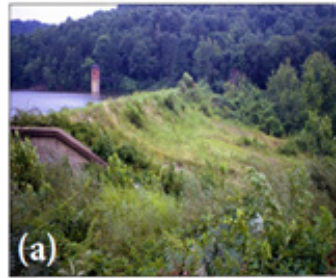
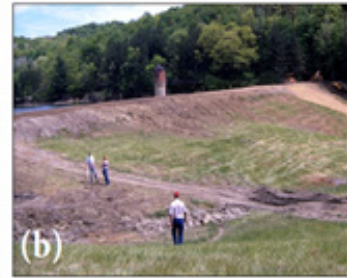
(a) Embankments covered with trees and brush makes inspections difficult. (b) Cleared of trees and brush, this embankment is much easier to inspect, but needs a good vegetal cover.

Trees and brush must not be permitted on embankment surfaces or in vegetated earth spillways. Extensive root systems can provide seepage paths for water. Trees that blow down or fall can leave large holes in the embankment. Brush hinders visual inspection, provides a haven for burrowing animals, and retards growth of grass vegetation.

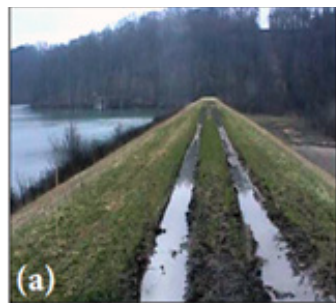
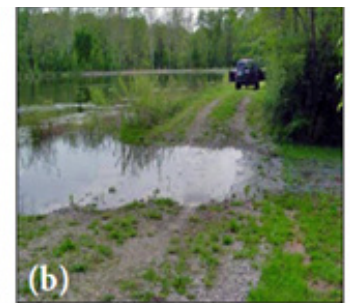
(a) Embankment crests with vehicle ruts will collect water and weaken the embankment. (b) Crest beginning to overtop in low area. This could lead to erosion and failure of the dam.

Vehicular traffic should be discouraged, especially during wet conditions, to avoid ruts. Water collected in ruts may cause localized saturation, thereby weakening the embankment. Ruts can develop into low areas. Low areas on the crest increase the likelihood that a dam will be overtopped during severe floods. Earthen embankments are not designed to be overtopped. Should the dam overtop, floodwaters will concentrate in the low area, increasing the likelihood of erosion of the crest and downstream slope. Severe erosion can lead to failure of the embankment. A well-vegetated earth embankment may withstand limited overtopping if its crest is level and water flows over the crest and downstream slope as an evenly distributed sheet without becoming concentrated.

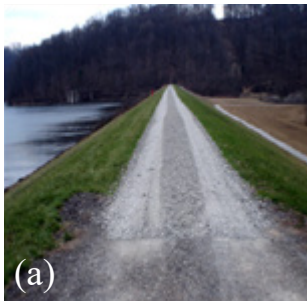
(a) Crest with a good cover that will reduce the effects of vehicular traffic.

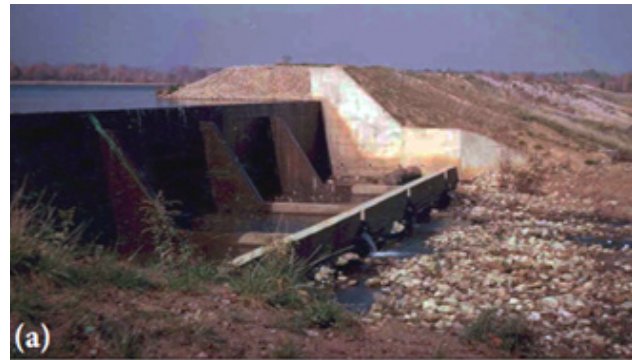
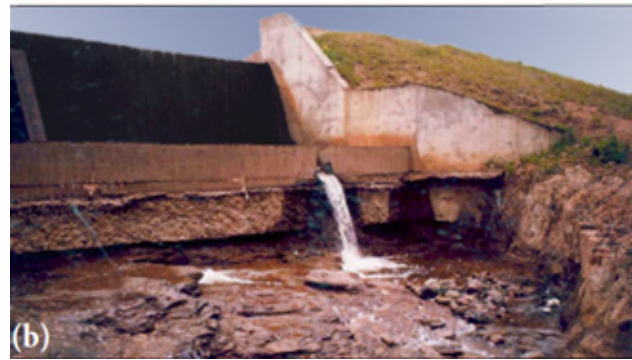
(a) A spillway outlet area as originally constructed. (b) Severe erosion has undermined the spillway outlet and threatens the overall structural safety of the spillways.

areas of spalled concrete. Even if the spillway is in good structural condition, seepage under the spillway or erosion at the outlet or along the sides can cause the spillway to fail. Spillway floor slabs and walls should be checked for erosion of underlying base material known as undermining. Indicators of problems with seepage and erosion under the spillway include misalignment at joints and large cracks.

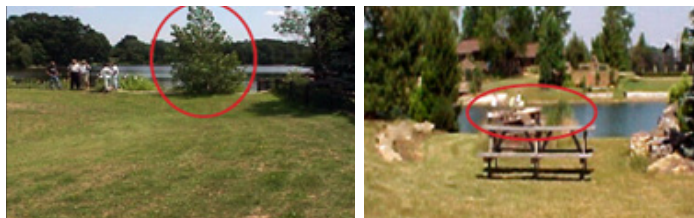
Left: A tree is obstructing this spillway. Right: Notice the landscaping directly behind the table. Obstructions in the spillway reduce the capacity to convey water. They also can collect debris, further diminishing the capacity of the spillway.

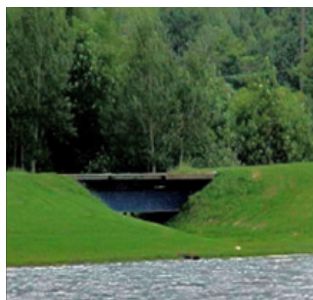
This bridge blocks much of the spillway, reducing its ability to convey water.

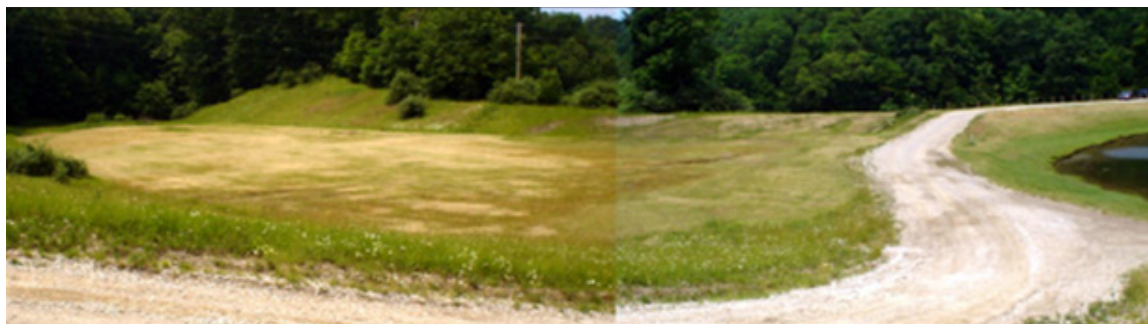
This open-channel emergency spillway is clear of trees, brush and other obstructions. Also note the good grass cover.
