Evaluation and Monitoring of Seepage and Internal Erosion

Interagency Committee on Dam Safety (ICODS)

FEMA P-1032 /May 2015

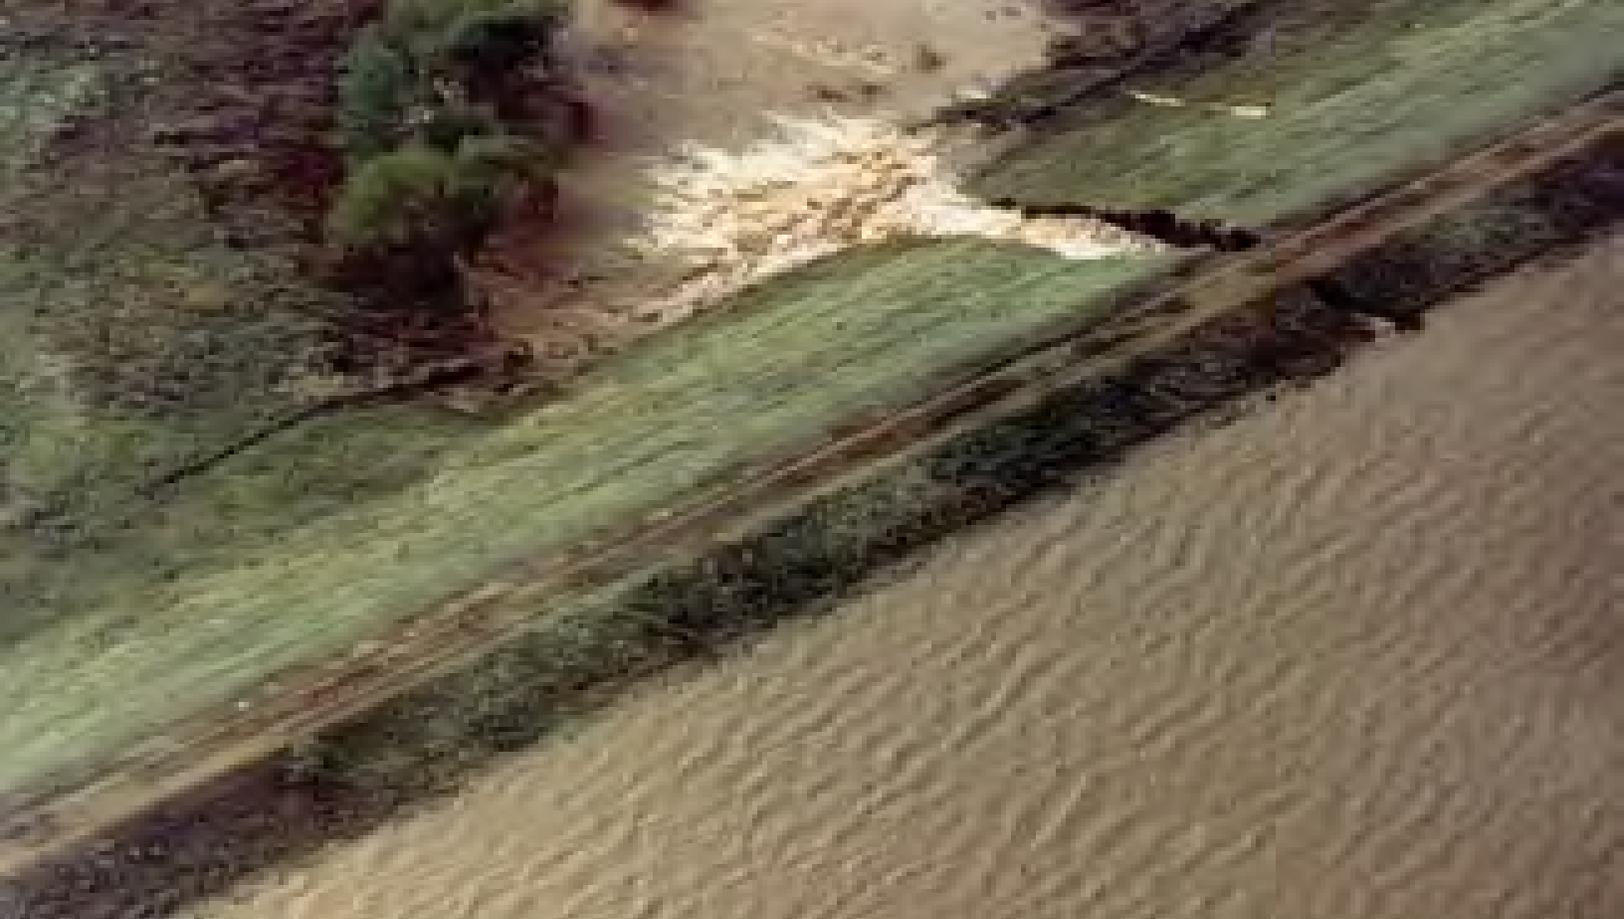
Cover photo: Upper Red Rock Site 20, Oklahoma – dam failure from seepage along poor lift joints in highly dispersive clay soil embankment.

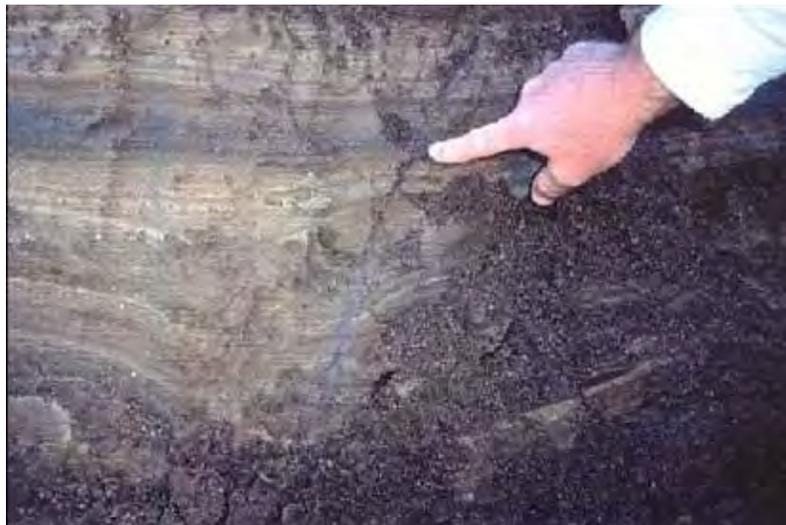
Figure 3-3.—Suspected hydraulic fracture at Ochoco Dam near the intake tower that was subsequently filled with reservoir sediments.

Hydraulic fracturing has been suggested to possibly have played a role in the failure of Teton Dam, which featured a very narrow, steep-sided cutoff trench backfilled with low plasticity soil.² It is believed that an example of hydraulic fracturing occurred at Ochoco Dam in Oregon (figure 3-3)³. The suspected hydraulic fracture was observed in an excavation near the intake tower and upstream portion of the outlet works conduit during dam safety modifications in the 1990s.

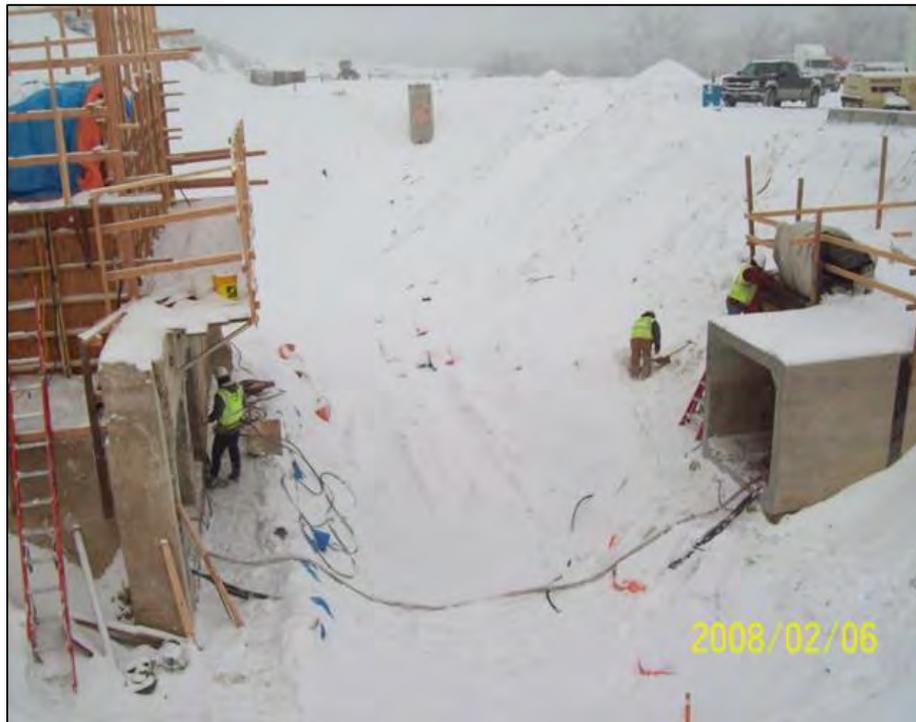
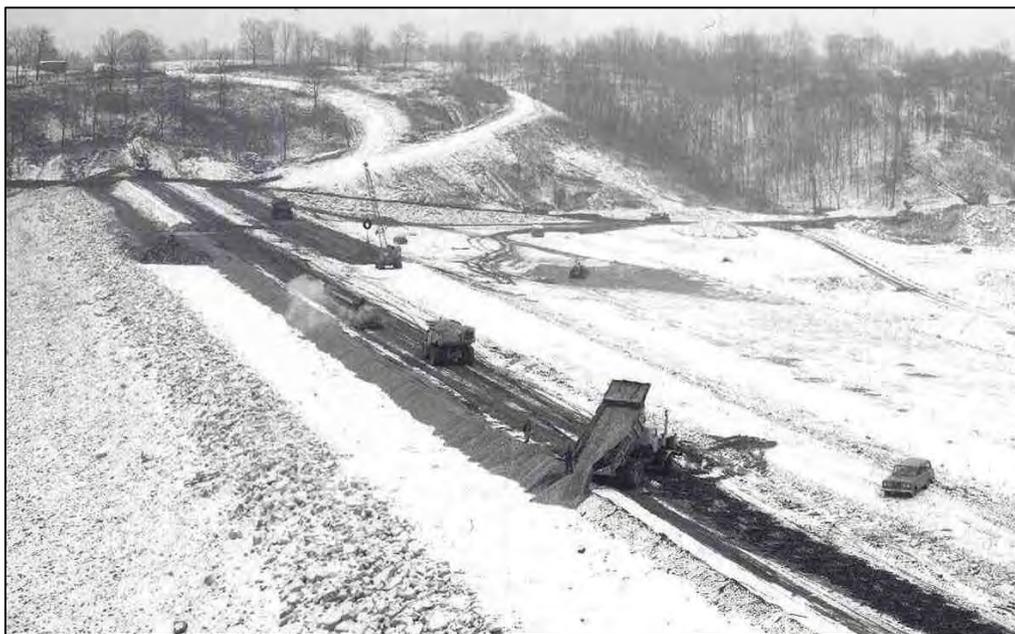
Figure 3-4.—Examples of winter construction at embankment dams prior to removal of snow and ice contamination. (Top) Blue blanket is insulated to prevent freezing of underlying soils. (Bottom) Placement of fill on improperly prepared frozen ground, snow, and ice.

In some cases, construction during winter is unavoidable. Similar to *Interruption in Fill Placement* described above, if the top lifts are allowed to freeze, a defect in the earthfill can result. Freezing may occur during temporary shutdown when the contractor chooses not to work until warmer weather returns or during winter shutdown when work is stopped for several months. Earthfill correctly placed and compacted originally will be damaged due to freezing action and will no longer have the properties of the specified lift. Ice and snow may also become mixed with the surface lifts of soil. Frost-damaged and ice-contaminated materials should be removed and replaced when better weather conditions return. Frost-susceptible soils such as silts and fine sands are of particular concern because ice lenses may form within them. Frost-damaged soils may be prone to development of preferential seepage paths and concentrated leaks. Examples of winter construction are shown on figure 3-4.

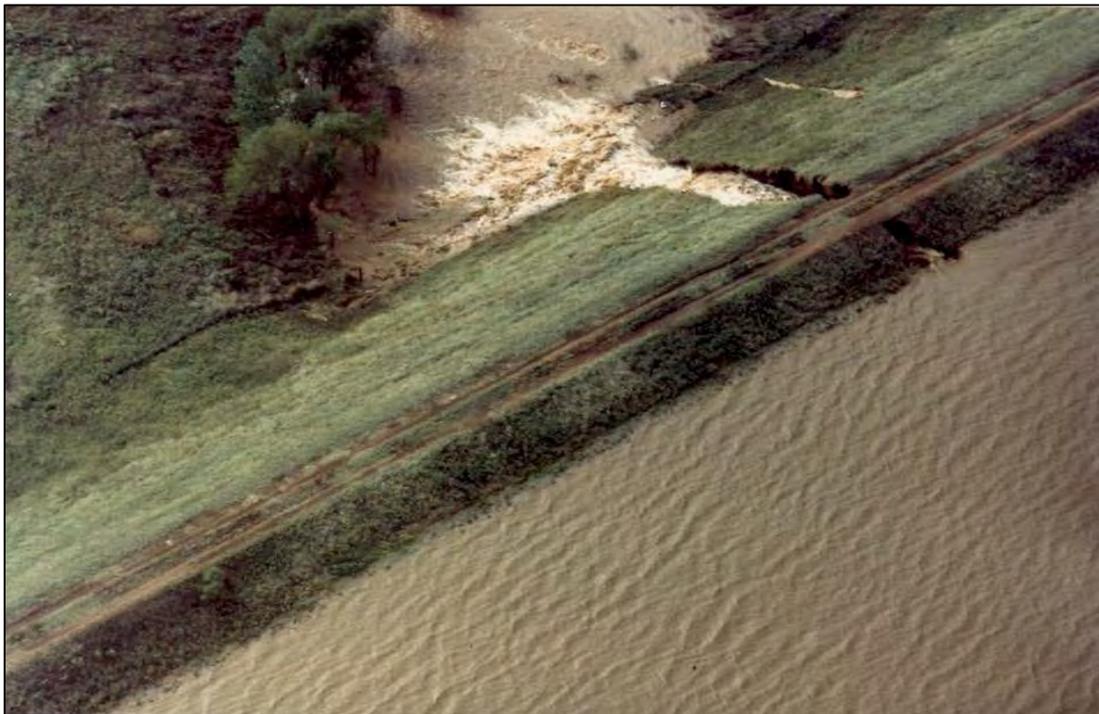
Figure 3-5.—Upper Red Rock Site 20 Dam internal erosion through dispersive soils.

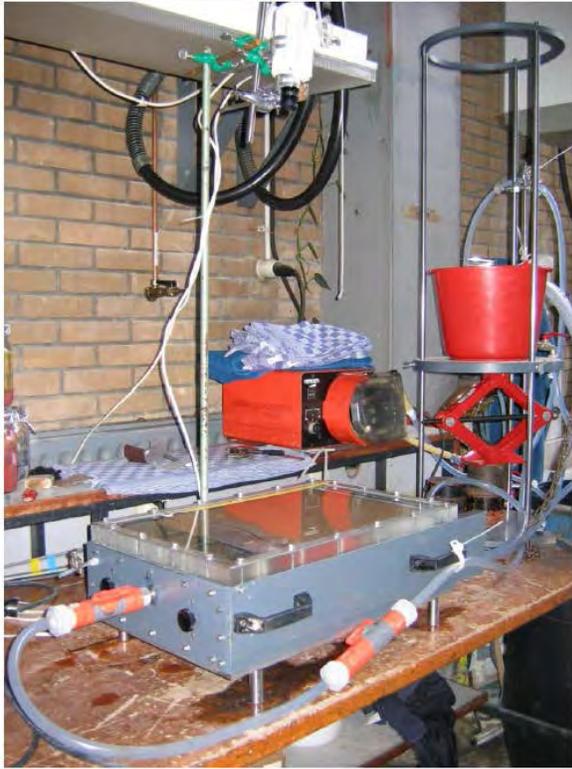
Figure 3-7.—Deltares small-scale laboratory test apparatus.

Research conducted by Geo Delft, which is now part of a Dutch organization called Deltares, through small- and large-scale piping tests indicated that low horizontal gradients could initiate piping (lower than the critical gradient calculated by Terzaghi's classical equation). Figure 3-7 shows the Deltares small-scale laboratory test apparatus, and figure 3-8 shows the large-scale field test. Progression of piping in the small-scale test is illustrated on figure 3-9. A conceptual "piping" model was proposed by Sellmeijer (1988), which was later updated by Weijers and Sellmeijer (1993), to estimate the critical gradient to initiate and progress backward erosion piping for dikes in the Netherlands. Based on the results of small, medium, and large-scale tests described in Van Beek et al. (2010), Sellmeijer et al. (2011) extended and updated this model and proposed an equation for the critical gradient required to advance a pipe toward the reservoir. The researchers noted that particle uniformity and particle size play a major role in initiation of piping and that less gradient is needed for piping to occur with more uniformly graded and smaller particle sizes. These researchers found that an equilibrium state is possible after initial development of pipes that did not progress to the upstream source of driving head (reservoir). By incrementally increasing the head, a critical/threshold head is reached, and the pipe erodes quickly to the upstream side. Erosion initiated, but did not progress, at heads that were 40 to 60 percent of the critical head needed for piping to both initiate and progress all the way upstream.

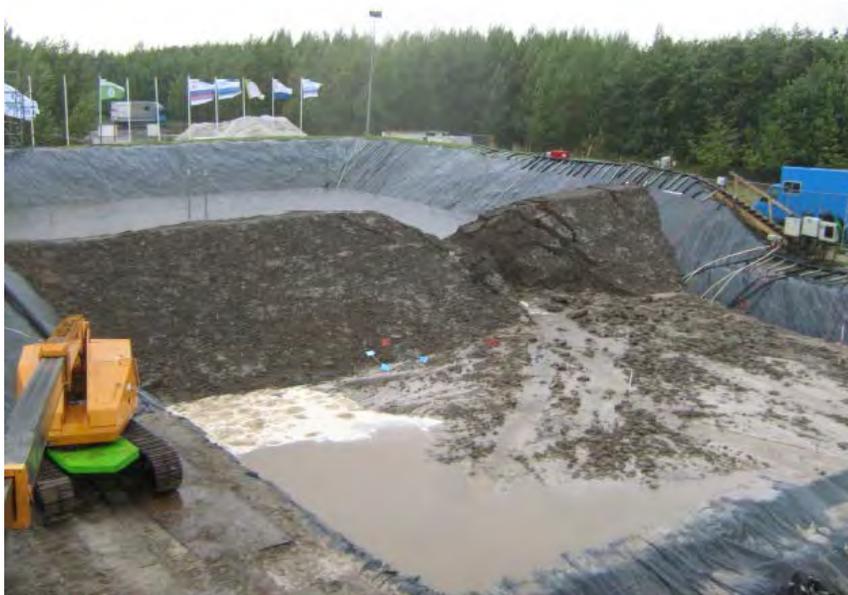
Figure 3-8.—Deltares large-scale field test (Van Beek).

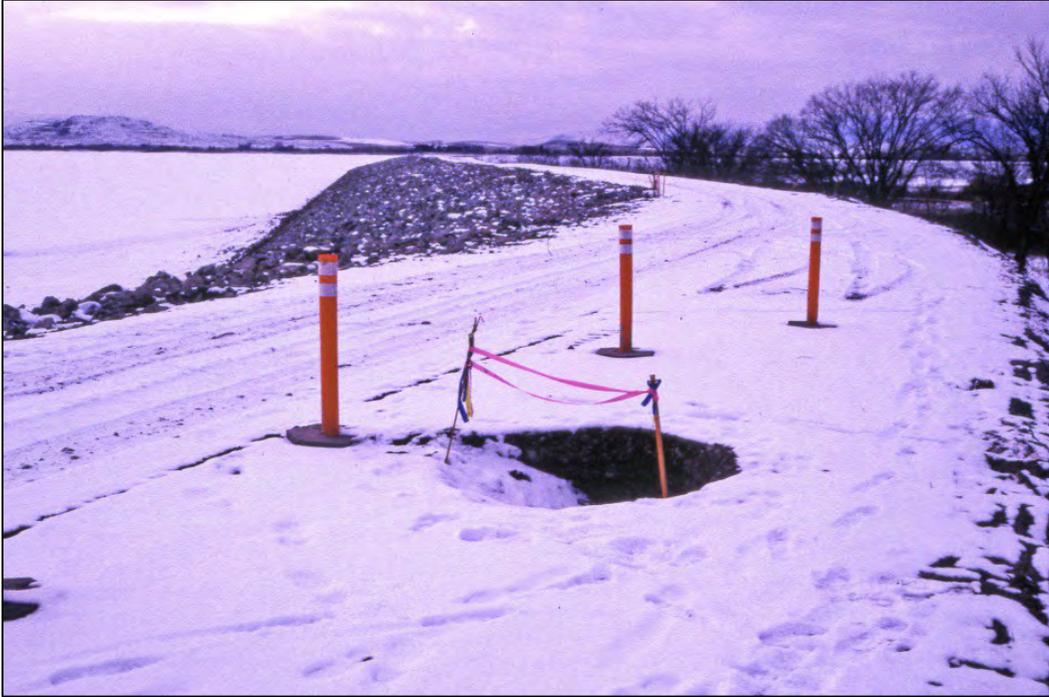
Figure 3-15a.—Sinkhole in crest of a dam in Montana.

There are many examples of stoping incidents. A large sinkhole (figure 3-14) developed suddenly in the crest of Willow Creek Dam⁸ due to this process, which took nearly 40 years to manifest. Another dam in Montana experienced a sinkhole on its crest due to internal erosion into a toe drain. The toe drain was original construction that was left in place after a downstream dam raise. The modified dam crest was located above the original toe drain, which served as an unfiltered exit (figure 3-15(a–b)).

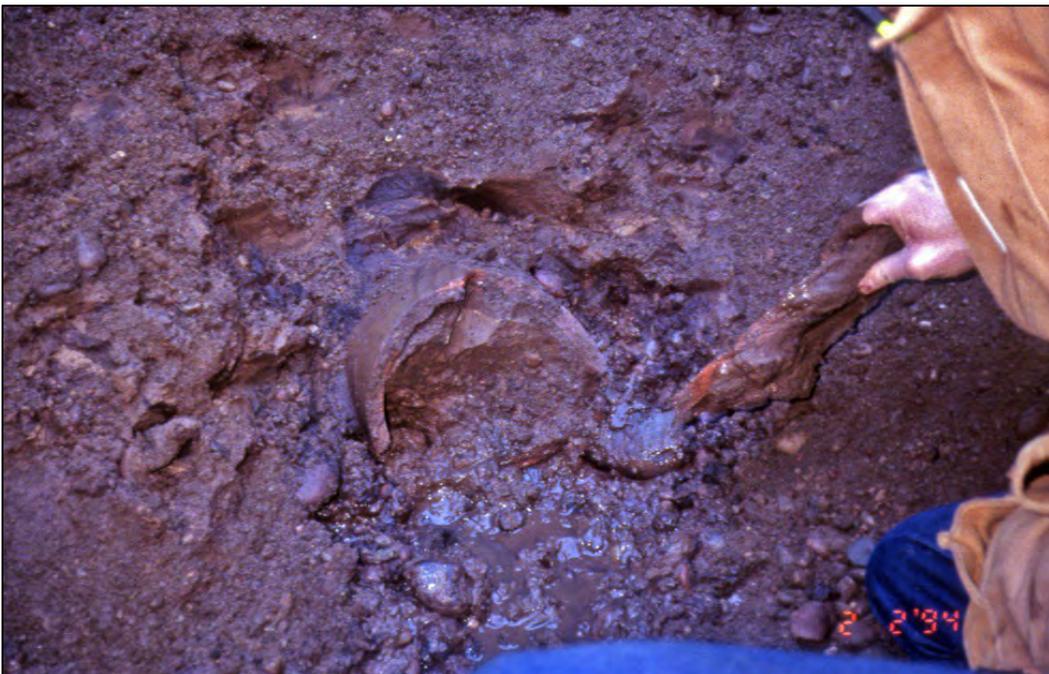
Figure 3-15b.—Excavation of the sinkhole shown in previous photograph revealed original toe drain below the sinkhole.

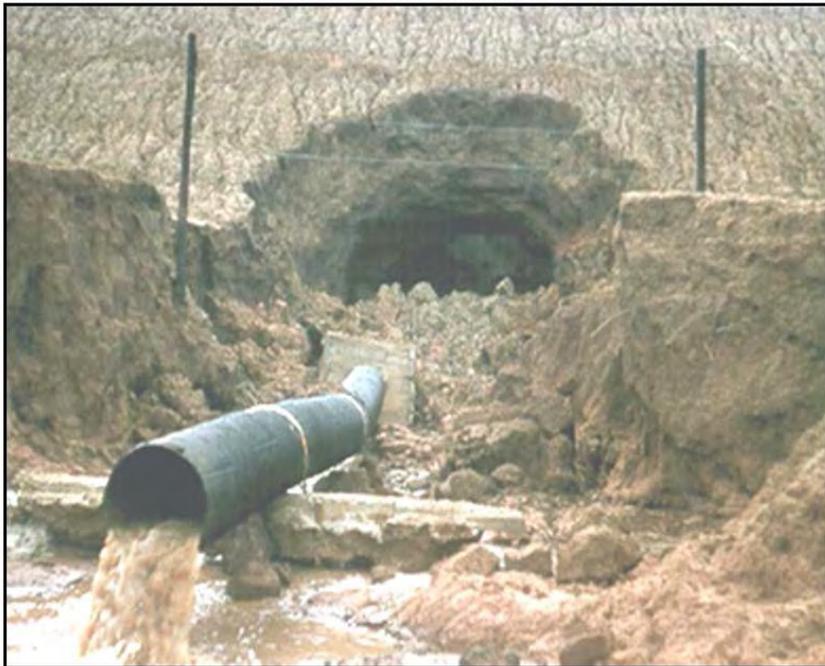
Figure 4-6.—Example of a dam that experienced gross enlargement, but the reservoir drained before erosion progressed to the point of crest collapse.

- *Gross Enlargement*: If the erosion pathway, or “pipe,” connects to the reservoir, rapid erosion and enlargement of the pipe could develop until the crest collapses into the pipe. If the amount of crest drop is greater than the available freeboard, overtopping of the embankment could quickly lead to a breach. It is also possible that if overtopping does not occur, the embankment could be severely damaged and breach could still occur by concentrated flow through cracks. Examples of gross enlargement include Teton Dam and Anita Dam.⁸ Figure 4-6 shows a dam that experienced gross enlargement, but the reservoir drained out before the pipe enlarged enough to cause the crest to collapse. If the likely breach mechanism for a PFM is breach by gross enlargement, as opposed to sinkhole development or sloughing, a breach is generally more likely to occur. If the downstream shell is unable to support a roof, sloughing/unraveling would be the more likely breach mechanism.

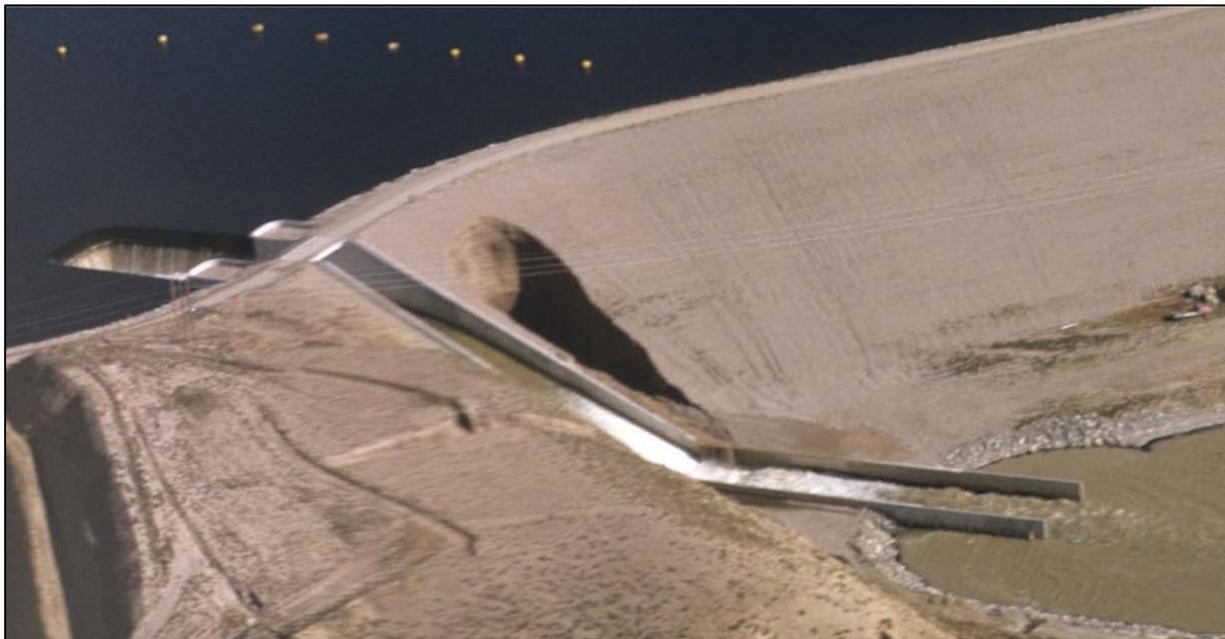
Figure 4-7.—Fontenelle Dam, which nearly breached by sloughing.

Reclamation's Fontenelle Dam in Wyoming nearly breached in 1965 by sloughing (figure 4-7), but the breach process occurred slowly enough so that the reservoir water surface was able to be lowered over the span of several days and arrest the breach. In contrast, Hell Hole Dam, a rockfill structure in California, failed from overtopping during construction in 1964, but handled a flow of about 13 cubic feet per second per foot before small slides and erosion began to progressively occur at the toe. Once this began, failure occurred within about 3½ hours (Leps 1973). The core of Reclamation's Minidoka Dam overtopped during construction (1904 to 1906), and the downstream rockfill zone withstood flows estimated up to 1,000 cubic feet per second. The water surface elevation was 8 feet below the normal water surface when the core overtopped. Figure 4-8 shows the maximum section of Minidoka Dam, which is approximately 80 feet high.

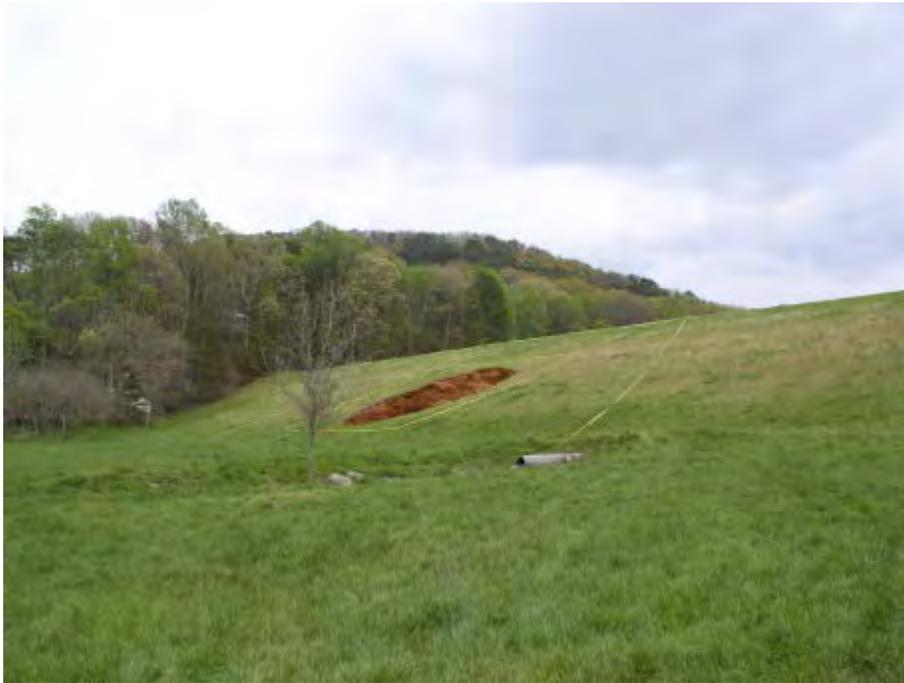
Figure 4-9.—Sallacoa Dam experienced a large sinkhole from internal erosion into a karst foundation.

- Sinkhole Development:* This mechanism refers to stoping of material upward, creating a sinkhole or depression in the crest that drops below the reservoir level. For breach to occur, the sinkhole would need to be large enough to lead to overtopping. USACE’s Wolf Creek Dam⁹ was constructed over karst features and has experienced numerous sinkholes. Due in part to concern that sinkholes may lead to potential breach, major mitigation measures have been undertaken. Sallacoa Dam¹⁰ also experienced formation of a large sinkhole for similar reasons (figure 4-9).

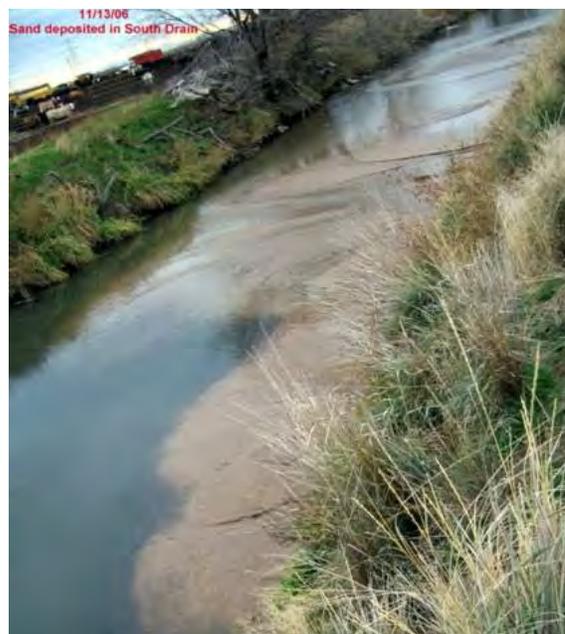
Figure 6-1.—Visual observation of failure mode in progress.

In November 2006, a local landowner riding a horse noticed seepage and soils exiting from the cut slope of the south drain on the A.V. Watkins Dike¹ in northern Utah (Demars et al. 2009). He called authorities, and the Bureau of Reclamation began emergency drawdown of the reservoir and 24-hour monitoring. Figure 6-1 illustrates the failure mode that was in progress when the first responders arrived.

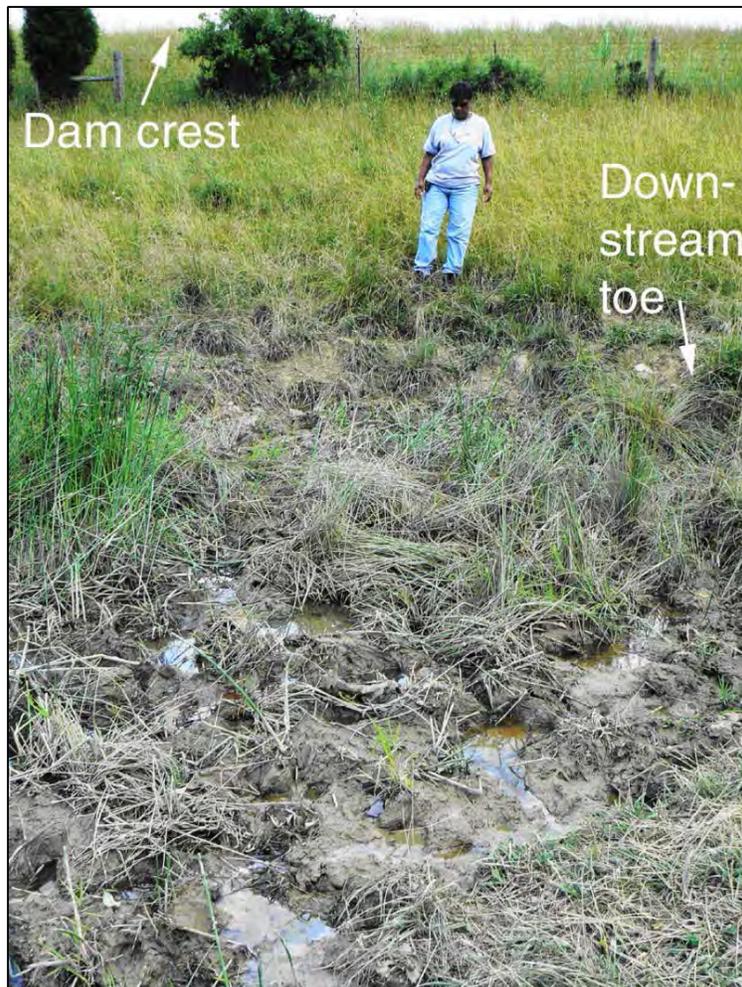
Figure 6-2.—Seepage discharge where the typical grass growth has been retarded in the saturated soil environment and where other vegetation species are becoming dominant.

Emerging surface seeps are harder to detect if there are no visual surface anomalies such as increased vegetation growth. Often a seep is indicated by a change in vegetation type (phreatophyte) or lushness. Non-visual techniques discussed later in this chapter may be performed to identify and delineate surface seeps if the perceived threat warrants additional investigation. Monitoring the surface seeps may be as simple as flagging their location and areal spread as illustrated on figure 6-4. In this illustration, the yellow flags mark the initial seepage discharge boundary, and subsequent lateral spreading is tracked with red flags. The location of the flags should be photographed, measured and mapped, and ultimately a decision made

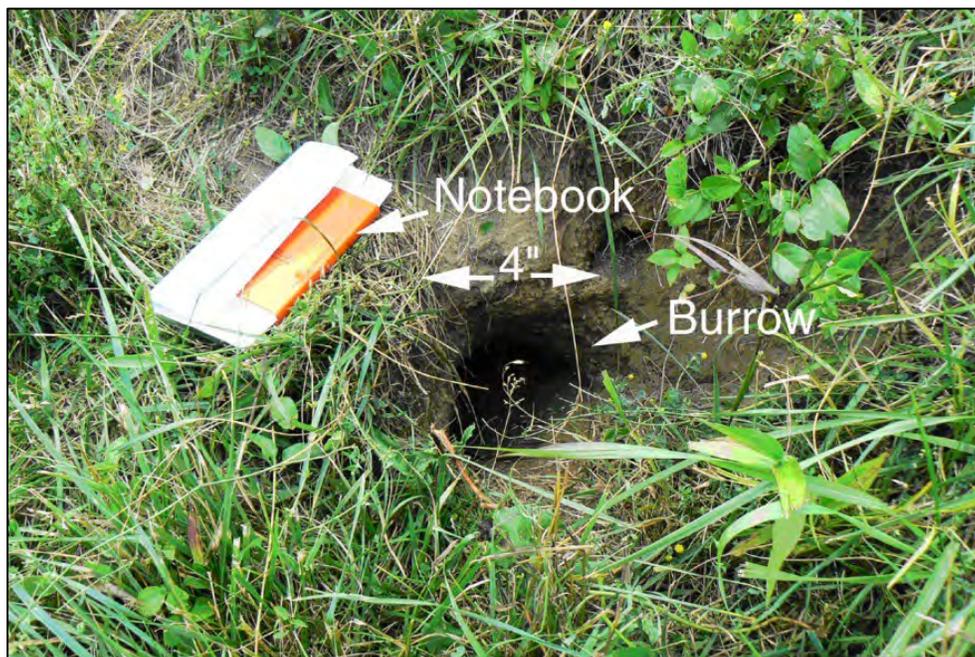
Figure 6-7.—Surface deformation indicative of animal activity observed on the downstream slope.

Figure 6-7 illustrates a small rodent burrow found in the downstream shell of an embankment dam. Figure 6-8 illustrates surface-erosion features (gullies) that also were not caused by internal seepage processes but could eventually become a preferential flow path if not repaired. A series or group of rodent holes may be an indication of low stress or cracked zones in the fill, as rodents tend to dig where it is easiest.

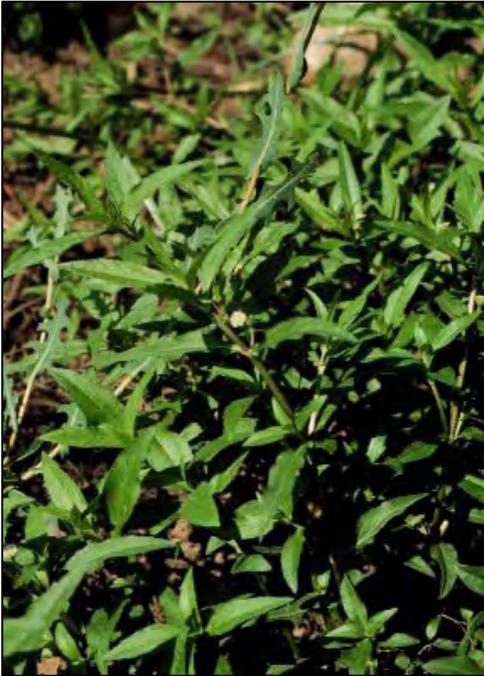
Figure 6-9.—Photograph shown without a visual reference or scale to establish the plant's size.

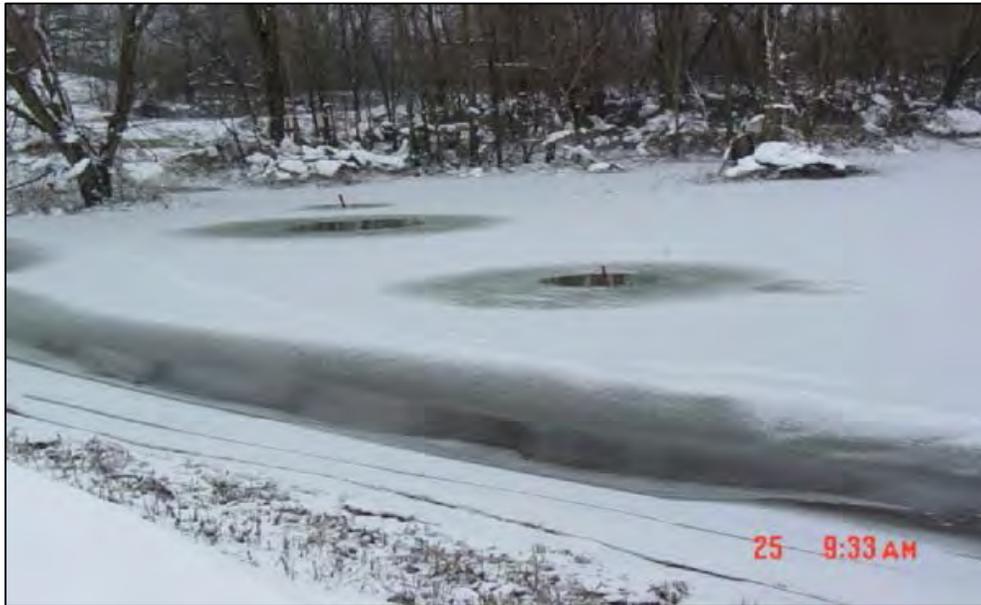
Figure 6-11.—Seepage water discharge locations (flagged with red markers) are more evident during the winter due to water temperature differences.

As water flows from its supply source into the dam or foundation materials, its temperature will change. Typically, deeper water is insulated from air temperature changes and remains at a relatively constant temperature. Influx of water from rivers or lakes will be reflected by temperature changes. Figure 6-11 shows seepage discharge locations that are easily identified during wintertime when the temperature difference between surface water and subsurface seepage is highest.

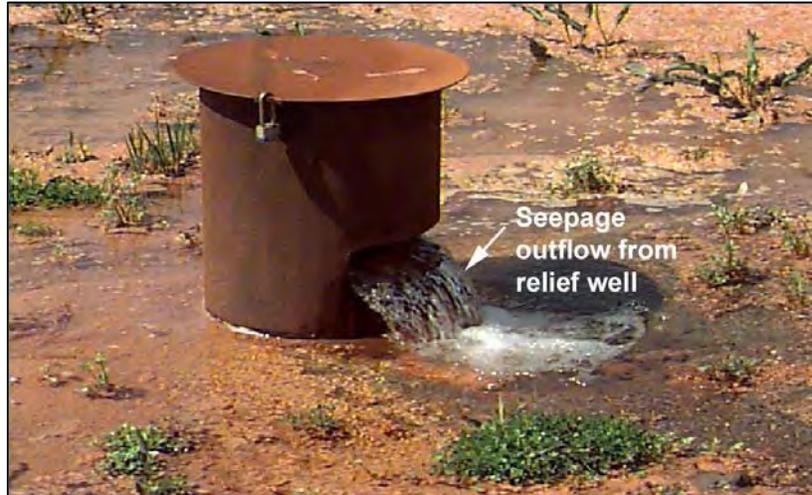
Figure 7-9.—Relief well seepage outflow. Although relief wells are not typically installed for the primary purpose of seepage water monitoring, their outflow can be collected, measured, and evaluated similar to open piezometers or observation wells.

Relief wells also function as observation wells, but their primary purpose is to reduce the hydraulic head at selected locations along the seepage flow path.³ Figure 7-9 shows a relief well discharge where the seepage water could be collected if necessary.

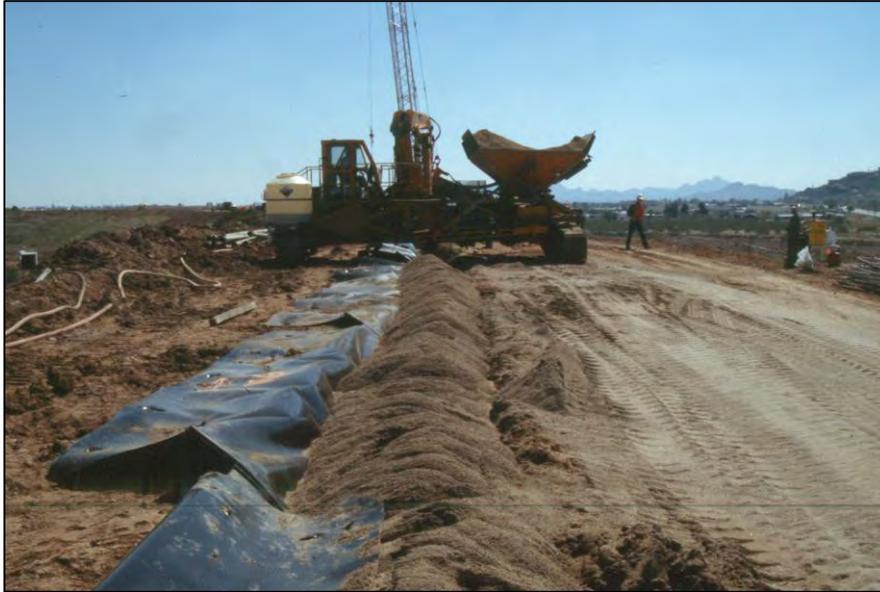
Figure 10-1.—Geomembrane cutoff with sand filter on Reach 11 Dike, Arizona.
(Photo courtesy of Reclamation)

Reclamation constructed a geomembrane cutoff wall at Reach 11 Dikes⁵ in Arizona. The cutoff consisted of both an impermeable barrier and a sand filter to mitigate the potential for internal erosion failure of the cracked flood protection dikes (figure 10-1). A trench was excavated

through the crests of the embankments, supported by biodegradable slurry. Stiff geomembrane panels of 80 mil high-density polyethylene were lowered into the trench. Interlocks similar to those on sheet piles enabled the construction of a continuous wall. The trench was then backfilled with filter sand (by tremie pipe) as an extra measure of protection against internal erosion. In principle, the biodegradable slurry completely decomposes and leaves no trace of an impermeable filter cake, thus permitting a filter to be an effective second line of defense. Since Reach 11 is a flood control feature, it is not loaded on an annual basis. As of the preparation of this manual, the structure had not been loaded; therefore, the performance of the repair has not been evaluated.

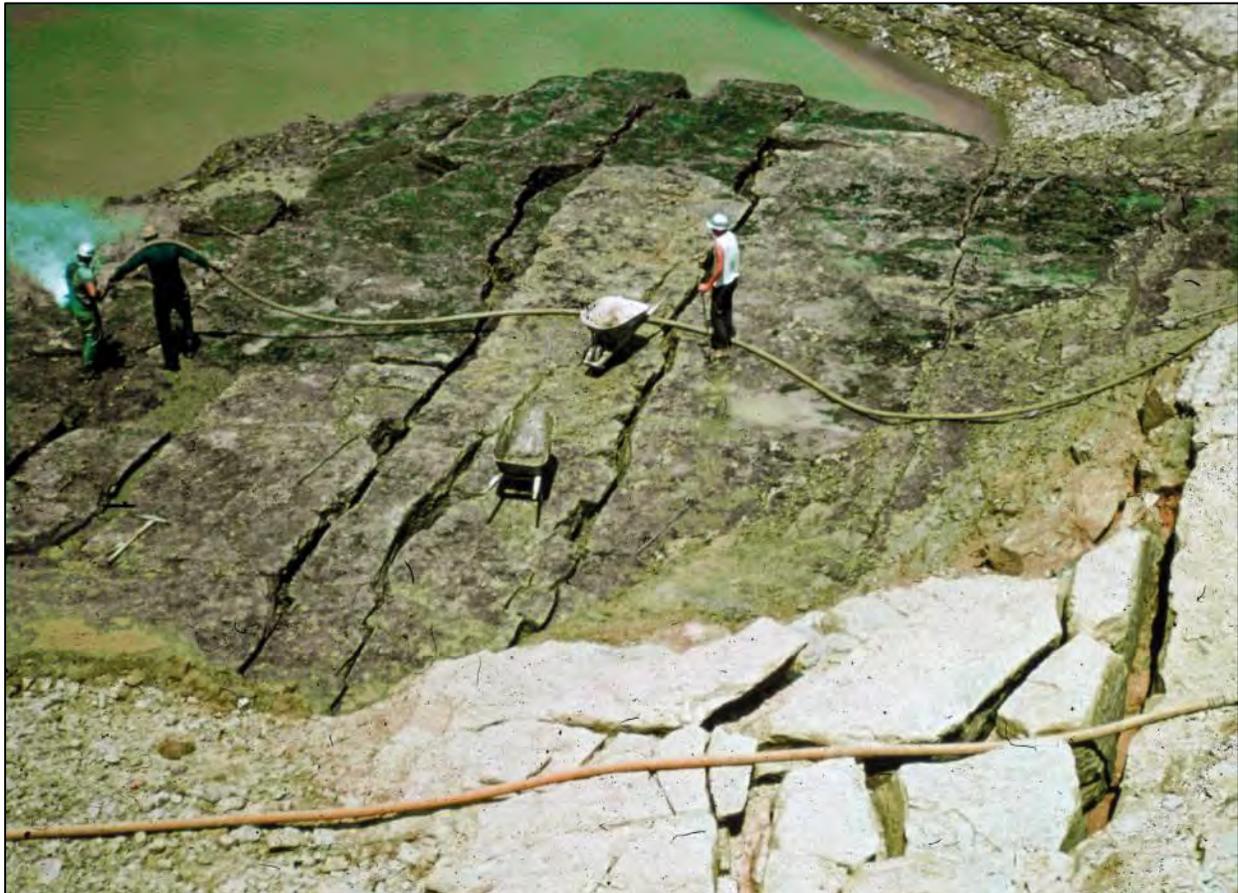
Figure 10-4.—Pressure washing joints and fractures in bedrock prior to dental grouting and covering with a blanket under the downstream shell of a dam. (Photo courtesy of NRCS)

Blankets must provide filter compatibility between foundation soils or bedrock that is not filter compatible with the overlying embankment. A properly designed blanket will protect finer embankment soils from piping into underlying coarser foundation soils or bedrock with joints and fractures as shown on figure 10-4. It can also protect foundation soils from piping into a coarser overlying embankment zone.

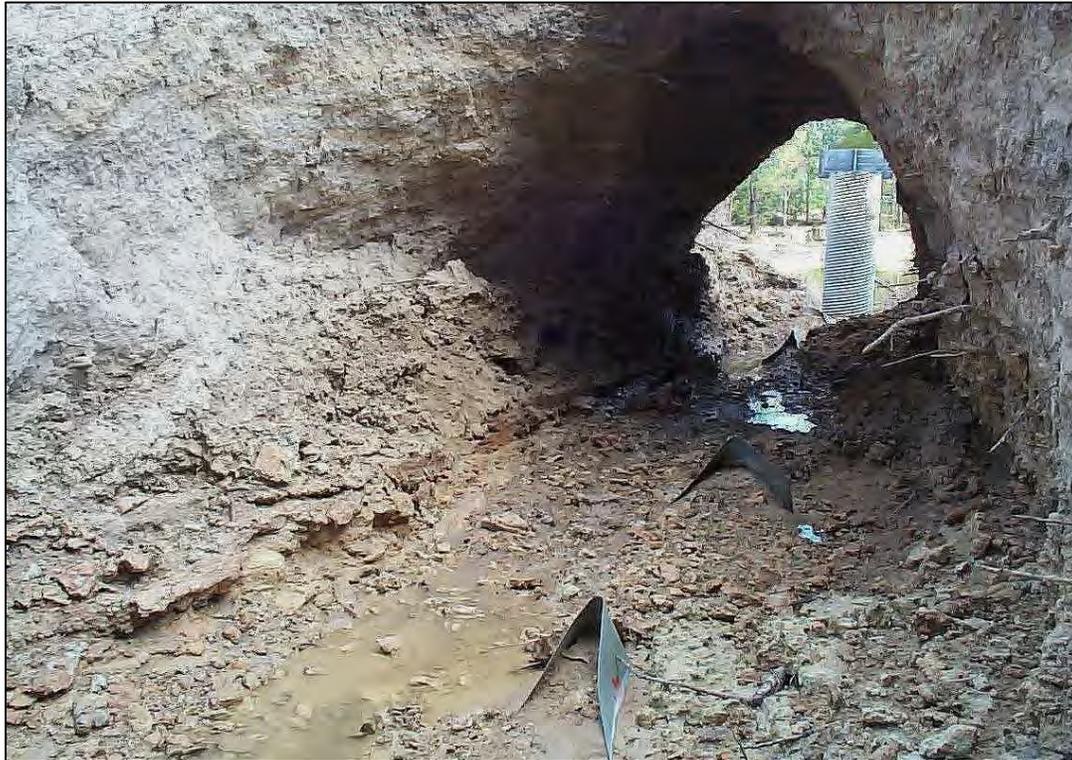
Figure 10-8.—Failure of an earth embankment in Louisiana along the principal spillway conduit, looking upstream toward riser. Notice damaged anti-seep collars on conduit. (Photo courtesy of NRCS, Louisiana)

Figure 10-8 shows the failure of a small dam in Louisiana consisting of dispersive soil, presumably due to cracking and concentrated leak erosion in the vicinity of the principal spillway conduit. Failure occurred during the first filling. It is noteworthy that metal anti-seep collars were used on the original conduit instead of a filter diaphragm. An opening was excavated through the embankment to access the conduit, and a filter diaphragm was installed around the conduit. The diaphragm extended across the full width of the opening and was successful in mitigating the problem.

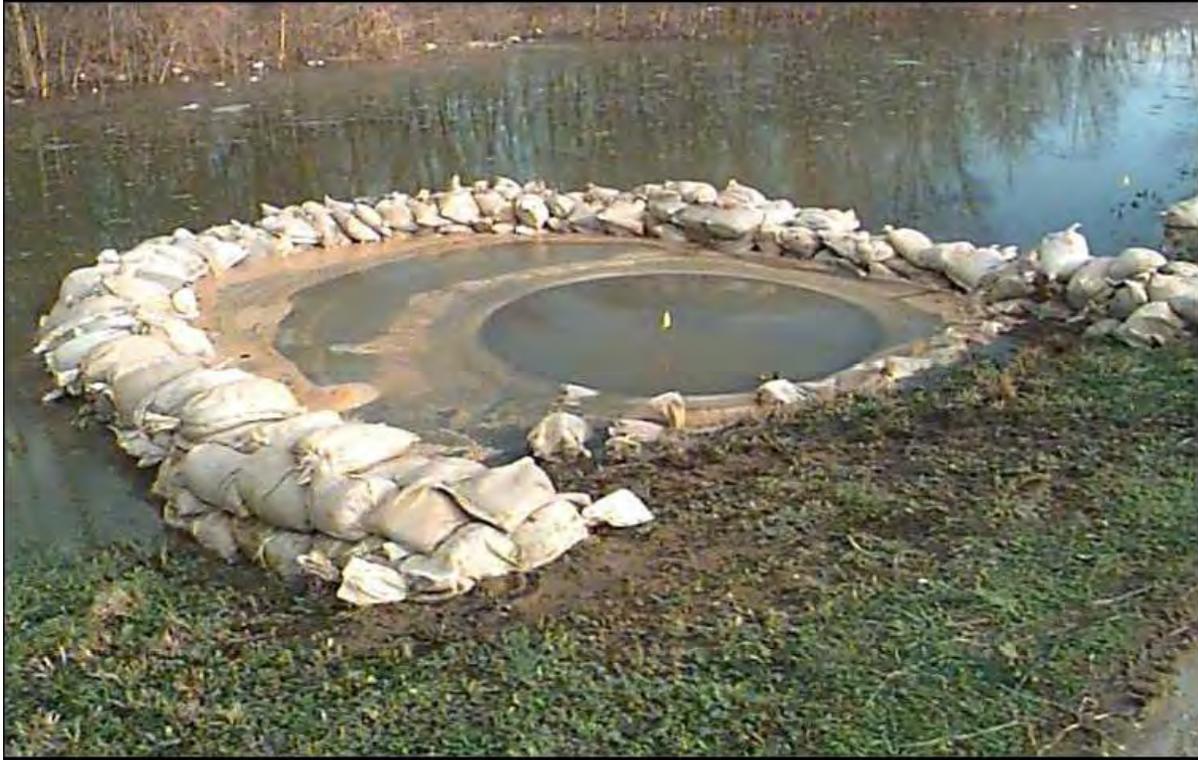
Figure 10-14.—Sandbags placed around a sand boil to increase tailwater level as part of a temporary risk reduction measure. (Photo courtesy of USACE, Missouri Valley Division)

Increasing the tailwater level on the downstream side of a dam reduces the potential for piping by decreasing both the exit gradient in the downstream area as well as the overall gradient under the embankment. Placing sandbags around a sand boil to elevate the tailwater level on the boil (figure 10-14) is a common flood-fighting practice. If the outlet channel of a dam is a critical location for uplift, then installing a hydraulic structure in the channel to permanently raise the water level can be a non-invasive, low-cost measure to control uplift. The effects of greater submergence on the conduit and any outlet structures must be considered in the remediation design. The water control structure must also be designed to survive the highest flows to which it may be subjected.

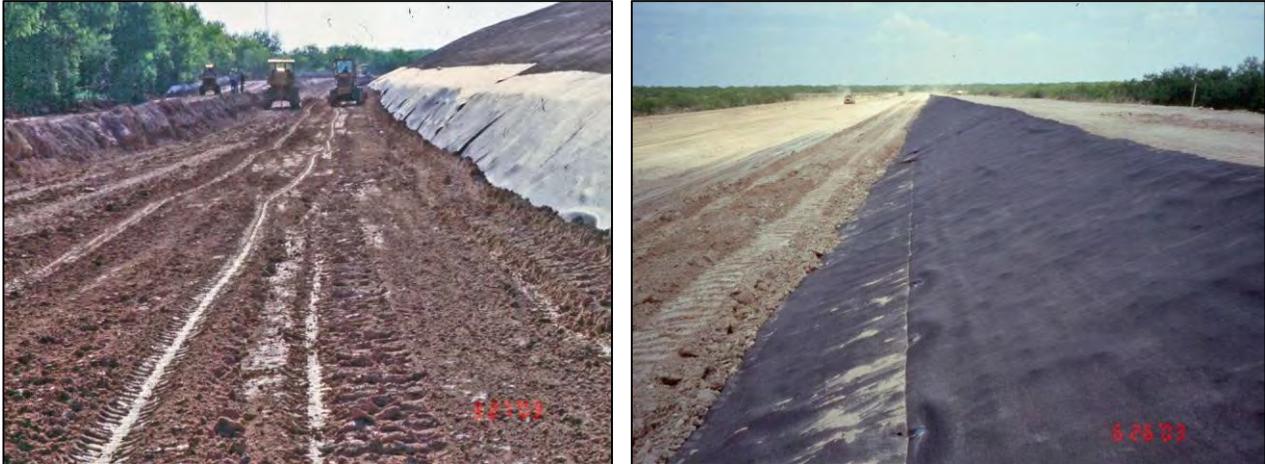
Figure 10-18.—Construction of geotextile barrier in Olmitos-Garcias No. 2 Dam in south Texas. The downstream side of the embankment is shown. Left – geotextile being backfilled in foundation trench. Right – geotextile on back slope of dam prior to backfilling. (Photos courtesy of NRCS, Texas)

Under certain circumstances, barriers for remediation have also been constructed using geotextiles in place of granular filter materials (Doerge 2010). If a geotextile is used as the sole element in the barrier, then it must be designed to be able to span any open cracks in the fill. Figure 10-18 shows a geotextile barrier under construction in the Olmitos-Garcias No. 2 Dam⁷ in south Texas. A heavy (16 ounce per square yard) non-woven geotextile was used in this project.

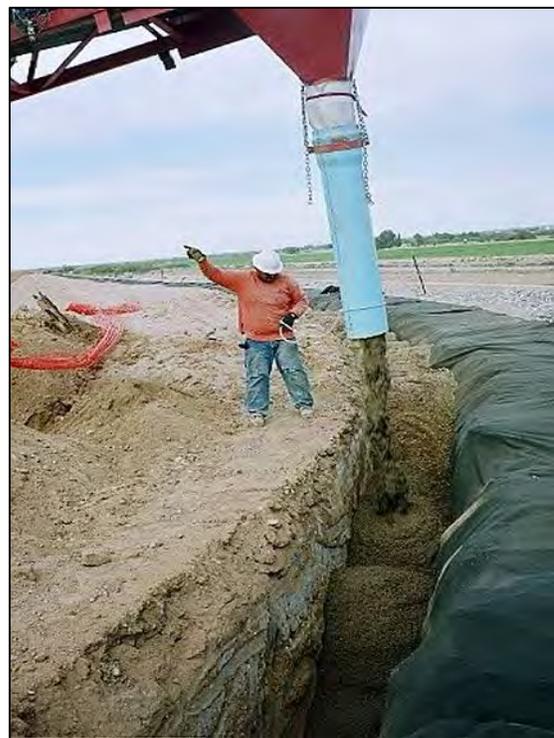
Figure 10-19.—Construction of a geotextile/aggregate chimney filter in Florence Dam in Arizona. Geotextile drape is on right (downstream) side of trench. (Photo courtesy of NRCS, Arizona)

To overcome the problems illustrated on figure 10-17, a geotextile can be used in conjunction with a granular chimney filter. In Florence Dam⁸ in southern Arizona (Doerge 2010), a geotextile was draped on the downstream face of the centerline trench prior to backfilling the trench with appropriately graded granular filter material (figure 10-19). In this case, the

geotextile served to span existing or future cracks in the fill and retain the filter material within the filter trench. The geotextile is theoretically not required below the depth where cracks become narrow enough to be filter compatible with the filter material itself.

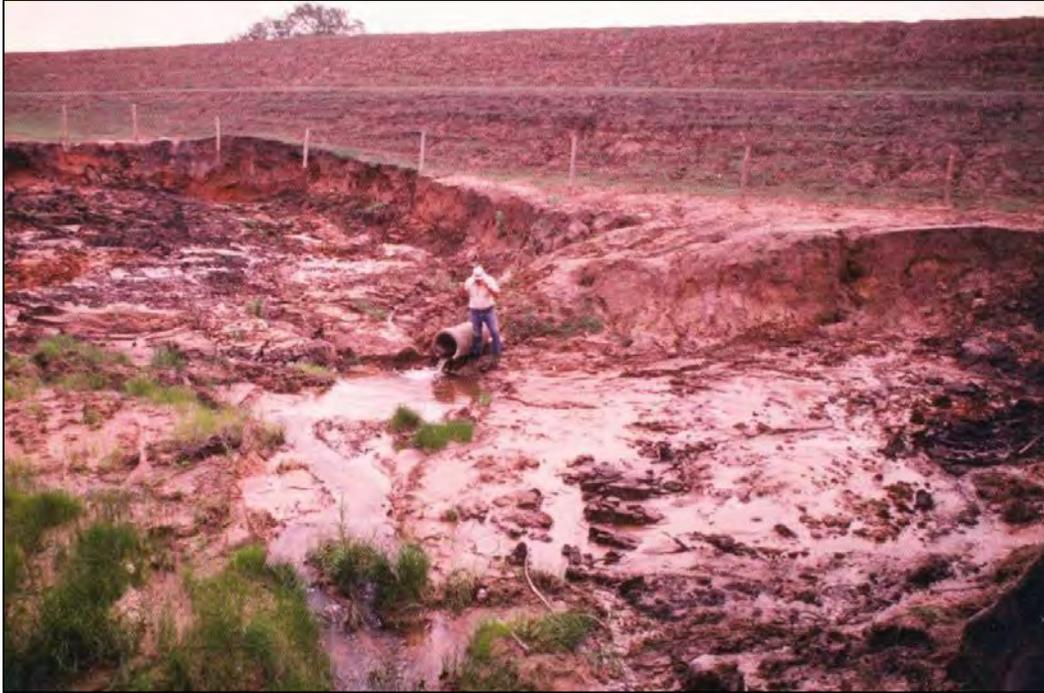
Figure 10-21.—Seepage-caused slope instability near outlet of principal spillway conduit, Little Washita No. 13, Oklahoma (1979). (Photo courtesy of NRCS, Oklahoma)

An example of a dam that was decommissioned to remediate seepage problems is Little Washita No. 13 Dam,¹⁰ a flood control dam in Oklahoma with gypsiferous foundation soils. The homogeneous earth embankment was 34 feet high and was constructed in the late 1970s. Following initial construction, the seepage resulting from the impounding of the reservoir began to dissolve the gypsum salts present in the foundation. This process greatly increased the seepage through the foundation and caused slope stability problems in the outlet basin and on the downstream slope of the embankment (figure 10-21). Various remedial actions were taken, including flattening slopes, installing drainage features, as well as several rounds of foundation grouting. The measures were temporarily effective, but the seepage problems reappeared following continued solutioning within the foundation. Sinkholes have been observed in the reservoir area on many occasions (figure 10-22). Finally, it was decided that the only permanent solution was to breach the dam and decommission it.

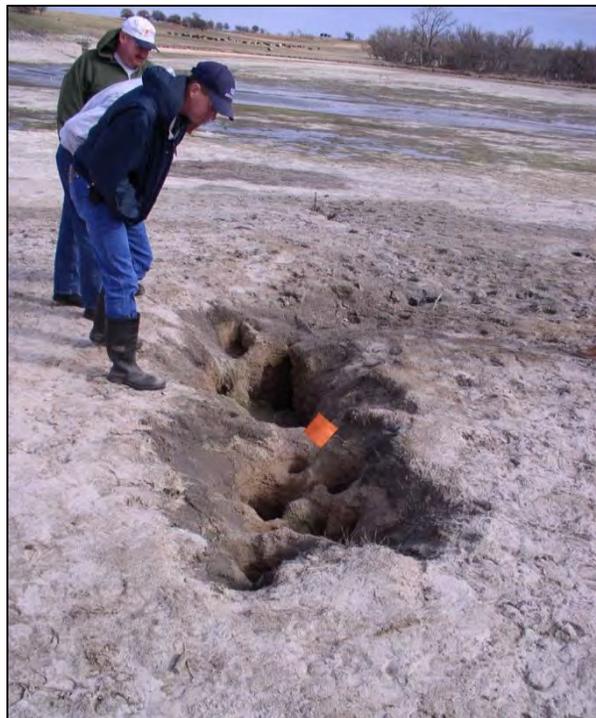
Figure 10-22.—Sinkhole in reservoir area of Little Washita No. 13, Oklahoma. (Photo courtesy of NRCS, Oklahoma)

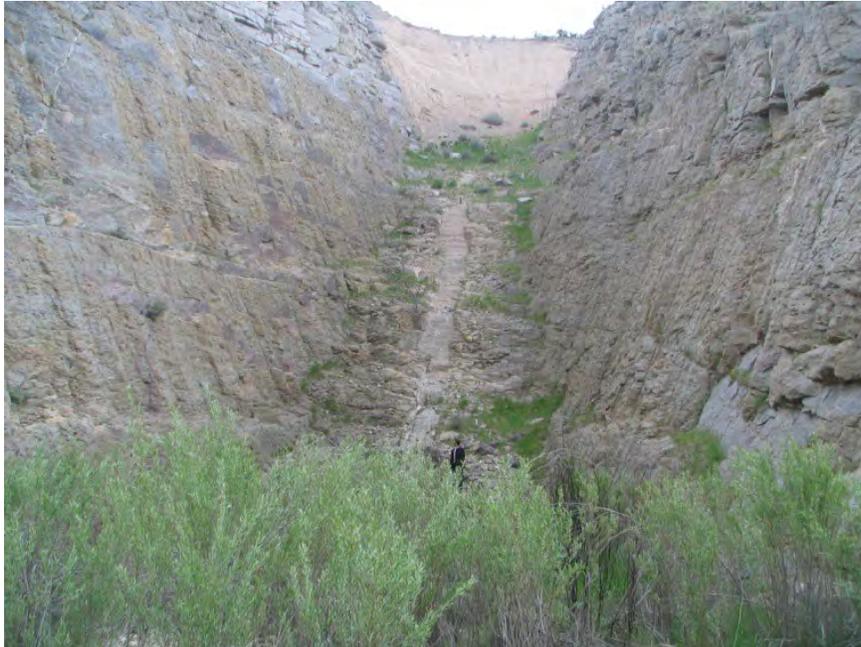
Figure 4.—Narrow, 70-ft-deep abutment cutoff trench. Man shown for scale (photo courtesy of James Wright 2007).

A 70-ft-deep excavation was made in the bedrock at the right abutment for the cutoff trench. There was a lack of foundation shaping and treatment in the cutoff trench. No shotcrete, dental concrete, or slush grout was used in the floors or walls of the cutoff excavation. Widely open joints were sealed with bucket grouting, and a grout cap was placed along the cutoff trench floor for installation of the grout curtain. Fine materials used in the core of the dam were placed against untreated bedrock. A grout curtain was installed the full length of the dam with grout holes on a single line. Grout holes of the primary curtain were spaced 10 ft apart. The grout curtain extended to depths of as much as 300 ft, and split spacing was used where needed.
