Evaluation and Monitoring of Seepage and Internal Erosion

Interagency Committee on Dam Safety (ICODS)

FEMA P-1032 /May 2015

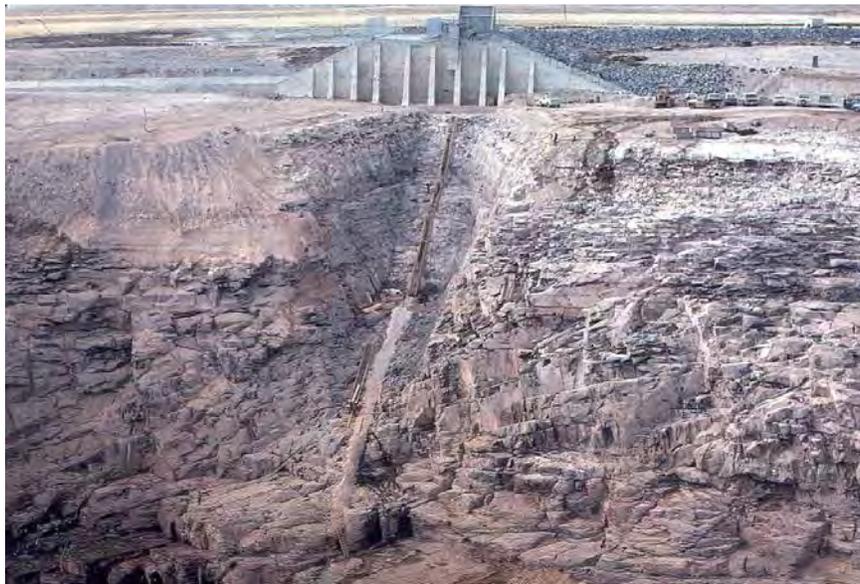
Figure 5.—Deep, highly fracture zone under the right abutment cutoff trench. Joints were generally open, some as much as 2 inches.

It is critical to recognize that the joints, fractures, and openings in the downstream wall of the cutoff trench and the remaining foundation downstream from the trench were severely incompatible with respect to filtering and retention of the very fine-grained, erodible core

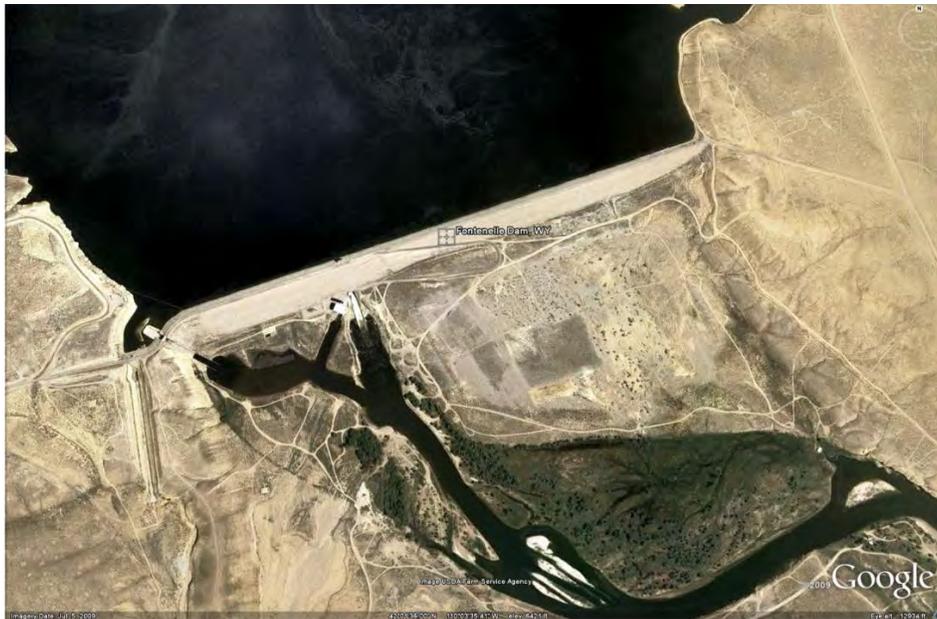
Figure 1.—Fontenelle Dam (Google Earth, July 5, 2009).

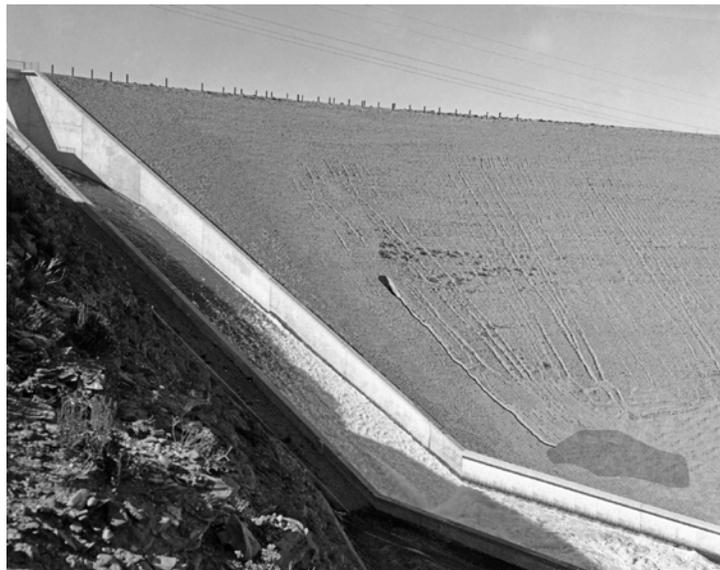
Figure 3.—First appearance of sinkhole, with drainage.

On the morning of September 3, 1965, a wet spot appeared near the left side of the spillway on the downstream slope of the embankment at about mid-height at elevation 6458 (figure 3). The reservoir filled rapidly under flood conditions and was about 1.6 ft above the spillway crest at the time. By mid-afternoon, water was flowing from the area, causing erosion and sloughing. By evening, the flow from the wet area of the embankment was estimated at 5 ft³/s.

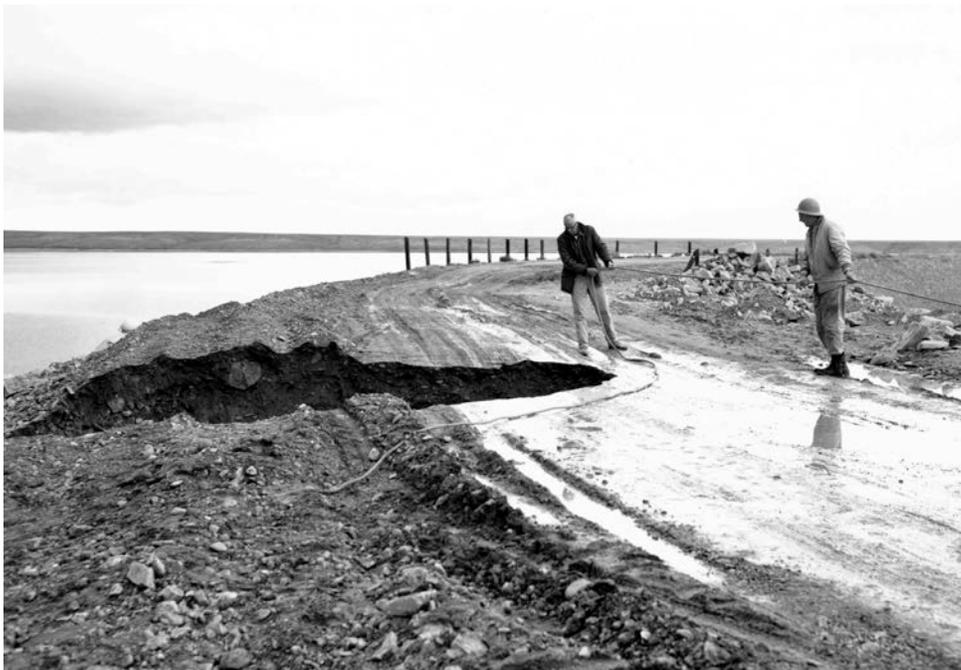
Figure 4a.—20-ft-diameter sinkhole on upstream side of dam crest. (Standing near the edge of a large sinkhole while hanging onto a rope is considered extremely dangerous and is not recommended.)

On the morning of September 6, the flow remained stable. However, later that afternoon, an area on the dam crest about 20 ft in diameter, with its center near the upstream edge of the crest, suddenly collapsed with a drop of approximately 33 ft (figure 4a). Bedrock was exposed on the abutment side of the newly created cavity, and water appeared to be issuing from cracks in the rock. Heavy rock was dumped into the hole to stabilize the area against further collapse (figure 4b). A cross section at the sinkhole locations is shown on figure 4c.

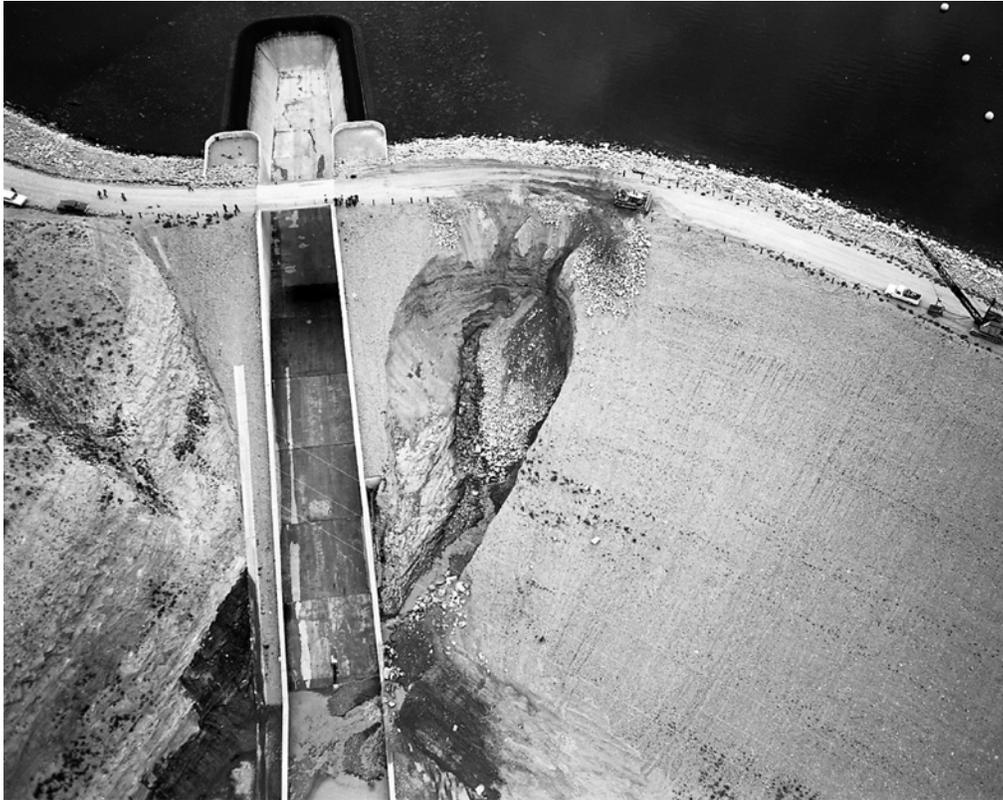
Figure 4b.—The sinkhole migrated in the upstream direction, expanding in size, as material progressively caved from the sides and was washed out of the bottom (stopping).

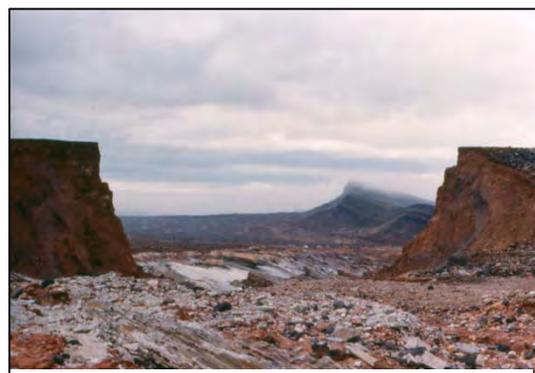
Figure 1b.—Breach through Quail Creek Dike.

The maximum height of the dike is about 78 ft with a crest width of 20 ft and an overall length of about 1,980 ft. The breach was approximately 140 ft wide and 80 ft deep (figure 1b). The foundation for this earthen dam consisted of dipping beds of sedimentary rock that strike almost perpendicular to the axis of the dike (figure 2). The construction of Quail Creek Reservoir took place in 1984, about 8 yr after the failure of Teton Dam, yet there were few additional measures taken to address the potential for concentrated leakage from constructing an earthen embankment on a rock foundation. The dam was constructed as a zoned earth embankment with a 10-ft cutoff trench (figure 3).

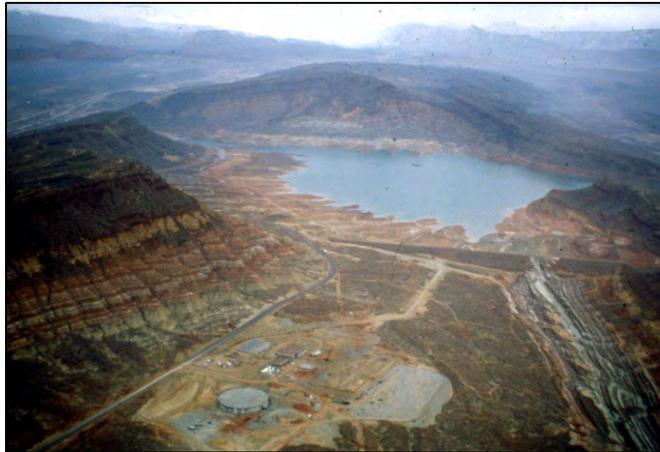
Figure 2.—The breach of the dike is located on the right limb of a large anticline where the rock outcrop extends beneath the dam in an upstream- downstream orientation.

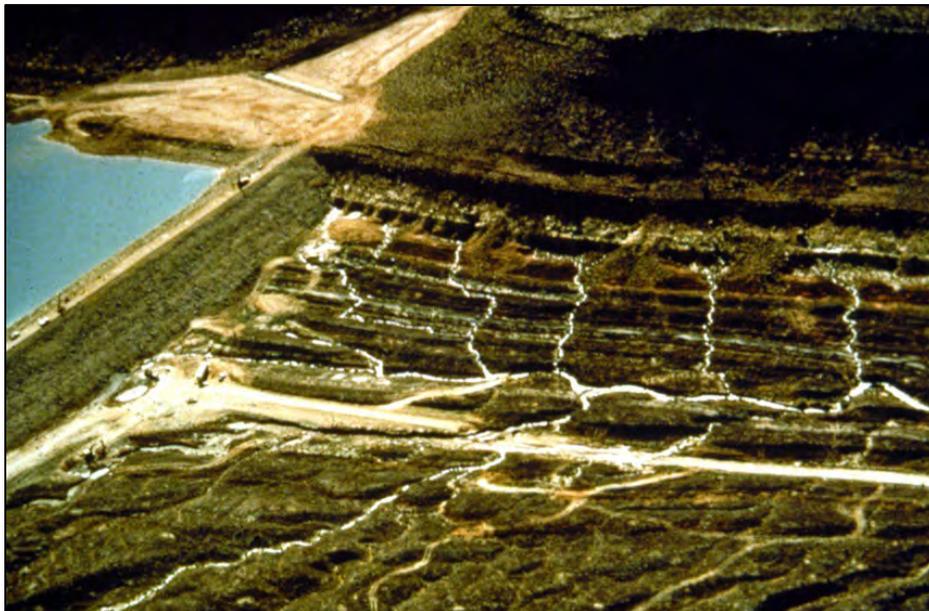
Figure 5.—Excessive leakage during first filling.

Foundation grouting was the selected remediation after excessive leakage occurred during first filling in 1985, 4 yr prior to the breach (figure 5).

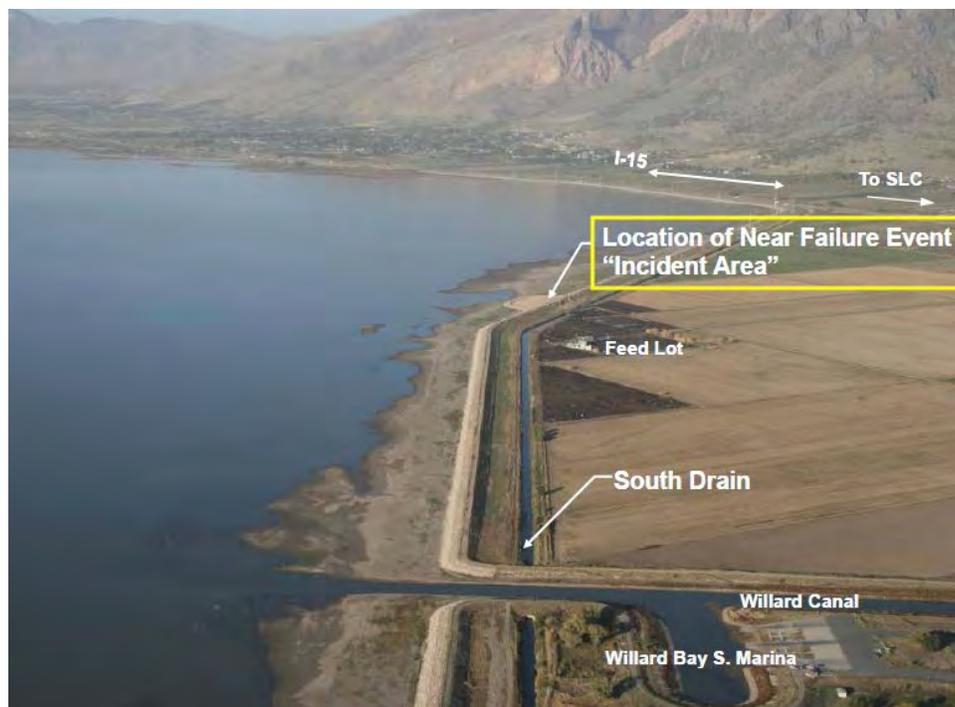
Figure 4.—Aerial view of the western portion of the dam showing the incident location in relation to the South Drain and feedlot.

In November 2006, a local landowner riding a horse noticed seepage and soils exiting from the cut slope of the South Drain. He called authorities, and Reclamation began emergency drawdown of the reservoir and 24-hr monitoring. Figure 2 illustrates the failure mode that was in progress when the first responders arrived, and figure 3 shows sediments eroded into the South Drain. Figure 4 is an aerial view of the western portion of the dam that indicates the incident location.

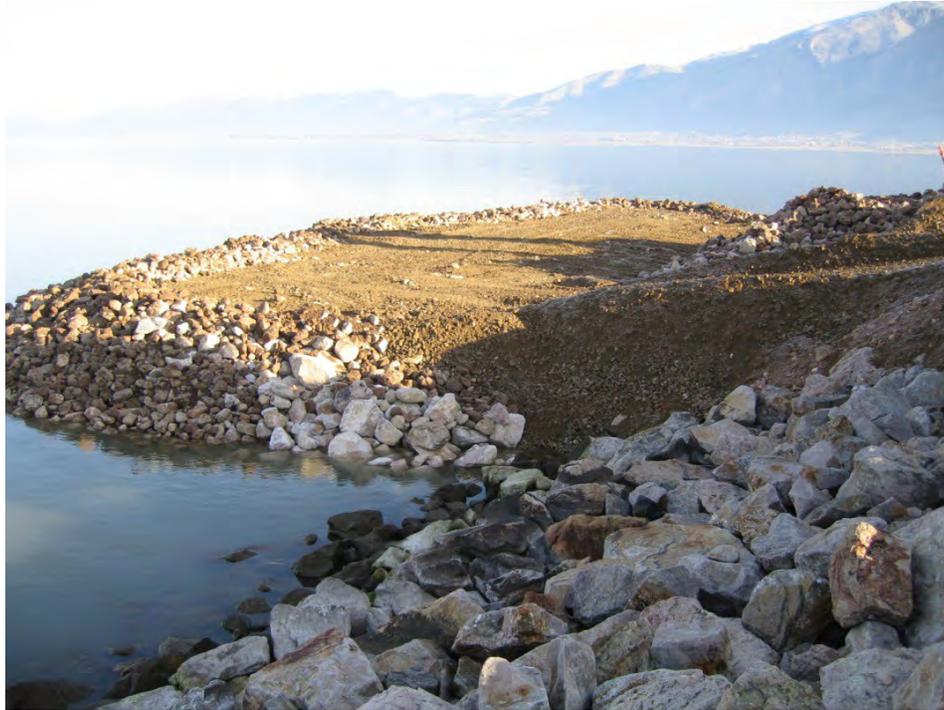
Figure 5.—Erosion into the South Drain did not stop until an upstream berm of gravel and pit-run material was pushed into reservoir.

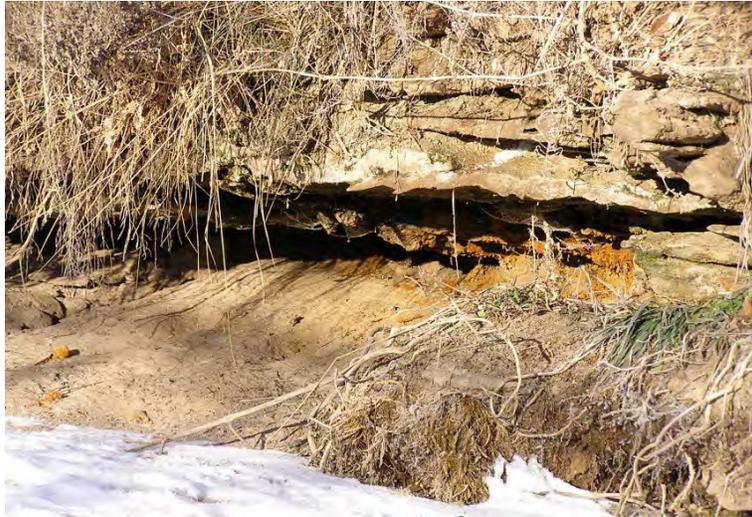
Figure 6.—Hardpan that formed a roof for the developing pipe.

- (3) **Hardpan:** Layers of carbonate and carbonate-cemented sand known as “hardpan” exist in the upper 3 m (10 ft) of fine to silty sand deposits (figure 6). The hardpan is at least partially continuous in the southeast reach of the dam. In the immediate area of the incident, there are two distinct layers of hardpan that are generally only 5 to 10 cm (2 to

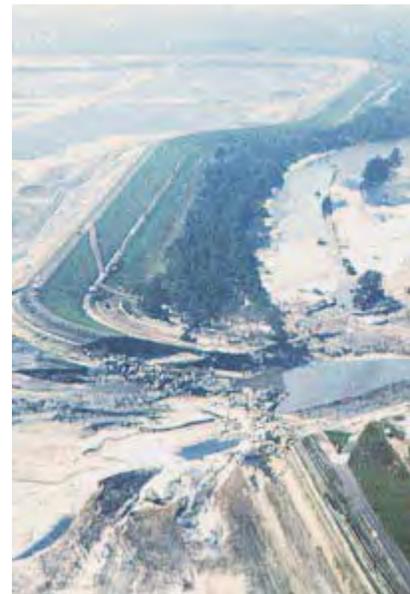
Figure 5.—Same area after breach.

Important to note is the presence of a railroad borrow pit and the L65 Canal in the southwest quadrant of the project site. The layout of these features, and the breach that occurred there, are shown on figures 4 and 5.

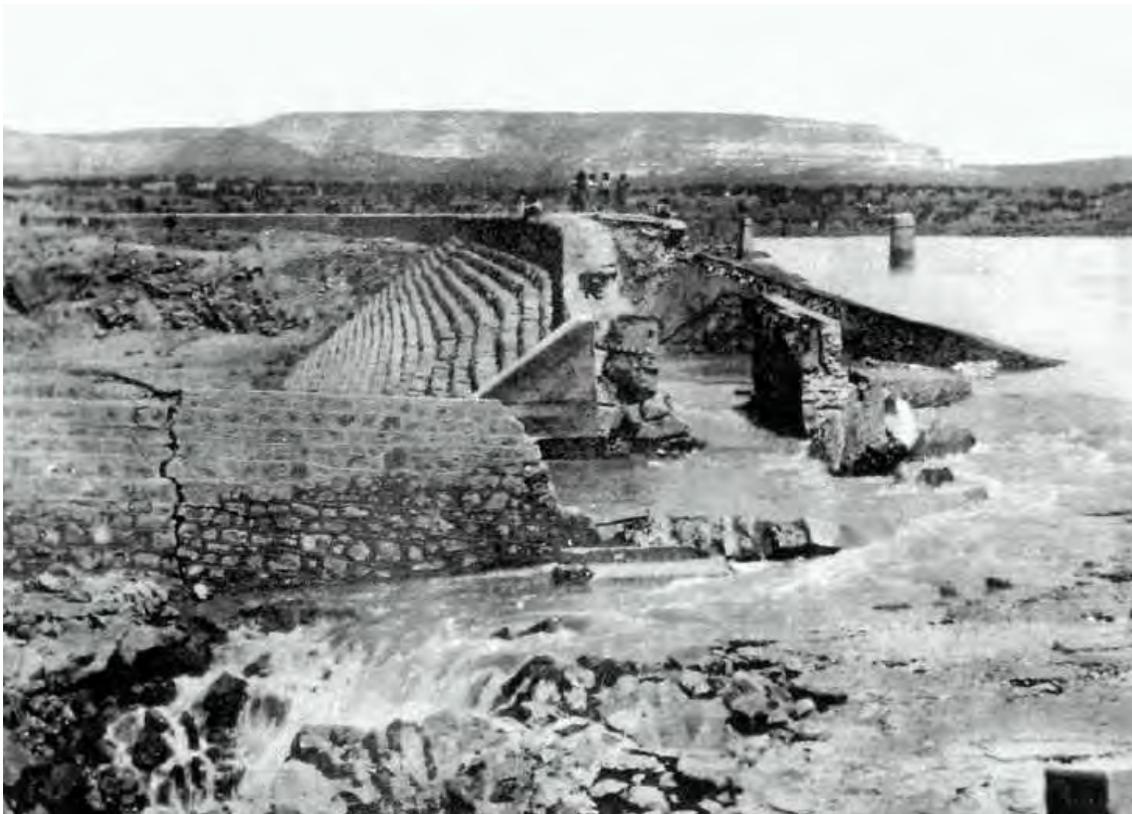
Figure 2.—Black Rock Dam near failure, 1909; spillway is in the foreground.

Seepage of reservoir water through fractures in the basalt in the upper portions of the abutments, and the subsequent erosion of underlying soil, had caused near failure of the dam on at least two occasions (figure 2). Preventing water from entering the basalt is a key consideration for improving the safety of the dam. The left and right abutment stratigraphy is similar and consists of several feet of eolian silty sand deposits over 15 to 30 ft of fractured basalt, over interbedded alluvial sands and gravels, and clays (figure 3). At normal storage levels, most of the basalt is exposed to reservoir water. The valley between the abutments was eroded into the material below the basalt.

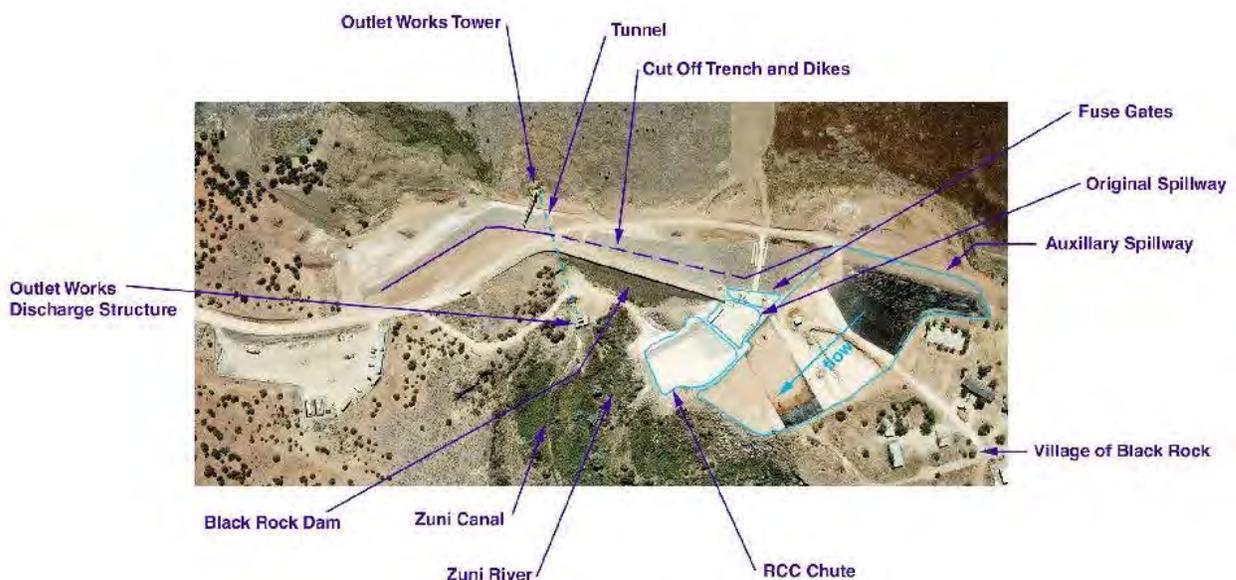
Figure 5.—Plan view of repairs to Black Rock Dam.

The cutoff trench and dikes greatly reduces reservoir water flowing through the basalt abutments of the dam. The auxiliary spillway on the left abutment is formed by lowering a section of the left dike and excavating a discharge channel downstream. Auxiliary spillway discharges would flow over the cutoff trench and downward into the basalt. To prevent this, the auxiliary spillway is lined with a HDPE liner. The liner is tied into a cutoff trench and extends to a point near the downstream end of the auxiliary. To complete the seal, the liner also extends across the service spillway and is tied into the hydraulic fill of the dam (figures 5 and 6).

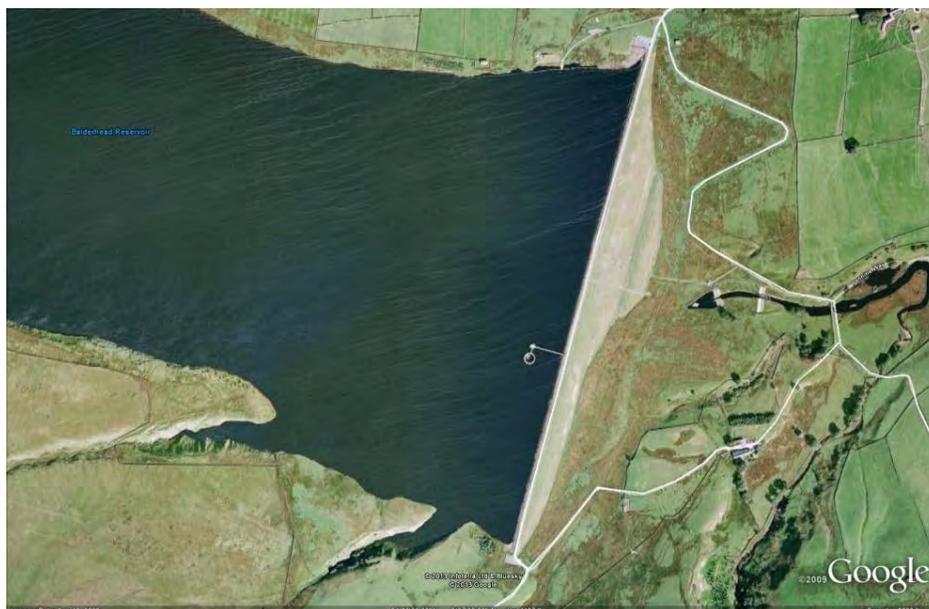
Figure 1.—Aerial view of 3,000-ft-long Balderhead Dam (Google Earth), which was the tallest earthfill dam in England when constructed.

Balderhead Dam (figure 1) is a 157-ft-high, 3,000-ft-long rolled-earth dam with a 222,000 yd³ boulder-clay core and 2,508,000 yd³ of shale fill forming the shoulders (Kennard et al. 1967). It is located on the River Balder in Tees Valley, in northern England, United Kingdom, and was constructed between 1961 and 1964 and went into service in 1965. The dam is founded on bedrock of the Yoredale sequence consisting mostly of Carboniferous shale with occasional horizontal thin sandstone, limestone, and coal seams. However, areas on the lower slopes of the valley contain boulder-clay glacial drift deposits that were left in place during construction of the dam.

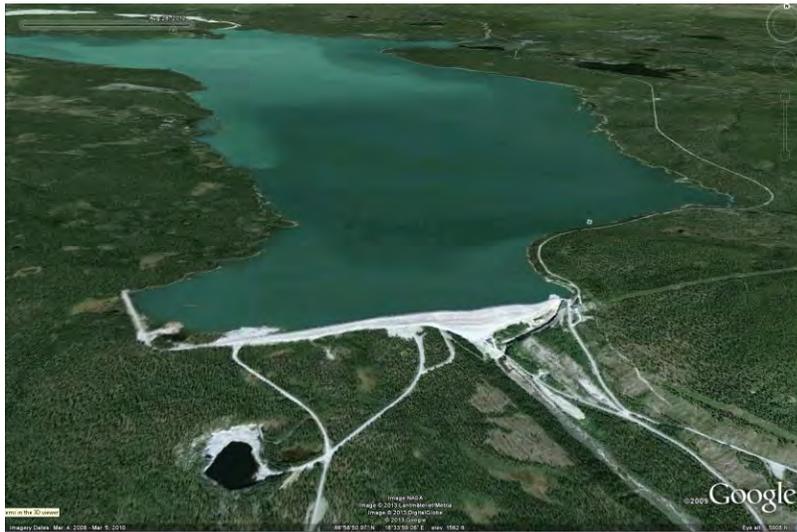
Figure 1.—The Seitevare Dam consists of a powerhouse, overflow spillway, main dam, and saddle dike. The right abutment was constructed on a glacial moraine.

Seitevare Dam, located in northern Sweden, impounds water for the Seitevare Power Plant (figure 1) in the highest reaches of the river Lilla Lule älv. The dam is 1,450 m long with a maximum height of 106 m. At the time the dam was constructed (late 1960s), it was becoming common practice in Sweden to construct new embankment dams with a curved form in plan view (Nilsson 1967); hence, Seitevare has a horizontal radius of 2,000 m. The right abutment is located on pervious glacial deposits. A 540-m-long, 10-m-high saddle dike is close to the right terminus of the main dam. The dam impounds 1,750 million m³ over an area of 82 square km at maximum pool.

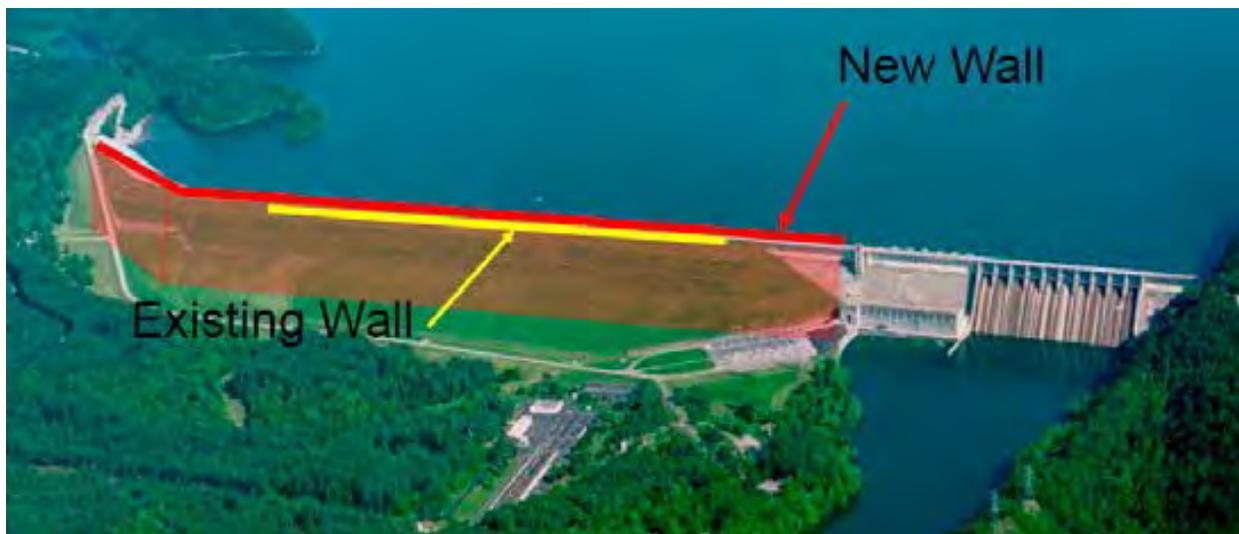
Figure 2.—Overall view of the dam showing extent of the existing and new cutoff walls.

turbines rated at 45,000 kW each. From the end of the concrete gravity section, a non-zoned compacted clay embankment with a maximum height of 215 ft above top of rock extends 3,940 ft across the valley to the right abutment. U.S. Highway 127 traverses the dam. There are limited outlets (six penstocks and six sluices) for emergency drawdown of the reservoir. An overview of the dam is shown on figure 2.

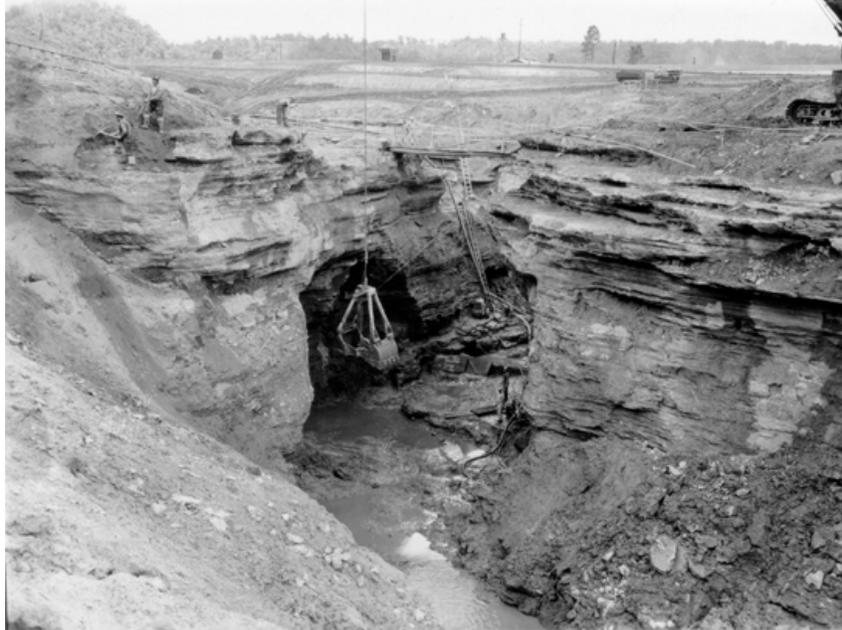
Figure 3.—View of solution feature in cutoff trench excavation.

The trench was of inadequate depth and width (10 ft at the bottom) to prevent seepage, and the fill was poorly compacted. Several large caves and numerous other solution features of varying size intercepted the trench at generally right angles. The sidewalls of the trench were not shot smooth or laid back to allow for tight contact between the fill and rock. Placement and compaction, often by hand, were therefore attempted on rough, vertical walls; in solution features; and under rock overhangs. Obtaining tight compaction and impervious fill against the sidewalls and in intercepting solution features was not considered important. The trench is so narrow and steep sided that bridging of the embankment is very likely.

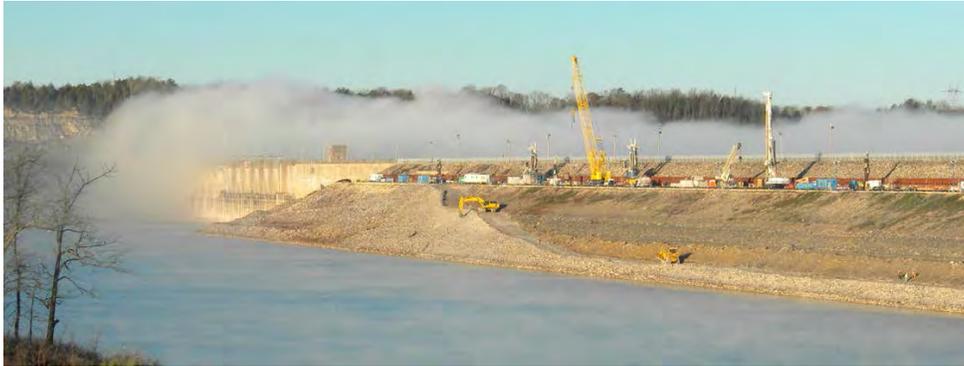
Figure 6.—View of working platform on upstream slope.

The new wall is being installed from a work platform constructed on the upstream face of the dam as shown on figures 6 and 7. The top elevation of the platform is 750 ft, and the design depth of the wall is to elevation 475 ft, making a total depth of wall in embankment and foundation rock of 275 ft. As much as 110 ft of that length is in the limestone foundation.

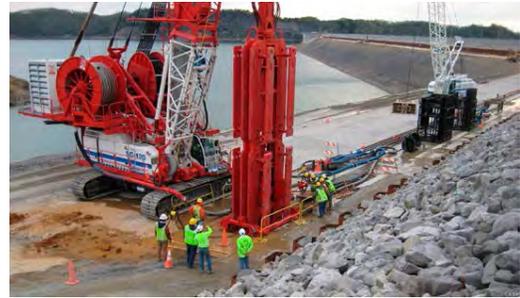
Figure 9.—View of hydromill construction.

To protect the earth embankment against the effects of construction activities, a 6-ft-wide protective concrete embankment wall was first constructed along the entire length of the embankment as shown on figure 8. Ranging from 110 to 225 ft deep, this wall was installed through the embankment and keyed 2 ft into rock. It is 40 ft upstream of the original wall completed in 1979 and defines the alignment of the new barrier wall. This wall was built in 9-ft segments using a hydromill as shown on figure 9.

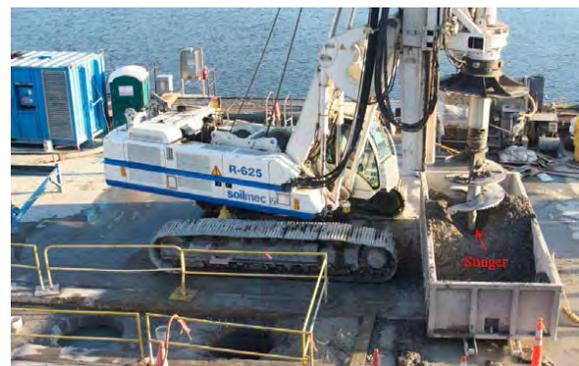
Figure 11.—Secant pile wall construction.

Excavation for the full-size pile begins with predrilling through the embankment wall to enlarge the pilot holes. Drill rigs advance the oversized secant piles to approximately 150 ft through the embankment wall depending on the depth of the embankment wall. For this task, a special 52-in-diameter drill with a leading stinger was developed that follows the pilot hole, thus guiding the pile drilling as shown on figure 11.

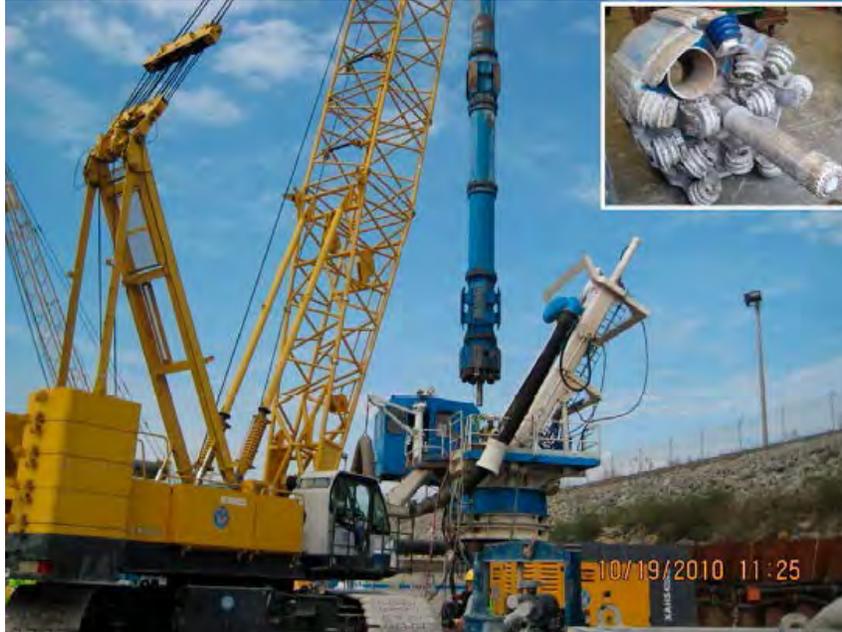
Figure 12.—Secant pile wall construction with reverse circulation drill.

From the bottom of the embankment wall, reverse circulation drill rigs drill the remainder of the 50-in-diameter piles into the underlying limestone rock as much as 100 ft for total wall depths reaching 275 ft as shown on figure 12.

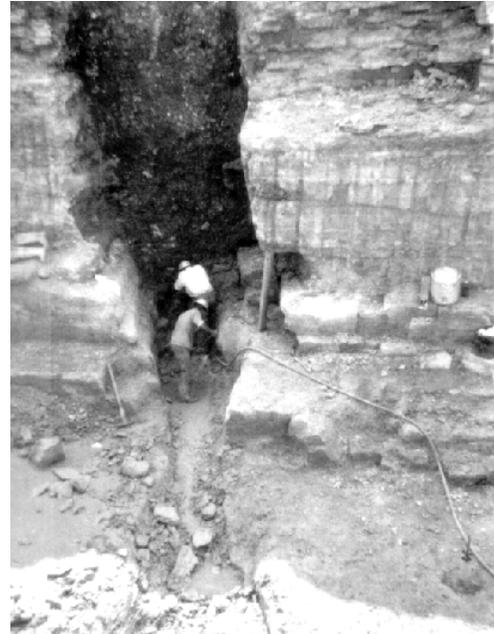
Figure 4.—View of solution feature in cutoff trench of the left abutment.

In response to the solution channel found in the conduit excavation, a 30-ft-wide cutoff trench was added to the design. In October 1964, the cutoff trench was begun between dam centerline Sta. 50+80 to Sta. 57+50 and excavated 7.0 ft into bedrock. In addition, the solution channel uncovered during conduit construction was excavated on both sides of the conduit and was found to be over 600 ft long (figure 4) and at an approximate 15-degree angle to the dam centerline. A second solution channel of similar vertical depth was excavated for nearly 200 ft before exiting the side of the vertical bedrock face. All exposed solution channels were blasted, cleaned, filled with concrete, and topped with select fill. After these large solution channels were uncovered, the original cutoff trench was extended to Sta. 75+00. This trench extension was 15.0 ft wide down to top of rock with no removal of weathered rock. No further solution channels were uncovered.

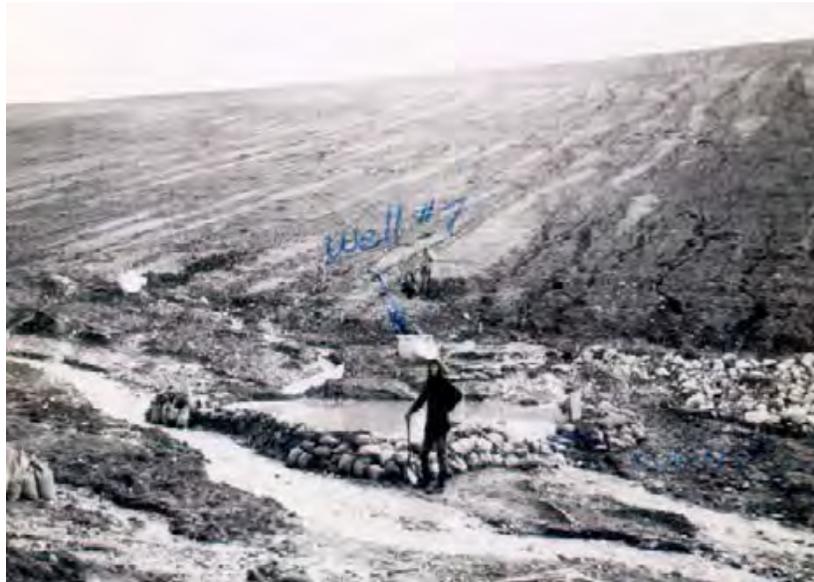
Figure 5.—Conditions during the boil event of 1966.

During the course of 2 weeks, the pool reached its highest elevation to that point (elevation 741.9), and the boil had become 12- to 14-in diameter. During this time, muddy water and mud balls ranging from a 3/8- to 1/2-in diameter were carried by a flow of 20–25 gpm (figure 5). Seepage was also noted in a gravel pit located approximately 400 ft downstream from the embankment toe. An area of approximately 2 acres on the right riverbank about 700 ft downstream from the toe was saturated with seepage water.

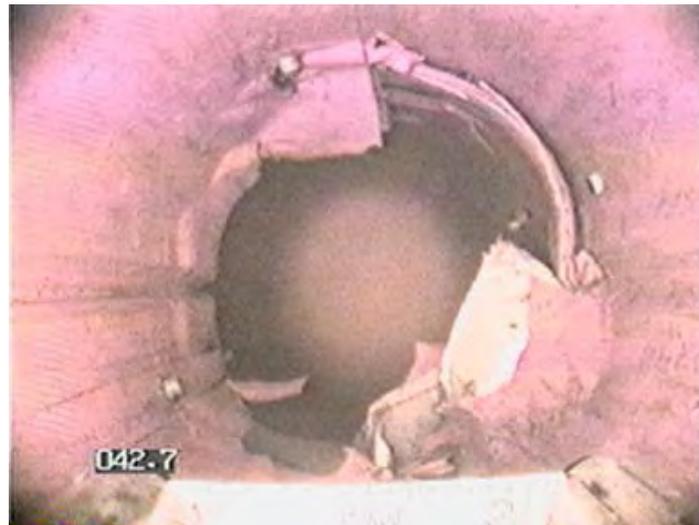
Figure 7.—Crushed inclinometer.

along the county road on the crest had a slight dip in it. This area was surveyed and inspected and was in fact significantly lower than the rest of the crest. This area of differential settlement was contained in a 400-ft stretch between Sta. 38+00 to Sta. 42+00. By 1999, a total of 0.85 ft of settlement had been experienced in the area, as compared to the 0.25 ft of post-construction settlement in the rest of the crest (figure 6). Also by 1999, two slope inclinometers, which had been placed in the settlement area to capture lateral movement, had been destroyed (figure 7). The instruments had been crushed by internal stresses developing in the embankment due to the settlement and deformation.

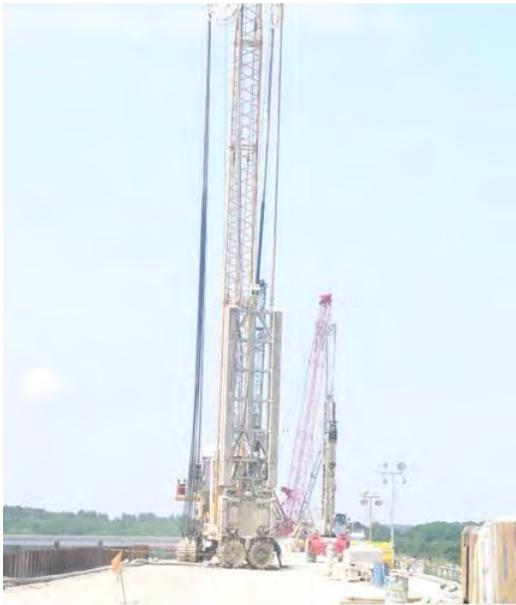
Figure 9.—Typical hydromill configuration.

Two principal pieces of excavation equipment were used during cutoff wall construction: a clamshell and a hydromill (figure 9). The clamshell rig was a CMV TL50 80-ton crawler crane with a 150-ft telescoping-kelly Casagrande KRC 2-180 Hydraulic Clamshell Grab. The clamshell bucket was capable of making a 10-ft by 30-in bite. An 8-ft by 30-in bucket was also available for closure panels. About 0.5 ft was removed per bite. The excavation rate was approximately 20 feet per hour, but decreased

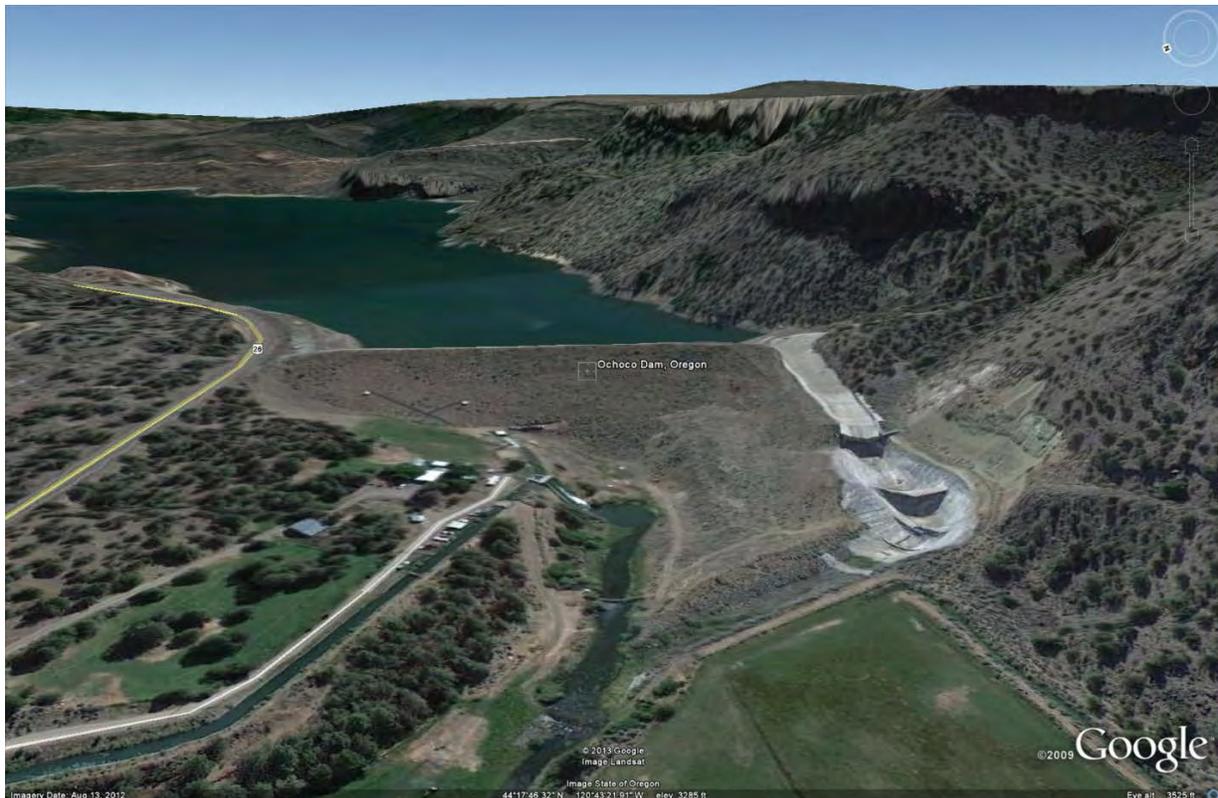
Figure 1.—Oblique view of Ochoco Dam, Oregon.

Ochoco Dam impounds a 46,500-acre-ft reservoir on the Crooked River near Prineville, Oregon (figure 1). The dam was constructed of hydraulic fill from 1918 to 1920. The dam is 120 ft high and 950 ft long with an inlet-tower and a cut and cover tunnel outlet works arrangement. An excavated, uncontrolled, concrete-lined emergency spillway is provided on the left abutment adjacent to the fill section. The left abutment is composed of alluvial fan/talus complex, and the right abutment and center-right portions of the dam were founded on an ancient landslide complex. The landslide complex contains open joints in rock blocks and coarse, open-work rubble zones with voids varying in size from 1/4 to 6 in and free of infilling. Post-construction excavations into the dam confirmed the dam was constructed with a fine-grained, laminated puddle core with an interlayered sand and gravel shell on the downstream side of the core. Outer zones of the embankment fill contain coarse-grained rock from 3- to 12-in diameter.

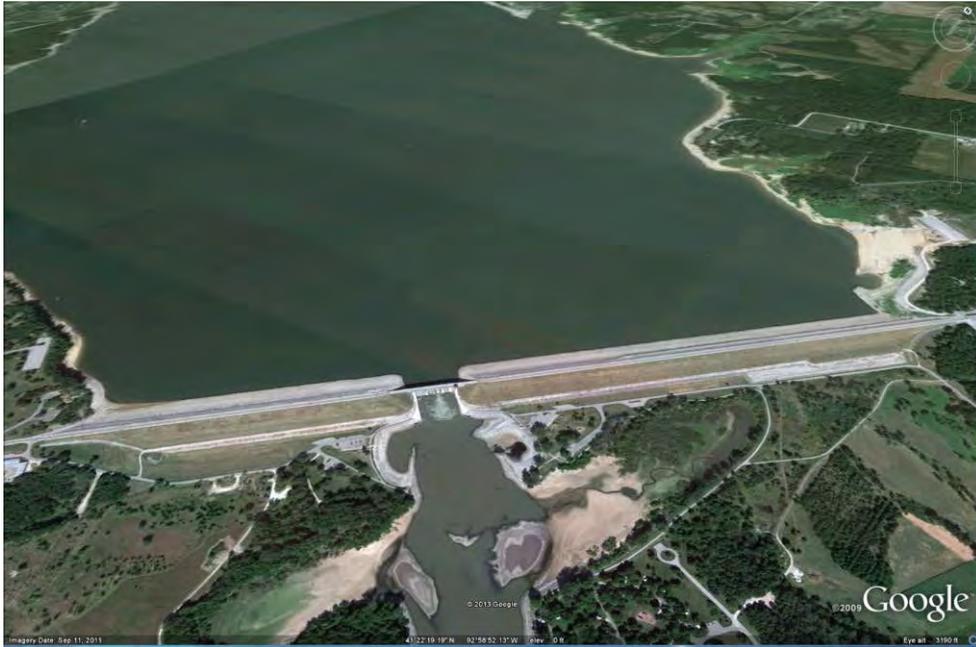
Figure 1.—Oblique view of Red Rock Dam (Google Earth, September 11, 2011).

The Lake Red Rock Project was constructed in 1969 on the Des Moines River as a flood control project by the USACE and is located in Marion County near Pella, Iowa. The dam consists of a 5,700-ft, 110-ft-high, rolled earth embankment with an integral gated spillway (figure 1). The dam impounds a 1,624,970-acre-ft reservoir from a drainage area of 12,323 mi².

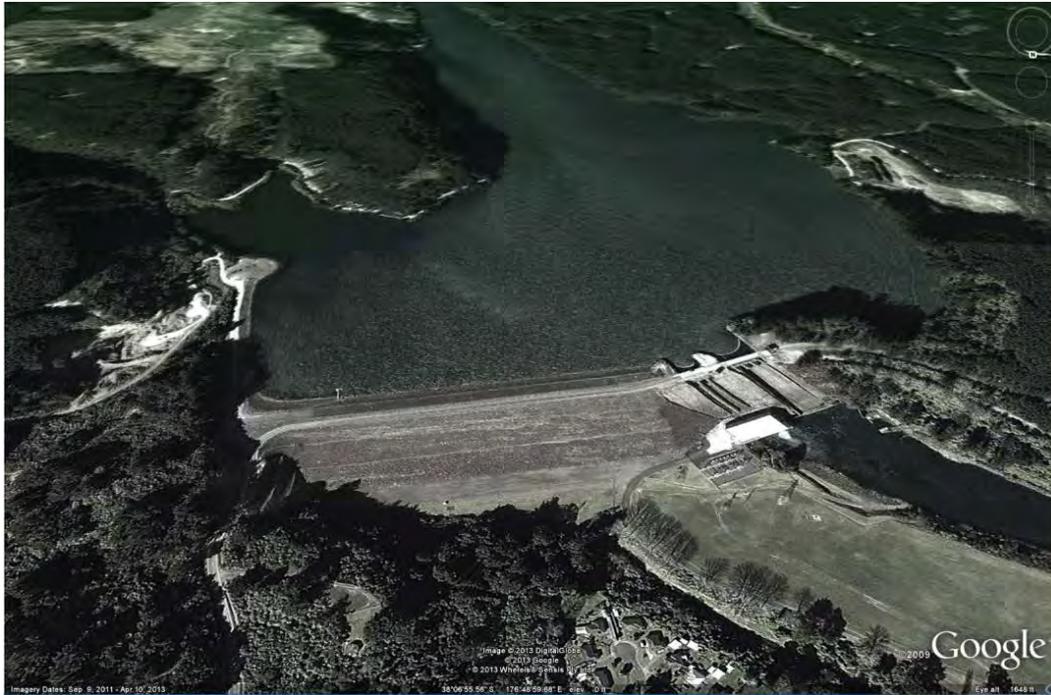
Figure 1.—Oblique view of Matahina Dam (Google Earth, September 9, 2011).

Matahina Dam is an 86-m-high, 400-m-long zoned earth and rockfill dam constructed in 1966 (figures 1 and 2). The dam is located upstream of the small community of Lake Matahina, on the Rangitaiki River, North Island, New Zealand. The project is also equipped with a spillway, penstocks and powerhouse, and diversion and dewatering tunnels. These features are located on a rock spur that makes up the left abutment of the dam. The rock spur contains two drainage tunnels and a grout curtain (Gillon 1988).

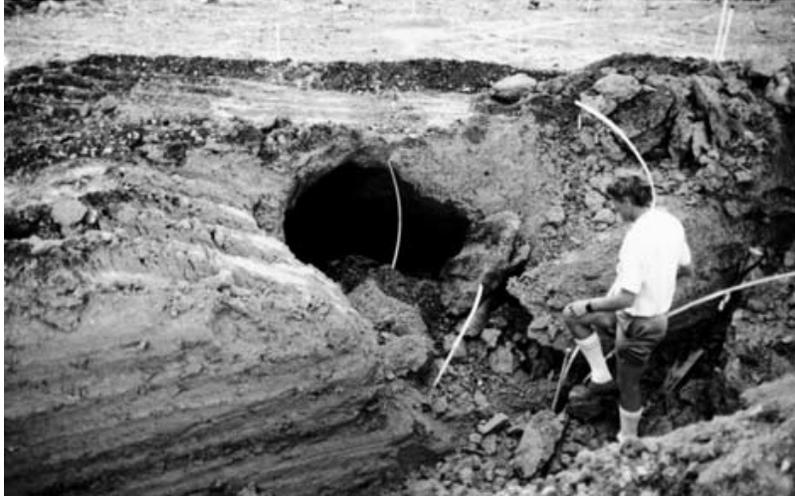
Figure 4.—Internal erosion in the dam core (Amos and Gillon, 2007).

With the use of trench investigations, transverse cracking was found to be shallow, and a large cavity in the same area of the right abutment as the 1967 sinkhole was discovered in line with the foundation anomaly but upstream of the core (figure 4). After discovery of the new cavity, two shafts were drilled to investigate the previous repairs to the right abutment. The sinkhole discovered on December 17, 1987, about 9 months after the earthquake, confirmed that internal erosion had occurred and was continuing (Centre for Energy Advancement through Technological Innovation [CEATI] 2010). After four inclined borings were drilled into the left abutment, high inflows downstream from the core were found. Twelve piezometers were installed in the left abutment, and anomalously high pore pressures were measured. Surveys confirmed that there was continuing settlement of the dam and left abutment spur several weeks after the earthquake (Gillon 1988). Seepage from the left abutment increased four-fold immediately following the earthquake and continued to rise for at least 8 months. The conclusion drawn from the investigations was that the core in the left abutment had experienced cracking and erosion similar to that experienced previously in the right abutment, although it could not be determined with certainty if the condition existed prior to the earthquake (Gillon 1988).

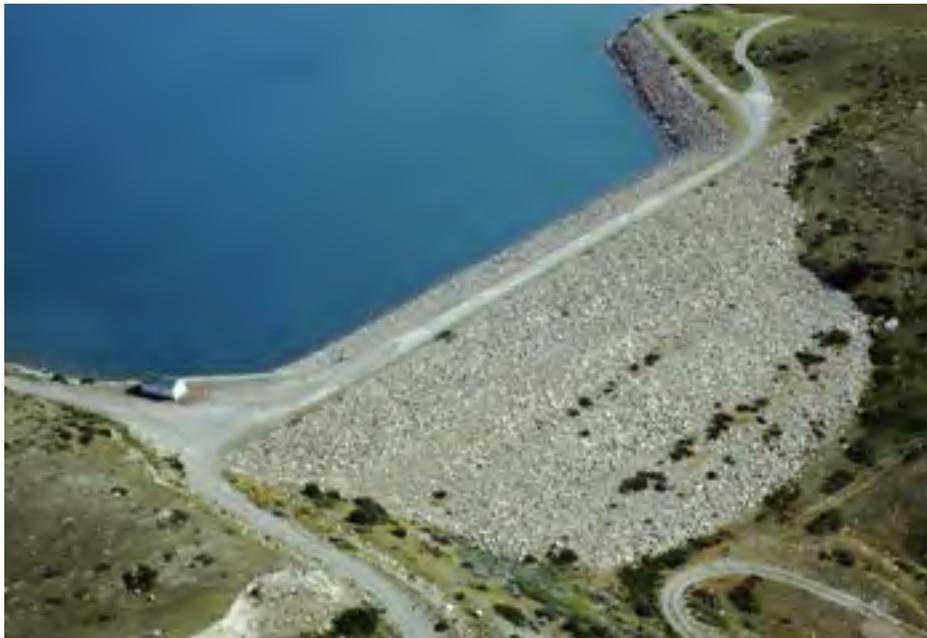
Figure 1.—Photograph of the Willow Creek Dam and gate house (Reclamation).

Willow Creek Dam is an earthfill structure on Willow Creek near Augusta, Montana (figure 1). In addition to storing water from Willow Creek, the reservoir is fed from the Sun River through the Willow Creek Feeder Canal. The structure is 93 ft high, has a crest length of 650 ft, and contains 275,000 yd³ of material. An open spillway channel 700 ft wide at the ground surface has a capacity of 10,000 ft³/s. The outlet works tunnel runs through the right abutment. The reservoir has a capacity of 32,400 acre-ft of water. Geology at the dam site consists of Cretaceous age bedrock of the Two Medicine Formation (horizontal bedded, decomposed to soft shales and siltstones prone to slaking, and fine-grained sandstones) overlain by Pleistocene glacial moraine deposits and recent alluvium and colluvium along the channel of Willow Creek. The sandstones are moderately hard to hard, and high-angle jointing is prominent and leads to formation of blocky, tabular fragments. Glacial moraine deposits in the area are quite coarse and generally consist of sand and gravel with minor amounts of cobbles, boulders, and silt and clay fines. Alluvium along the creek channel is a highly variable mixture of material ranging in size from clay fines to boulders. A thin layer of material at the base of the dam, identified as alluvium, is composed of mostly cobbles and gravel with almost no fines. Glacial deposits form the foundation of the dikes and spillway.

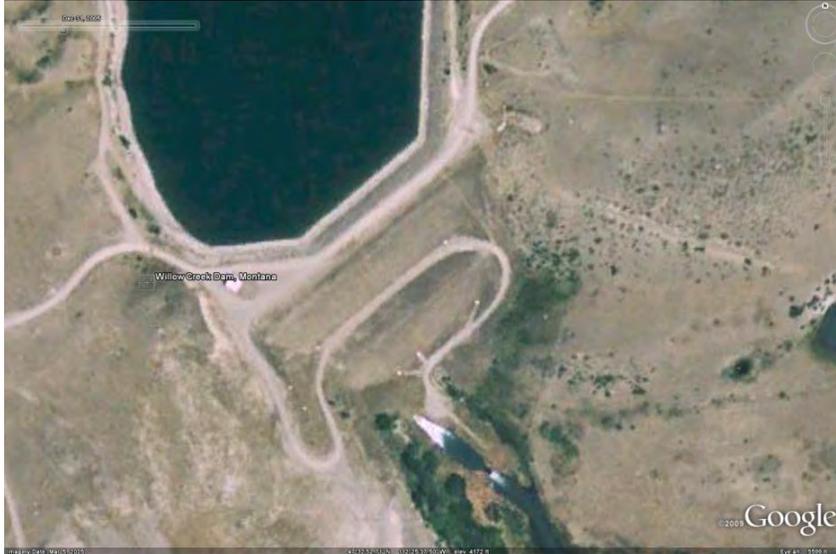
Figure 2.—Willow Creek Dam after 1996 and 2000 repairs (Google Earth, December 31, 2005).

Dam safety modifications were completed in 1996 and 2000. The 2000 modifications included removal of the downstream rockfill slope protection, excavation of potentially liquefiable foundation materials at the downstream toe, and construction of a downstream filtered berm buttress with toe drain system to control seepage and reduce liquefaction concerns during a major seismic event. The downstream face of the modified dam now has a grass cover, with a slope of 2H:1V above and below the top of the berm, at elevation 4116.0 (figure 2). A portion of the downstream tunnel was lined with CIPP in 1997 following a piping incident (see below). A new air vent pipe and concrete gate house were also provided for the outlet works at that time.

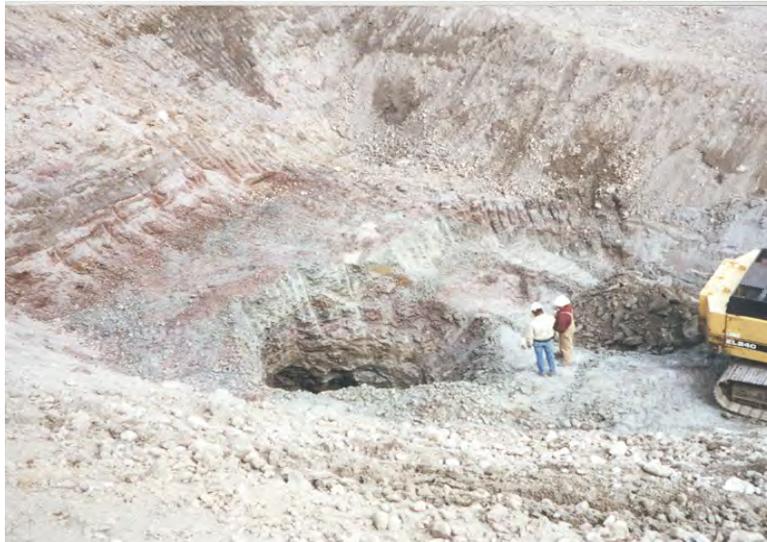
Figure 3.—View from top of dam after excavation was complete.

As part of the process to repair the sinkhole in 1996, the reservoir was drawn down, and a portion of the right abutment was excavated to within about 12 ft of the crown of the tunnel in the vicinity of the sinkhole. A layer of fractured sandstone separated the excavation from the tunnel crown. A total of 374 yd³ of lean concrete grout was tremied into the void around the tunnel and brought up to about elevation 4087. After letting the grout set up, lean backfill concrete was placed to fill the excavation to the foundation surface at elevation 4110. Pressure grouting of the bedrock was also performed along an 80-ft length of the tunnel. A total of 32 grout holes, with an average length of 35 ft each, were drilled, water tested, and grouted at mostly low pressures of around 5 lb/in², with an average grout take of 0.2 bag per linear ft. Filter sand was placed over the exposed bedrock surface in the bottom of the excavation, and the excavated embankment fill was replaced and recompactd. As a precaution, an upstream berm was constructed to provide 100-yr flood protection in the event the embankment construction could not be completed before winter. The berm extended 240 ft across the right abutment groin,
