Evaluation and Monitoring of Seepage and Internal Erosion

Interagency Committee on Dam Safety (ICODS)

FEMA P-1032 /May 2015

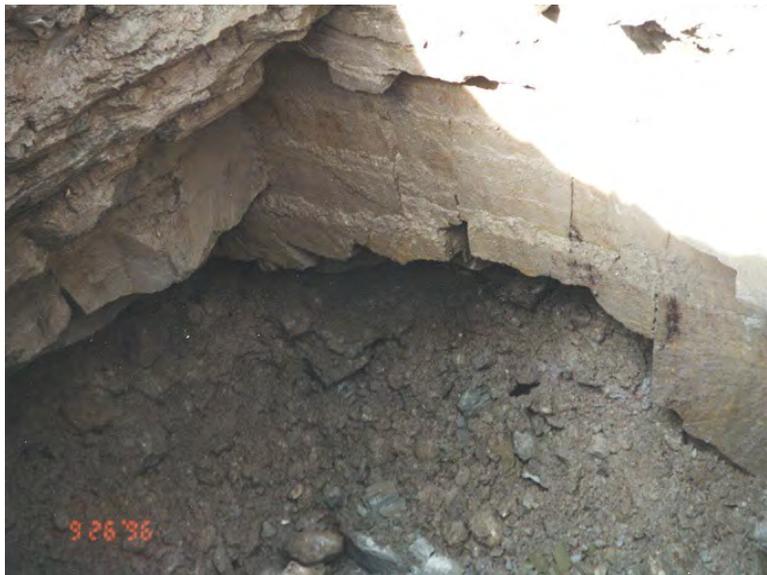
Figure 4.—Looking into sinkhole from foundation contact.

On June 28, 1996, a sinkhole was discovered on the crest of Willow Creek Dam about 50 ft downstream from the gate house (Reclamation 2013). Emergency investigations determined that embankment material had been piping into a large cavity surrounding the outlet works tunnel at the location of a tunnel collapse in 1958 (figures 3 and 4). In addition, some material had been piping into the tunnel through weep holes drilled through the concrete lining to provide pressure relief. Emergency repairs were undertaken in the fall of 1996 to excavate the right abutment area, backfill the sinkhole cavity with grout, pressure grout the foundation, place a filter on the dam foundation contact, replace the embankment, and construct an upstream berm to provide a longer seepage path through the abutment. Designs were also undertaken to repair the outlet works, including the addition of a new air vent (constructed in June 1997), a partial tunnel lining (constructed in August 1997), a new trashrack structure, a new gate house, and guard gate repairs.

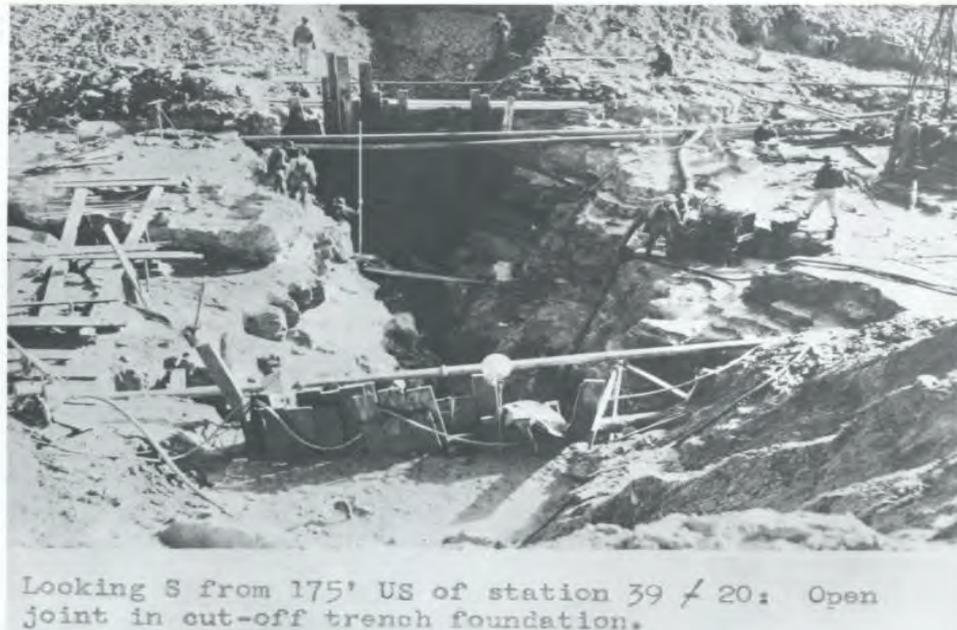
Looking S from 175' US of station 39 / 20: Open joint in out-off trench foundation.

Figure 3.—Solutioned dolomite observed in cutoff trench.

Clearwater Dam is located on the Black River in Wayne and Reynolds Counties in southeast Missouri (figure 1). It is a 154-ft-tall and 4,225-ft-long embankment dam that was completed in 1948 (figure 2). During construction, a cutoff trench was excavated to the foundation rock. Some large solution features (figure 3) were revealed and treated with dental concrete and grouting. Only the rock in the cutoff trench was exposed and treated.

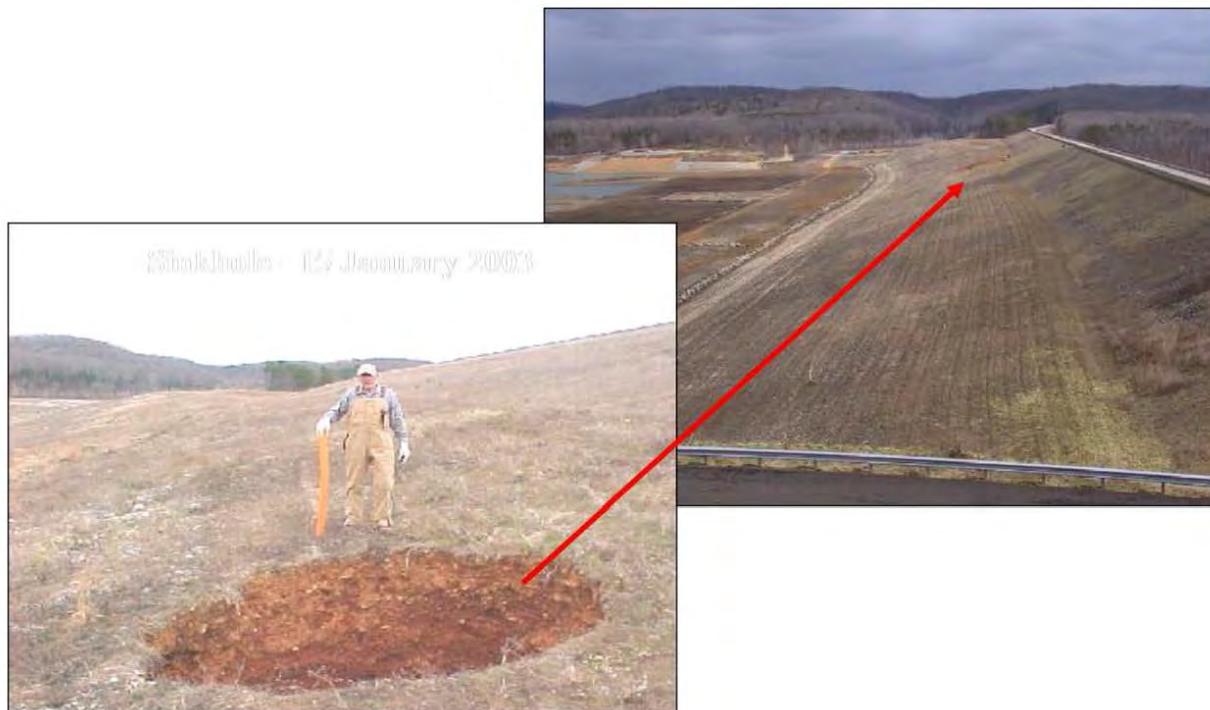
Figure 5.—Sinkhole through upstream impervious blanket.

The reservoir experienced the pool of record in May 2002. The following January in a period of low pool, a sinkhole (figure 5) opened up on the upstream embankment face above the pool elevation. It is believed that the sinkhole pipe developed below the dental treatment through a karst feature that was originally soil filled but over time was cleaned out by erosion (figure 6). It is also possible the pipe eroded the core above the dental treatment into an untreated feature and bypassed the treated cutoff trench. Following the incident, the dam was placed under a pool restriction until major repairs could be implemented.

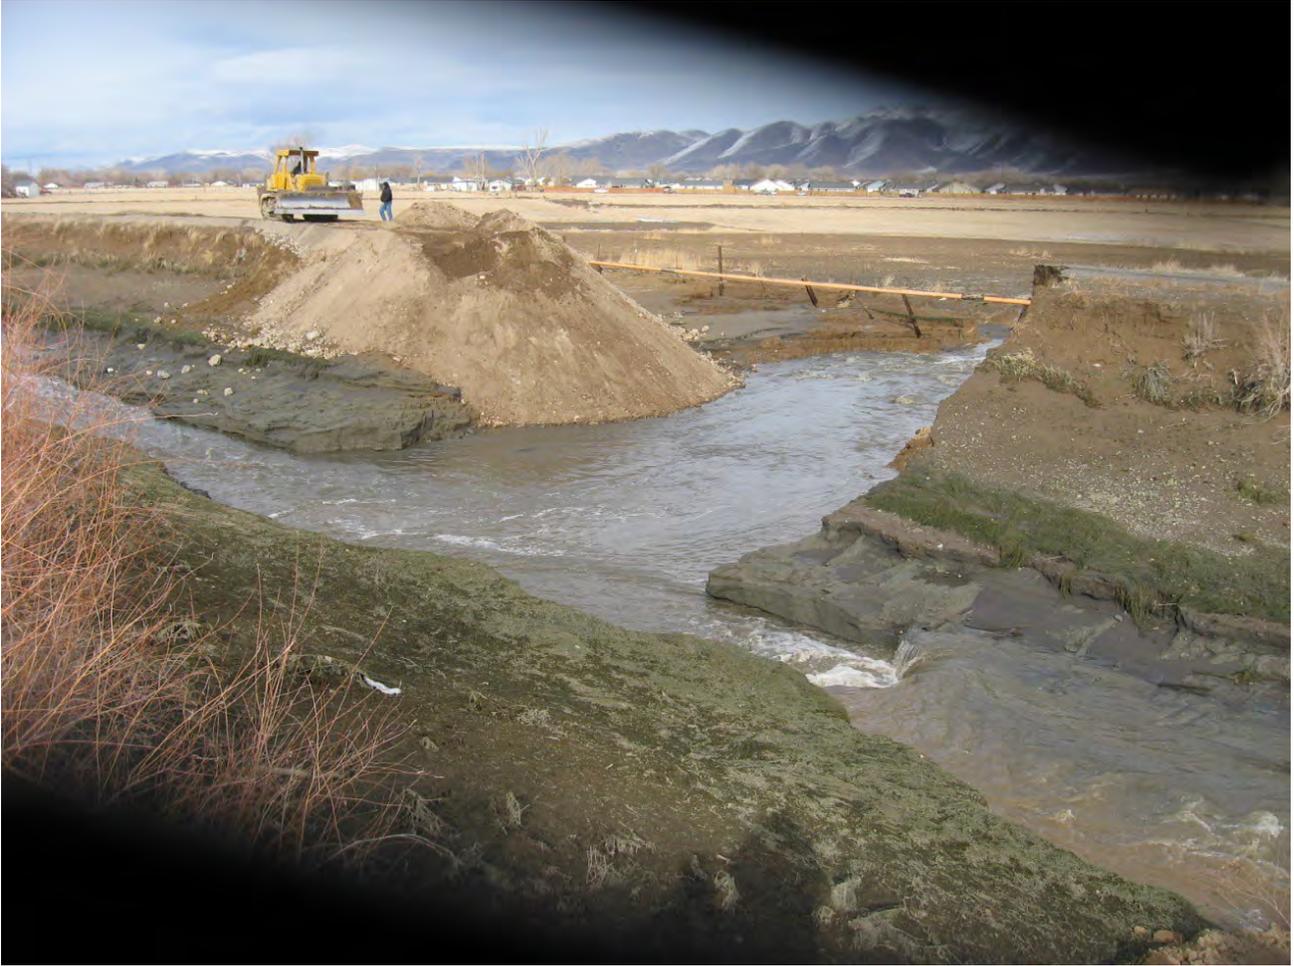
Figure 1.—Photo of the breach during early phases of temporary breach repair on the morning of January 5, 2008. Normal canal flow is from left to right in this photo. The breach is being filled by pushing fine-grained soil into the gap in the canal embankment. Some of the scour of the canal bottom can be seen along with some scour of the area immediately downstream from the breach. The pipeline shown is an abandoned natural gas pipeline that had been buried in the canal embankment. The pipe remained in place after the breach despite eroding all support provided by the original embankment.

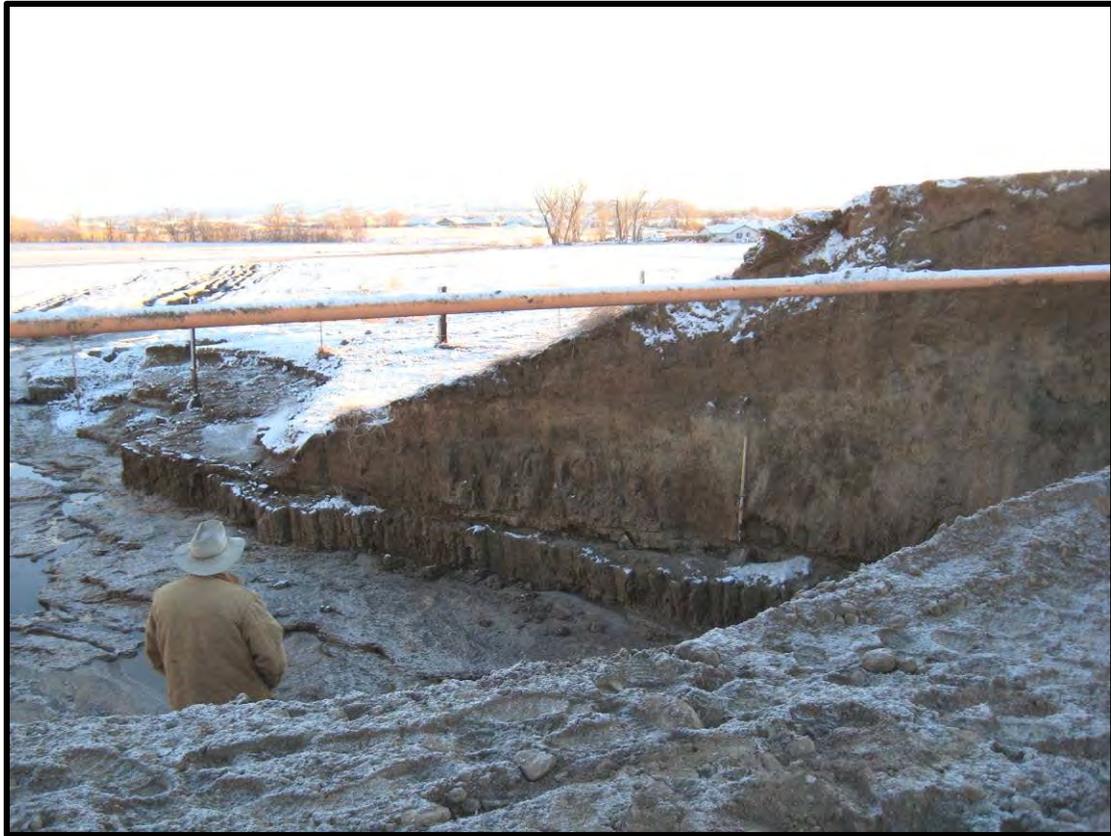
Figure 3.—View through the breach toward Fernley, Nevada. The downstream breach face cut into the left canal embankment is 17½ ft high.

During the breach event, water from the Truckee Canal flowed from both upstream and downstream in the canal through the breach for at least 9 hr. Water eroded through the left embankment of the canal (which was about 8 ft high in this area) and downcut into the foundation beneath the embankment an additional 9½ ft, for a total erosion depth of about 17½ ft (figure 3).

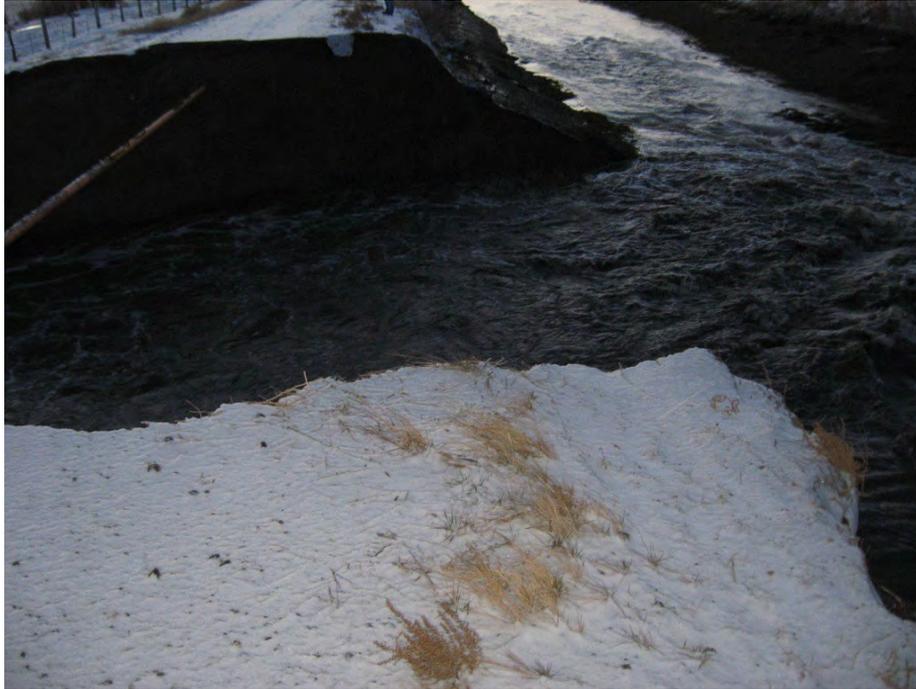
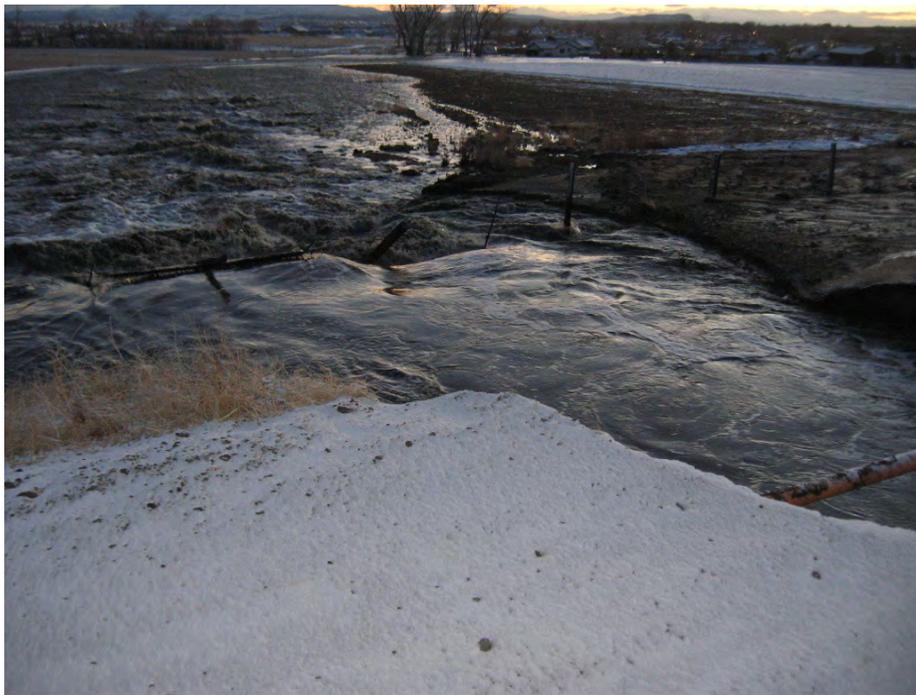
Figure 5.—Earliest photos showing breach (estimated time about 6:30 a.m. on January 5, 2008) (photos by Walt Winder, TCID).

Based on the verbal report of the project engineer, the dimensions shown on figure 6 were substantially wider than that first noticed upon his arrival at the breach site at least 45 minutes after the breach had occurred (figure 5), which would suggest the widening to the final size occurred sometime between 4:45 and 6:30 a.m.

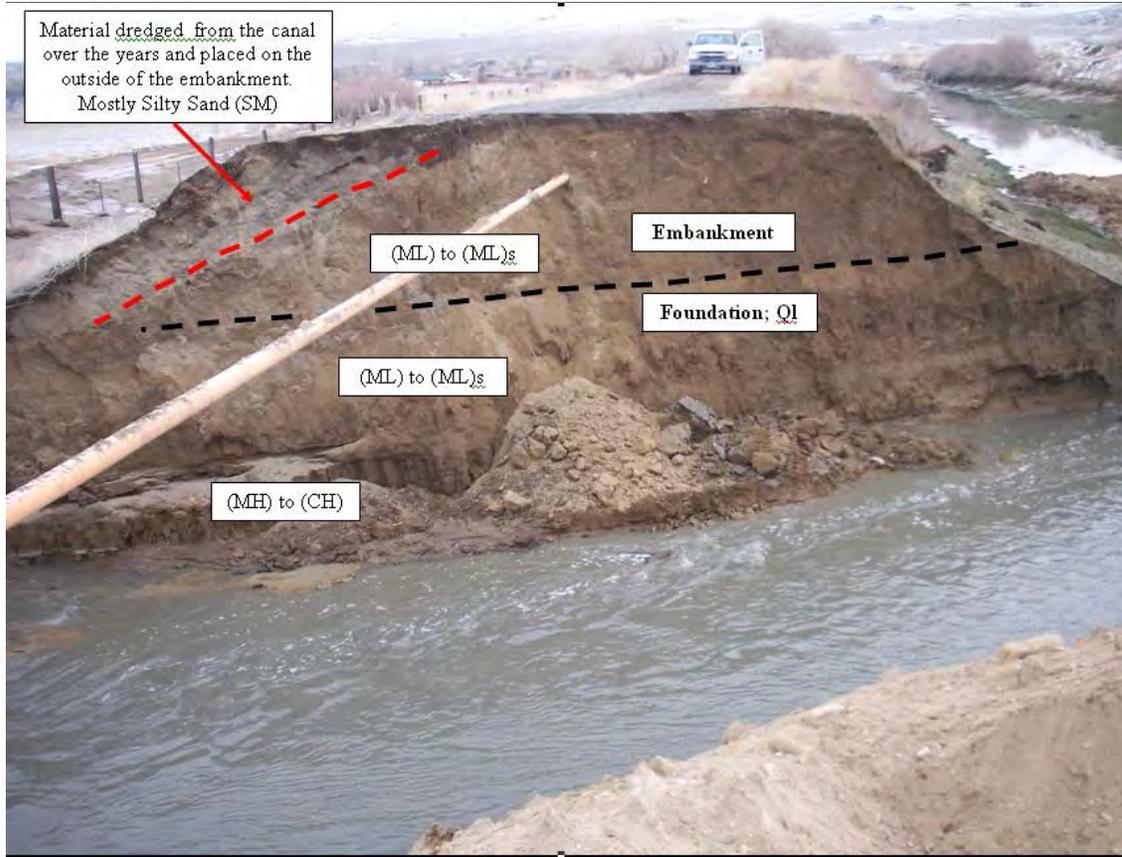
Figure 7.—Downstream view of the Truckee Canal breach. Dashed, black line is the approximate contact between the canal embankment and in-place lakebed deposits (Q1) composed primarily of silt with sand (ML)s and elastic silt (ML) with minor sandy lenses. Center-left is an abandoned Sierra Pacific Power gas pipeline.

noted during recent geologic studies, it appeared that some material had been excavated from within the canal over the last 100 yr and deposited on the crest and landside slopes of the embankment (noted as “dredged” materials on figure 7).

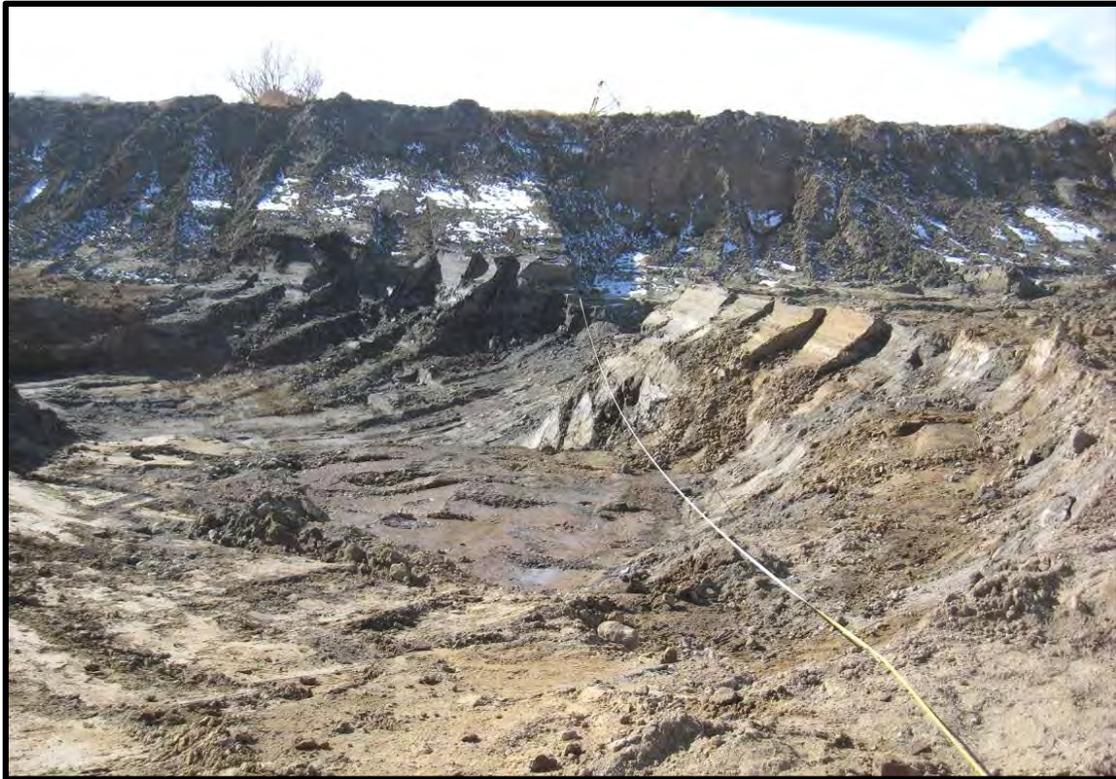
Figure 8.—View to the southwest (toward the right side canal embankment) of the final excavation of the scour hole site.

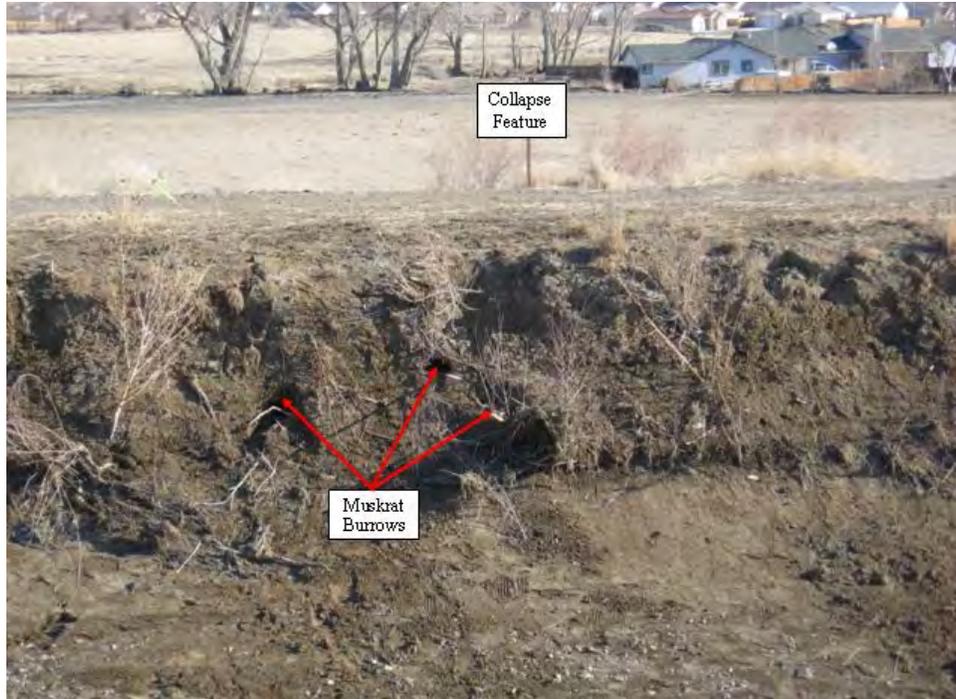
Figure 11.—View of canal embankment prior to investigations showing three muskrat burrow entrances on the waterside and the location of a collapse feature (feature not visible) on the landside. The burrow entrance appeared to be located a foot or so below the approximate 350 ft³/s flow line.

A few days after the breach, an informal inspection of the canal embankment revealed a series of animal burrows located a few hundred feet downstream from the breach. A tape inserted into one of the burrows penetrated to an approximate horizontal distance of 11 ft. On the landside of the canal, almost directly across from the burrow, a fresh delta of sand was found with a collapse feature noted on the canal face.

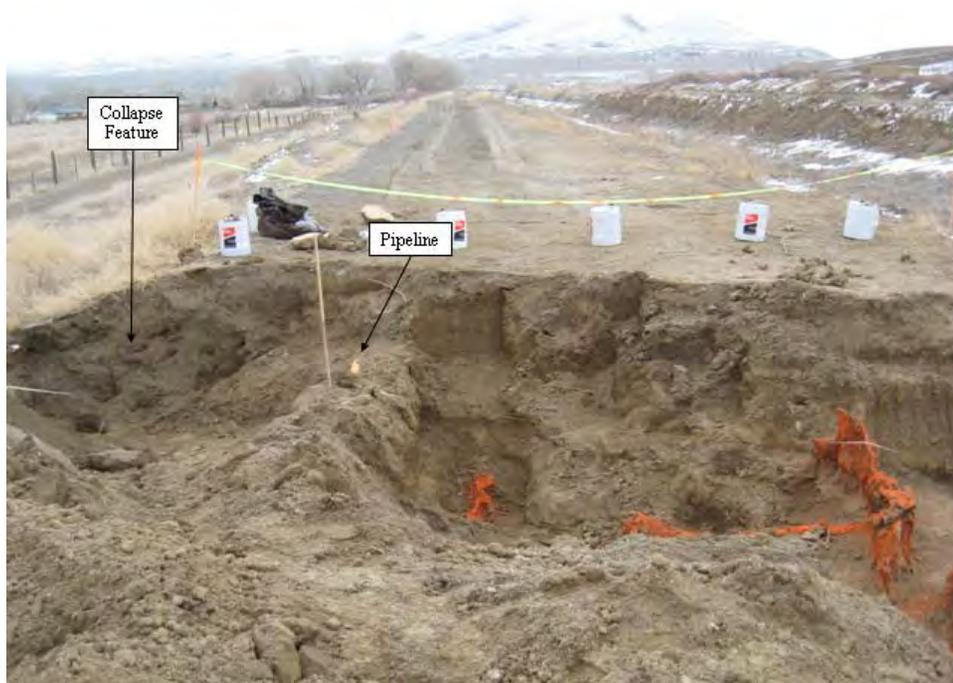
Figure 10.—View of partial excavations of canal embankment crest following grouting with Stratathane™. Features that were found grouted have been painted with orange paint.

To determine the conditions in the crest of the canal embankment, investigations conducted of the muskrat activity were documented in a report. As discussed in that report, a grout program was implemented that injected a Stratathane™ and water mixture under low pressure into the burrow area. The area was later excavated. Observations indicate that a “cast” of portions of a burrow warren had been made. It indicated that the series of burrows, dens, and voids had penetrated to within a few feet of the landside of the canal bank very close to the collapse feature area. From all of this, it can be reasonably surmised that the burrowing had been occurring in the months prior to the failure when the canal had been flowing at an approximately steady rate of about 350 ft³/s. When the canal flows were sharply increased the morning of January 5, the burrows would have flooded with a few feet of hydraulic head. This increase in water head likely caused concentrated seepage from the landside face of the canal embankment, which started the erosion process. The fresh deposit of sand below the collapsed feature and nearly directly in line with the animal burrows appears to be evidence that erosion had started. It is likely that the erosion would have progressed and caused a failure if the breach had not happened just upstream with the resulting drop in water surface.

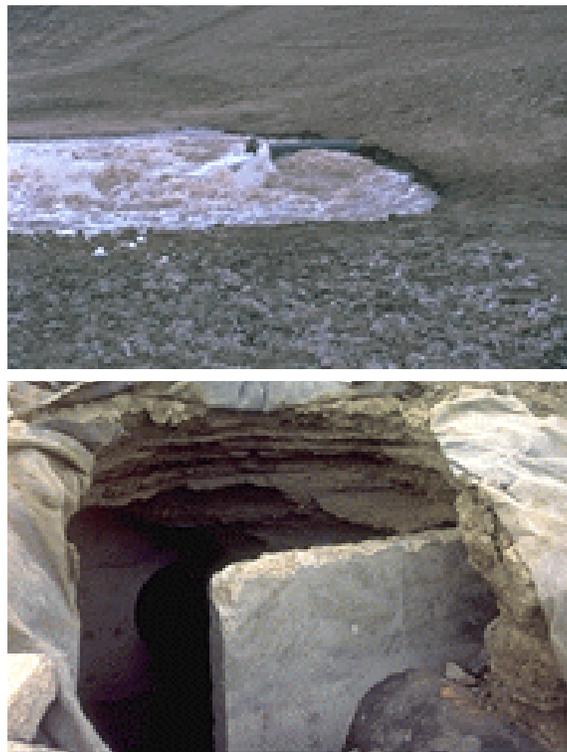
Figure 2.—Discharge of water from internal erosion adjacent to conduit (top photograph) and erosion of fill from around seep collars at upstream end of conduit (bottom photograph) taken after the reservoir emptied.

The board concluded that the cause for failure was piping, initiated by a small flow path along the outlet pipe through the dam embankment. This flow path need only have been a fraction of an inch and could have been started by settlement, pipe rotation, freeze-thaw, or inadequate pipe compaction. It was discovered that the dam was constructed of a dispersive clay material, which looks like “regular” clay material but goes into colloidal suspension in water and very rapidly loses cohesiveness. This both accelerated the failure and precluded the possibility of the piping void healing itself. The dam design lacked redundancy to avoid this type of failure. The dispersive clay problem can be remedied by adding calcium chloride to the soil and/or by installing a sand filter in the embankment. These actions would preclude a similar failure.

As cited in the literature following failure of this dam (FEMA 2005), the cause of the failure was probably due to a combination of the presence of dispersive clay fill; hydraulic fracture; presence of antiseep collars, leading to poor compaction around the conduit, use of flowable backfill rather than a continuous concrete conduit support; and lack of a filter and drain around the conduit at the downstream portion of the embankment. Also, it was noted that cold air flowing through the conduit may have created ice lenses adjacent to the conduit that could have provided a path for concentrated seepage.

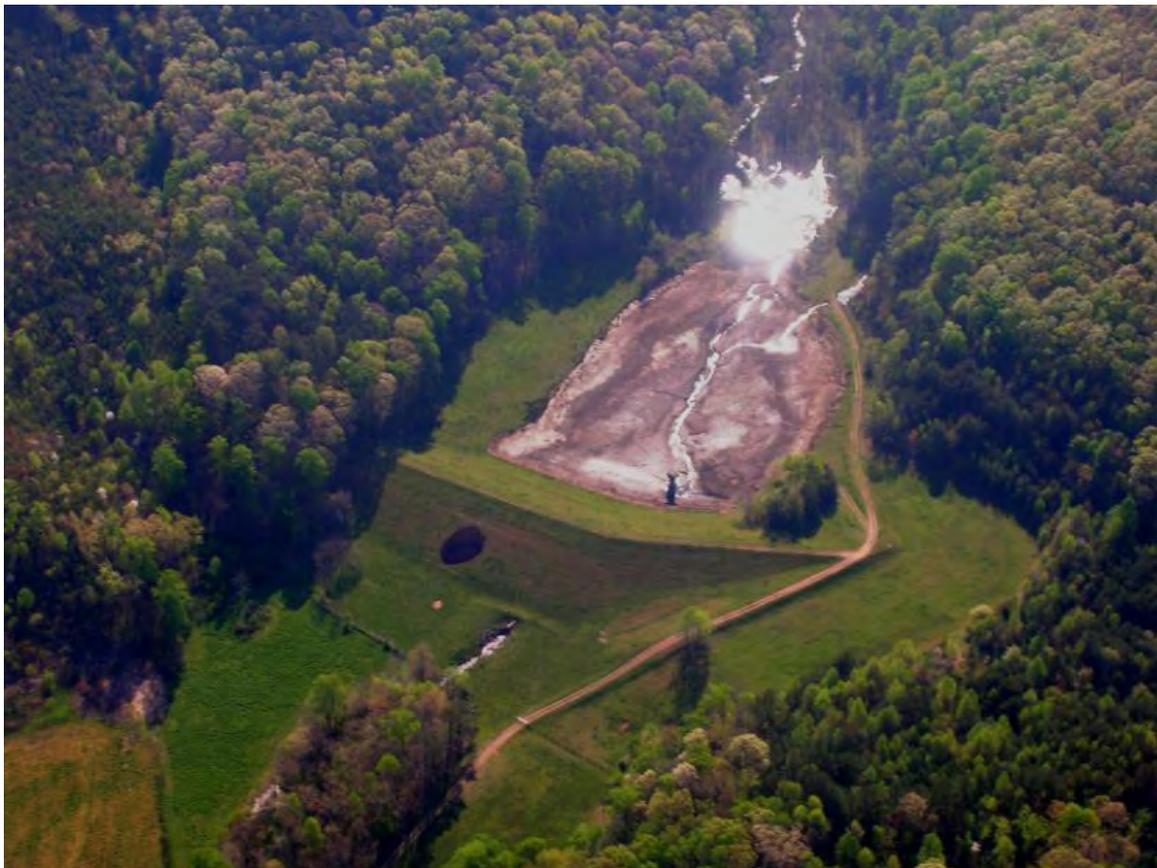
Figure 2.—Aerial view of the sinkhole on the downstream slope of the dam. Photo was taken after the reservoir had been drained.

After 35 yr of operation, a large sinkhole developed very suddenly on the downstream slope of the dam (figure 2). On April 10, 2008, the dam was observed to be in normal condition. On April 11, a landowner downstream from the dam noticed a large “brown spot” on the downstream slope of the dam near the eventual location of the sinkhole. On April 12, the presence of the sinkhole was confirmed. Upon examination of the structure by engineers and emergency personnel, the low stage gate was opened to drain the reservoir as a precautionary measure.

The sinkhole was approximately 65 ft in diameter and 40 ft deep. It was located about 100 ft to the right (looking downstream) of the principal spillway conduit. Groundwater was present in the bottom of the sinkhole, and the elevation of the bottom was several feet below the invert of the core trench and therefore was in in-place bedrock. The bottom of the sinkhole was about 10 ft below the collector pipe in the foundation trench drain. The pipe showed no signs of flow.

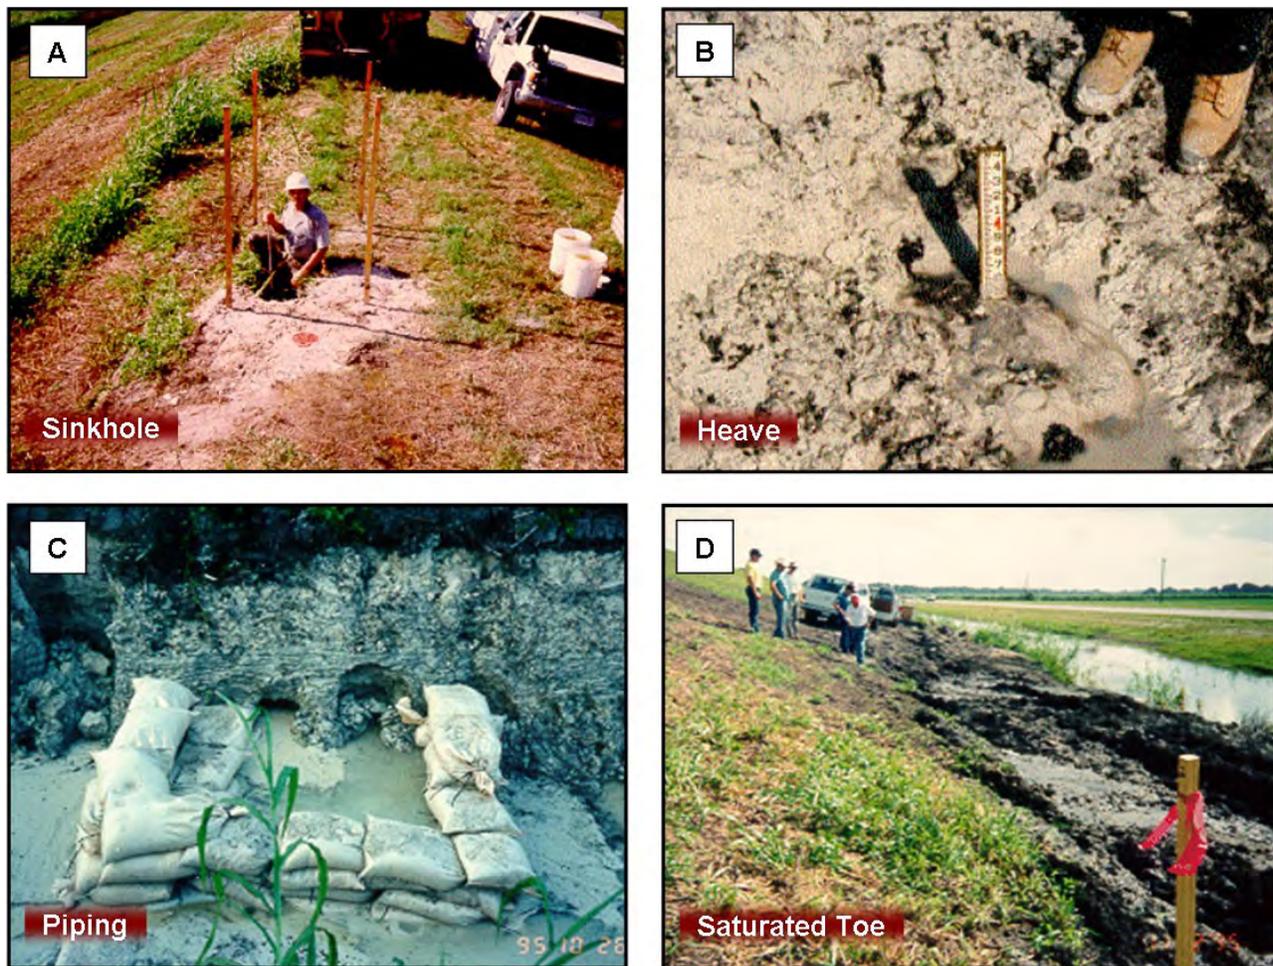
Figure 3.—Representative photographs of prior seepage erosion conditions at HHD near Lake Harbor. Downstream area seepage distresses were observed during events having a ~30-yr return period: (A) sinkhole formation in crest, (B) heave of downstream toe caused by upward seepage flow - surveyrod was easily embedded 4 ft deep, (C) piping at downstream toe of dike, and (D) saturation of landward toe and embankment slope.

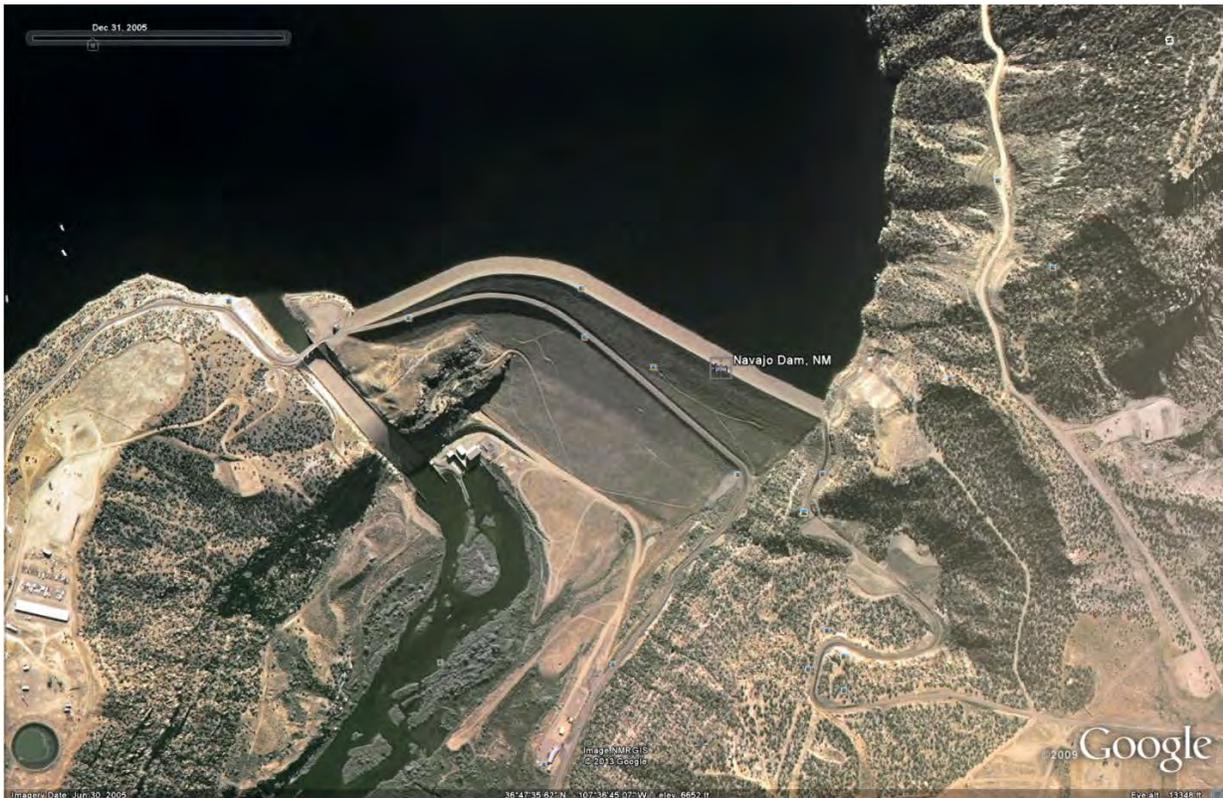
Figure 1.—Navajo Dam and spillway (Google Earth, June 30, 2005).

Construction of Navajo Dam began in July 1958, and it was dedicated on September 15, 1962. The nearly 3/4-mi-long dam (figure 1) stands 402 ft (123 m) high with a crest length of 3,648 ft (1,112 m). Nearly 26 million yd³ (19.8 million m³) of selected cobbles, gravel, sand, and clay taken from 16 borrow areas beside the San Juan River and along valley benches were used in construction of the rolled earthfill embankment. Navajo Reservoir extends 35 mi (56 km) up the San Juan River, 13 mi (21 km) up the Pine River, and 4 mi (6 km) up the Piedre River. When full, the surface area of the reservoir is 15,610 acres (6,317 hectares), with a total capacity of 1,708,600 acre-ft (2,107 million m³).

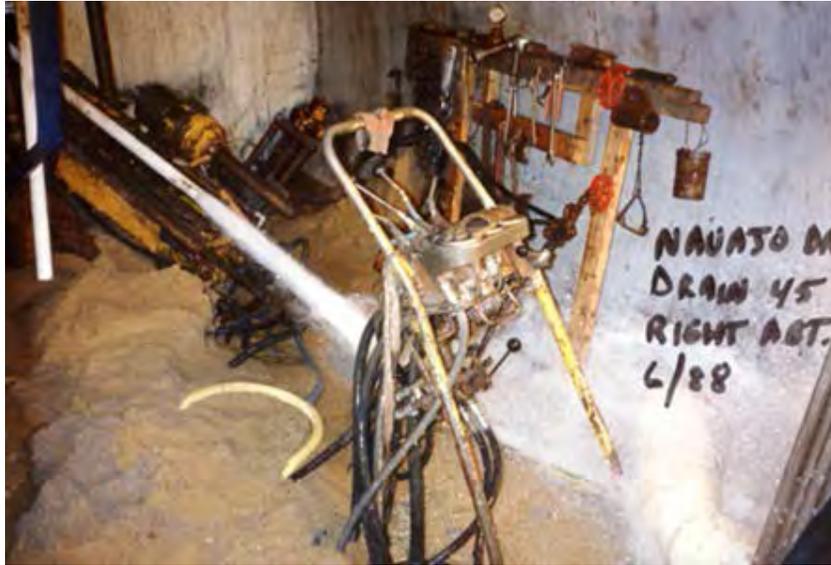
Figure 8.—High flows and sand washing into drain hole No. 45.

the drains consist of only the slotted PVC pipe. High seepage flows (up to 750 gpm) were encountered when drilling the last 15 drains (drain Nos. 32 to 46 located toward the left end). In one instance, large amounts of sand were washed into the hole (figure 8). Because of the very large seepage inflows washing sand and shale particles from the holes, four holes were grouted off and one was fitted with a valve and its flow shut off. An additional four holes were not drilled.

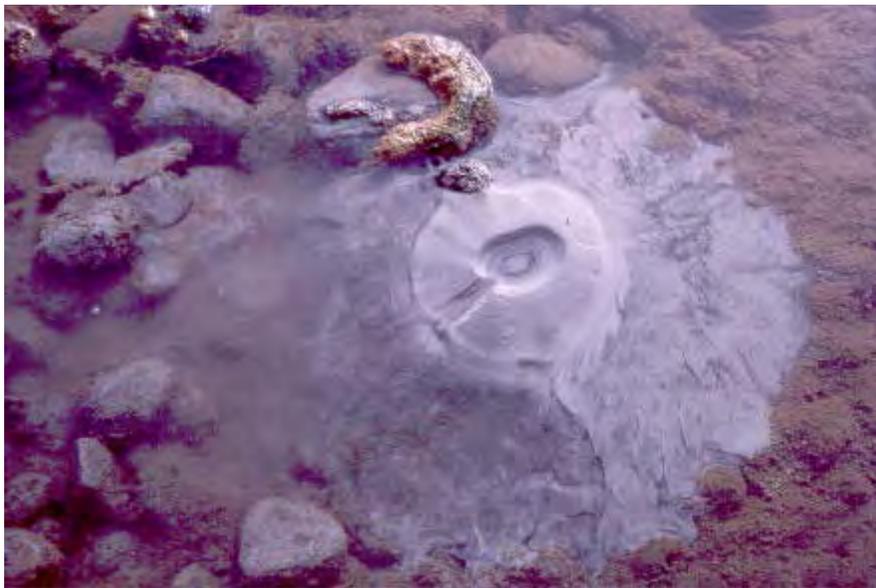
Figure 2.—Boils in outlet channel at Canby Creek, R-1 Dam, Minnesota.

In 1994, a deep slurry trench cutoff was installed along the front embankment toe. The slurry trench cost was in excess of \$1 million. While somewhat effective, it did not reduce the piezometric levels downstream enough to provide adequate safety factors against heaving. The slurry trench caused the combined flow in relief wells to decrease by about 50%, but sand boils still developed in the channel downstream when the relief wells were shut off for testing (figure 2).

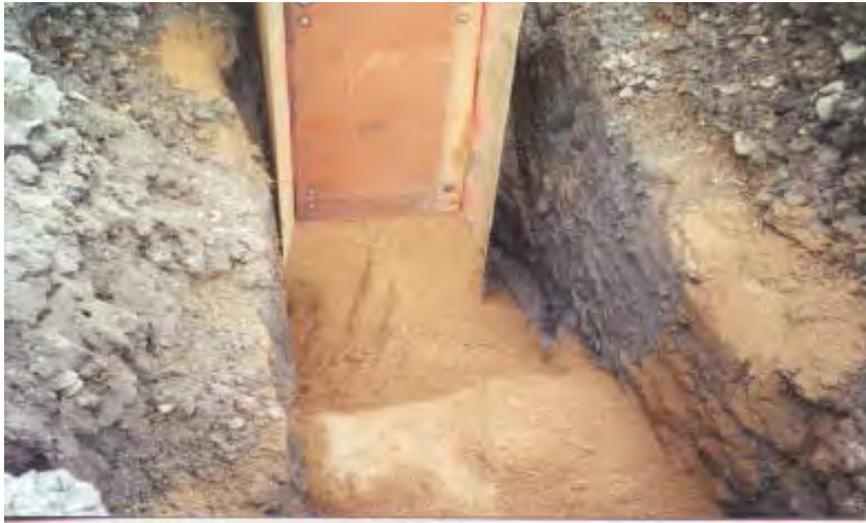
Figure 3.—Trench drain installation at Canby Creek, R-1 Dam.

through the clay blanket was a deep trench drain installed along the outlet channel of the dam (figure 3). The trench penetrated through the clay blanket at least 2 ft into the underlying sand aquifer and was as much as 15 ft deep. It extended about 250 feet downstream from the embankment toe. Installing the trench drain required well points to dewater the excavation without lowering the pool. Piezometric levels dropped appreciably after installing the trench drain and have remained at lower levels even though the relief wells have not been further rehabilitated since 1998. The repair is considered a success.

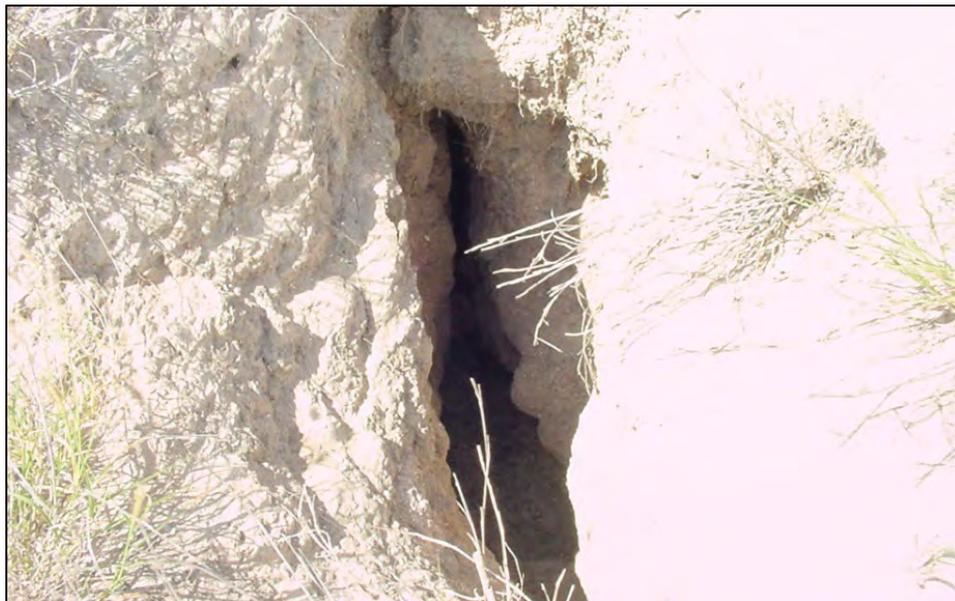
Figure 2.—Large crack in embankment, Olmitos-Garcias No. 2 Dam.

Olmitos-Gracias No. 2 Dam is located in Starr County in the southern tip of Texas (figure 1). Numerous cracks and sinkholes were discovered in the embankment during a 1999 inspection. The cracks were both transverse and longitudinal. The sinkholes had formed through erosion of soil into cracks and were found on both the upstream and downstream slopes and on the crest (figure 2). One 3-in-diameter hole was measured to be over 25 ft deep. Insects and animals, including badgers, were using the cracks and holes to facilitate burrowing into the embankment. Numerous mesquite trees were found growing on the embankment, and mesquite roots had penetrated into many open cracks to considerable depths.

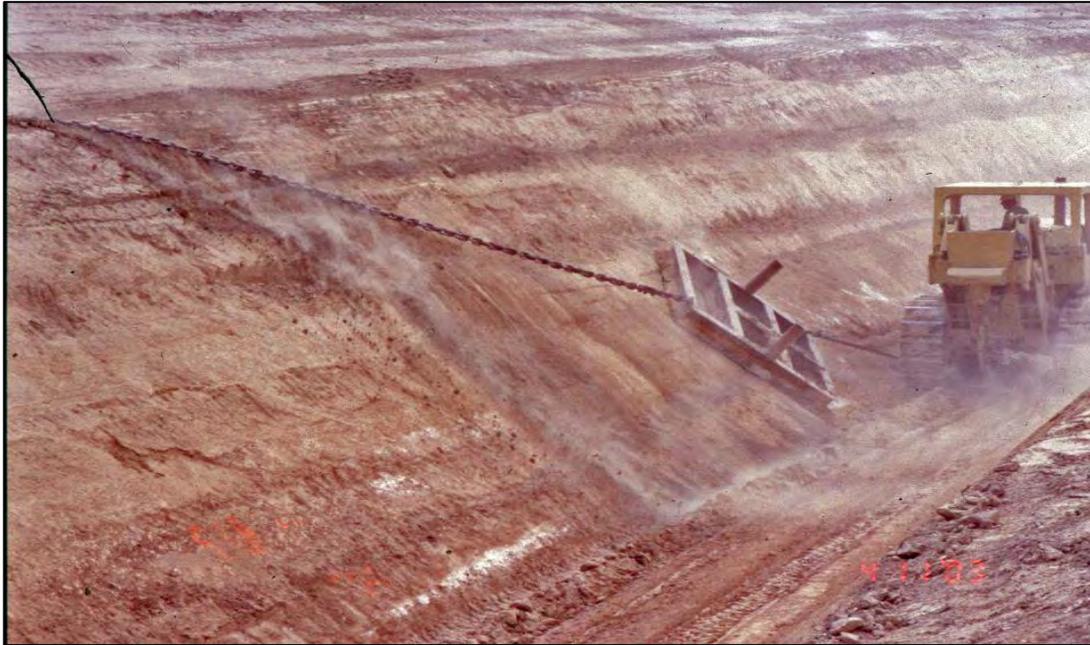
Figure 4.—Smoothing geotextile subgrade with metal frame, Olmitos-Garcias No. 2 Dam.

The outside 12 ft (measured horizontally) of the 2.5H:1V downstream slope were removed, and a trench with a 12-ft bottom width was excavated down to competent claystone. The subgrade for the geotextile was smoothed by dragging a flat metal frame over the slope surfaces using a tractor and cables (figure 4). Then, the geotextile was placed on the slope, beginning at the bottom of the foundation trench and extending to within 1 ft of the top of the dam. Finally, the trench was backfilled, and the slope and stability berm were constructed with compacted earthfill (figures 5 and 6). In the vicinity of the principal spillway conduit, the geotextile within the foundation trench was replaced with a vertical trench filled with flowable fill (figure 7).

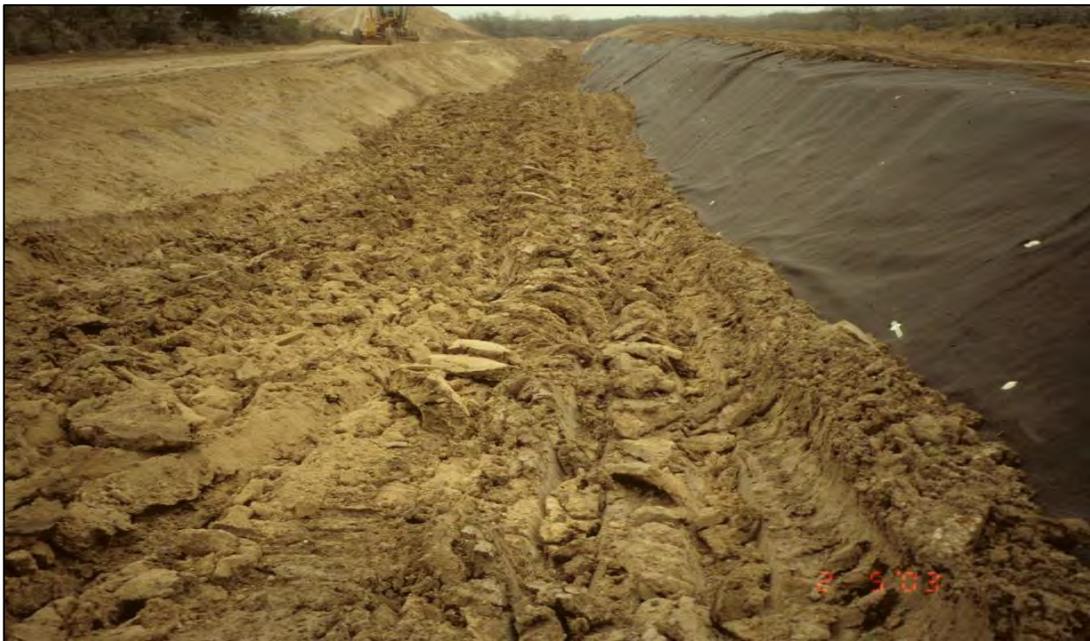
Figure 5.—Backfilling foundation trench, Olmitos-Garcias No. 2 Dam.

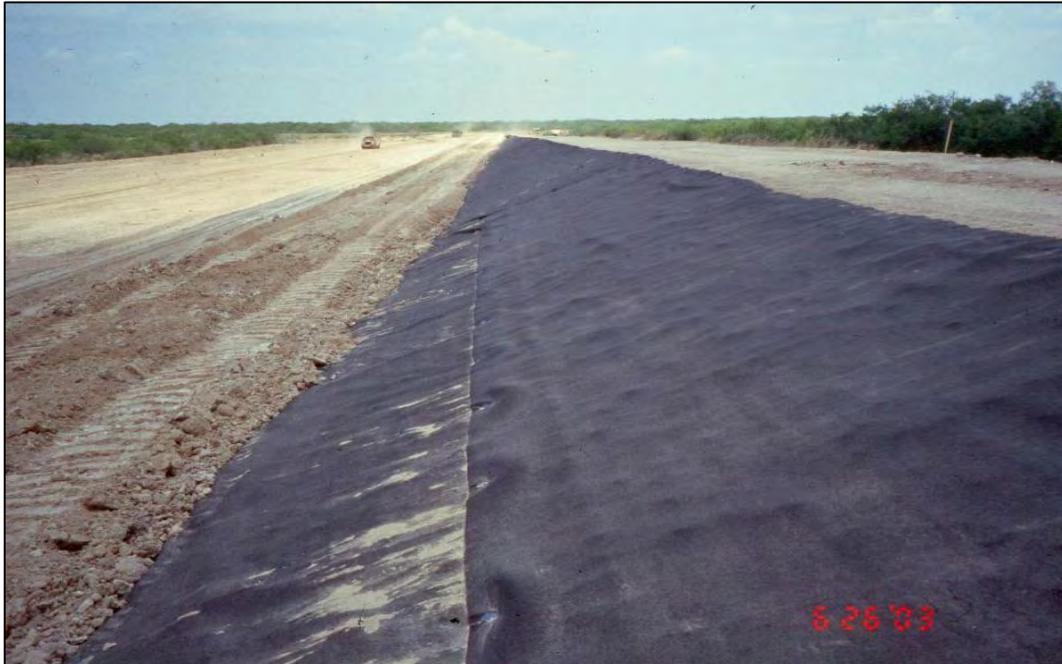
Figure 6.—Fill placement against geotextile, Olmitos-Garcias No. 2 Dam.

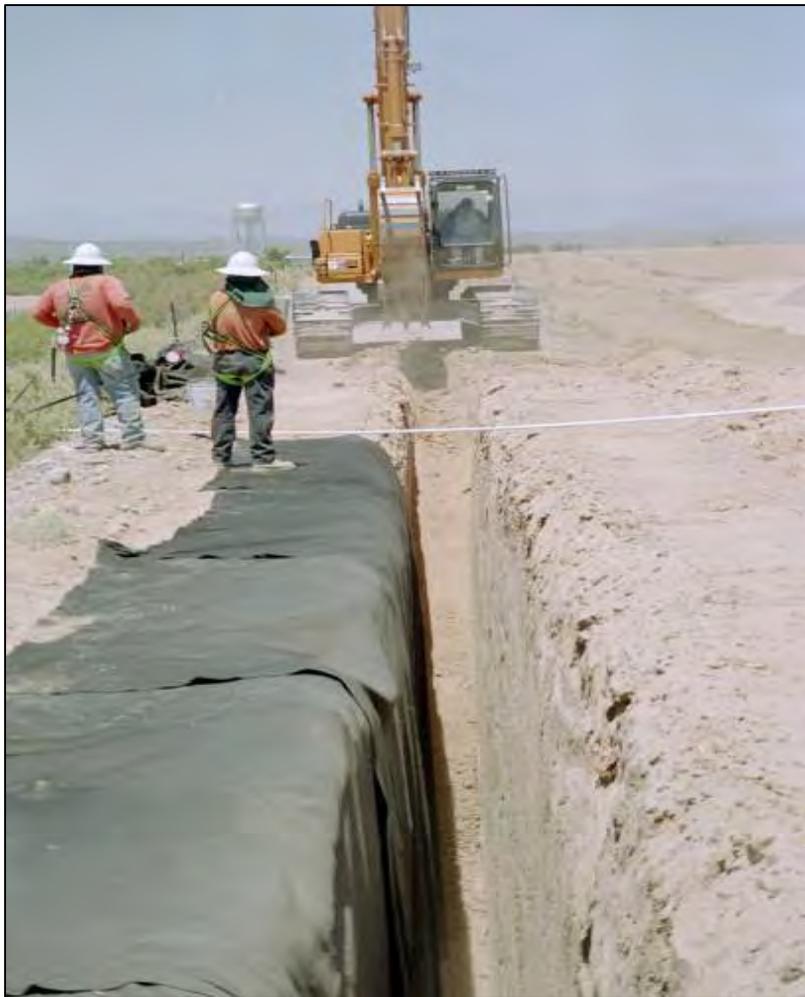
Figure 3.—Trenching and operation, Florence Dam.

of the filter material in the trench to within 1 ft of the top, and (4) placement of 1 ft of compacted earthfill over the trench and covering the embankment crest with 3 in of gravel. The two major challenges with construction were excavation of the 25-ft-deep trench in dry, partially cemented earthfill and blending and placing the broadly graded filter material without segregation. The trench was successfully excavated with both hydraulic excavators (figure 3) and a Case CX 290 trencher. No instability of the trench occurred between trench excavation and placement of the filter material. The gradation of the filter material was equivalent to a 50-50 mix of ASTM C33 Fine Aggregate for Concrete and ASTM C33 No. 57 gravel. The grading and blending of the filter material was accomplished using a screening machine and an auger-type mixer/elevator (figure 4). Placement of the filter material in the trench was performed using a tremie pipe to control segregation (figure 5). An 18-in overlap between adjacent sections of geotextile was used.

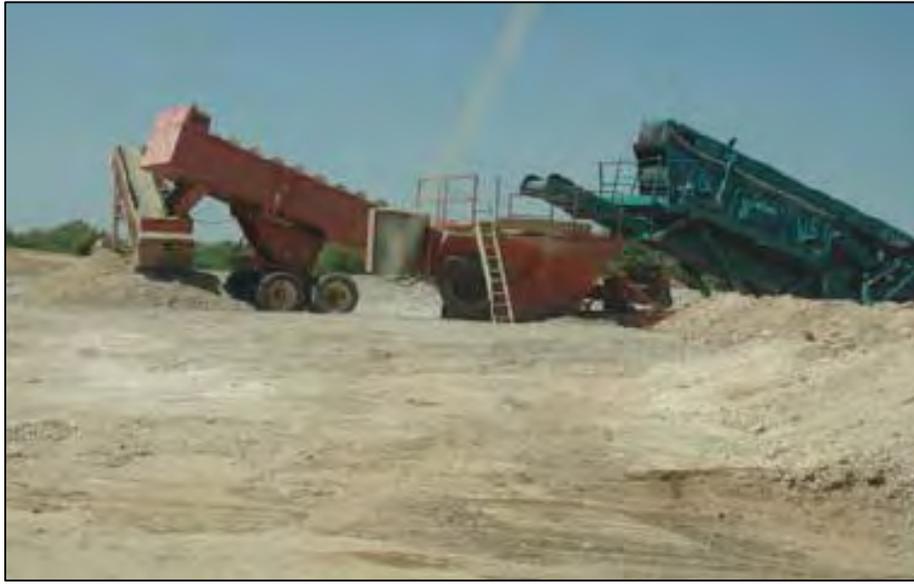
Figure 4.—Screening machine (right) and mixer/elevator (left) for processing filter material, Florence Dam.
