Evaluation and Monitoring of Seepage and Internal Erosion

Interagency Committee on Dam Safety (ICODS)

FEMA P-1032 /May 2015

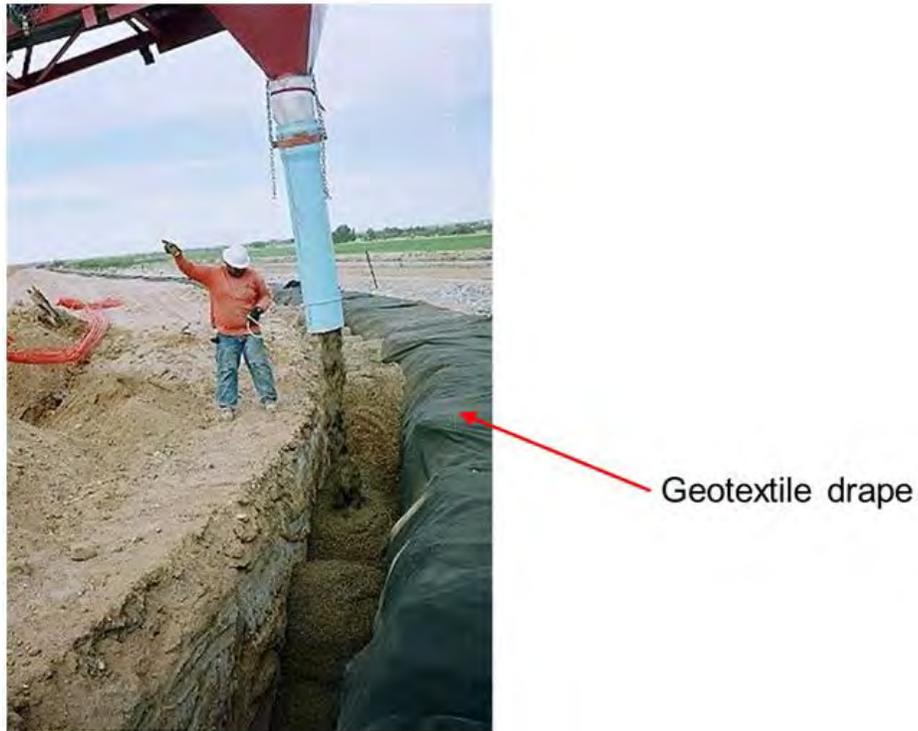
Figure 5.—Placing filter material with tremie, Florence Dam.

of the filter material in the trench to within 1 ft of the top, and (4) placement of 1 ft of compacted earthfill over the trench and covering the embankment crest with 3 in of gravel. The two major challenges with construction were excavation of the 25-ft-deep trench in dry, partially cemented earthfill and blending and placing the broadly graded filter material without segregation. The trench was successfully excavated with both hydraulic excavators (figure 3) and a Case CX 290 trencher. No instability of the trench occurred between trench excavation and placement of the filter material. The gradation of the filter material was equivalent to a 50-50 mix of ASTM C33 Fine Aggregate for Concrete and ASTM C33 No. 57 gravel. The grading and blending of the filter material was accomplished using a screening machine and an auger-type mixer/elevator (figure 4). Placement of the filter material in the trench was performed using a tremie pipe to control segregation (figure 5). An 18-in overlap between adjacent sections of geotextile was used.

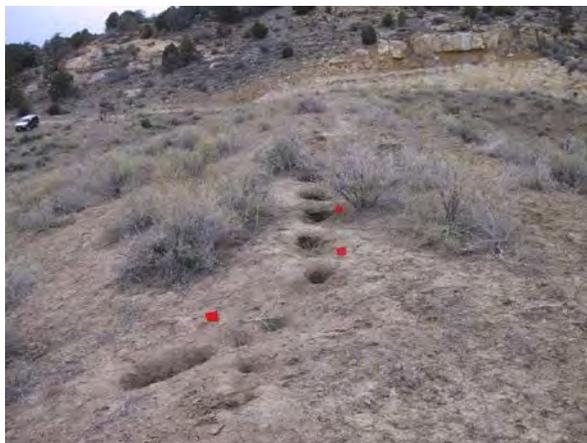
Figure 2.—Holes observed in crest.

Beneath the large holes on the embankment surface (figure 2), cracks were found to be as much as 5 in wide (figure 3), and to the depths investigated, virtually all cracks maintained their widths. Consolidation of the collapsible foundation material was believed to be the source of the cracks, and it was confirmed that these cracks did not extend through the collapsible material. The compaction effort was within the requirements of the original specifications. Though the dam site had experienced years of drought, desiccation cracking was found to be insignificant.

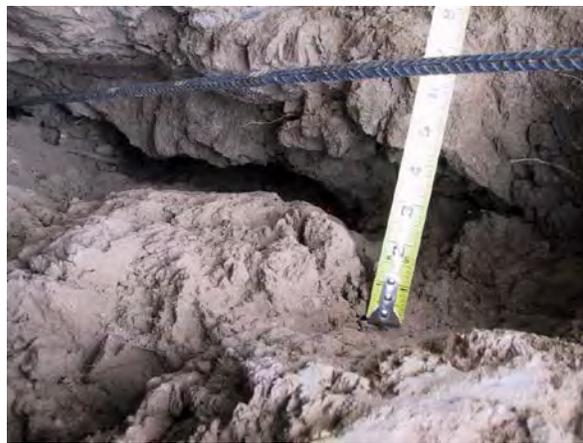
Figure 3.—Up to 5-in-wide cracks under holes.

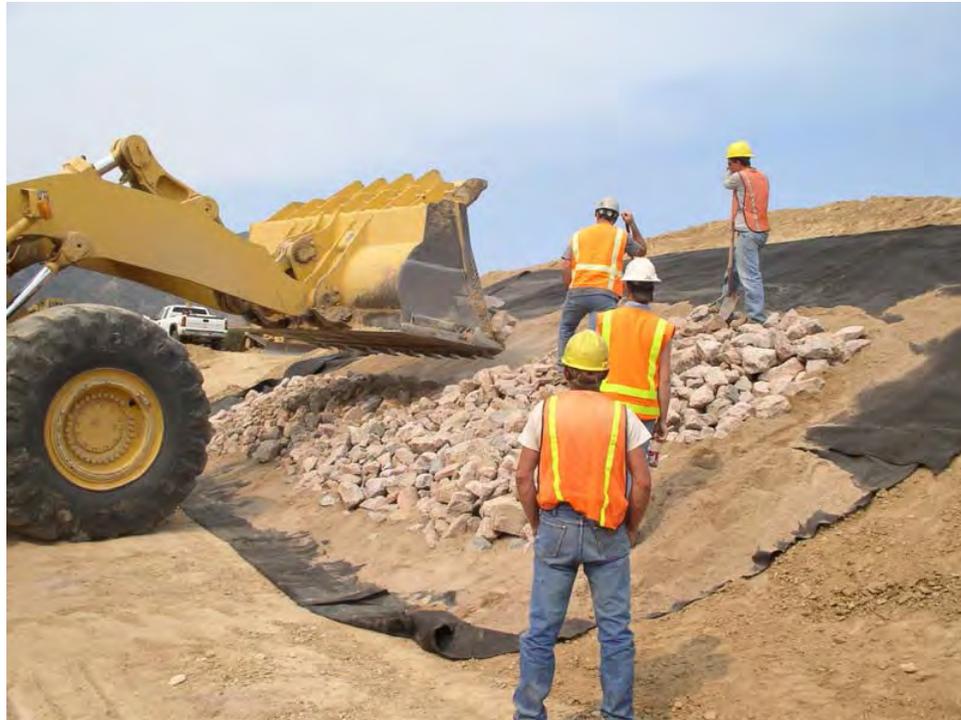
Figure 7.—Constructing the mockup.

Several mockups were constructed before one finally received approval (figure 7). The contractor's method of choice for building the composite zone was to mix and place proportions of cobble and sand using a front-end loader. The use of vibrating equipment and hand placement were found to be unnecessary. The approved composite zone had a cobble to sand ratio of

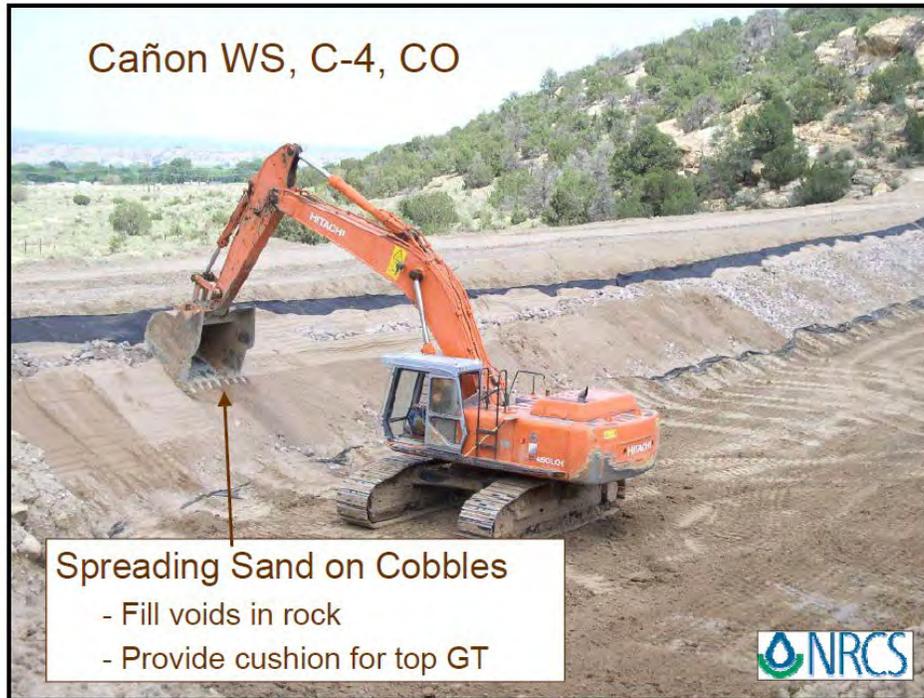
Figure 8.—Placement of geotextile, rockfill, and sand on upstream face (prior to placement of overlying geotextile).

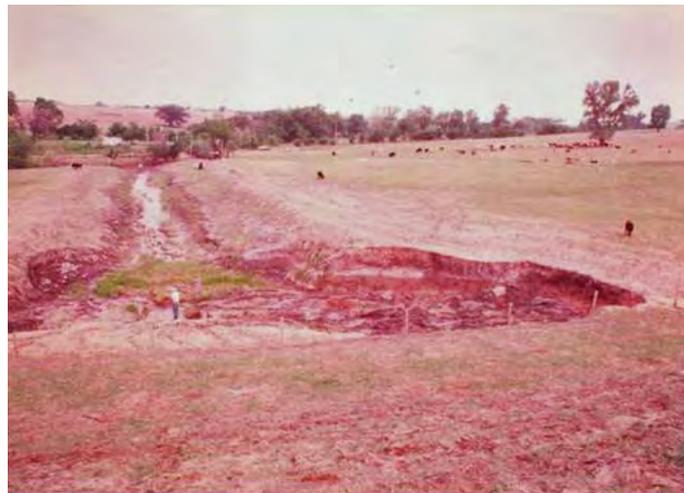
Figure 2.—Sloughing of plunge pool in May 1979.

The sloughing problem reoccurred, and problems were noted in a trip report by Mavis Jones, dated May 4, 1979. Figures 2–4 show the problems observed in May 1979. After this, the area downstream was apparently reworked, and a more extensive foundation drain was installed. Documentation is lacking on the details of the repairs done at this time, but apparently the main effort was directed at providing a drain on the right side of the plunge pool, extending up the right abutment. The drain may have wrapped around the plunge pool and may have extended some distance to the left of the pool. The pictures of the failure shown below indicate that the damaged foundation area was to the right of the plunge pool, but documentation on this repair is minimal. It is well known that a drain was added on the left side of the flood plain area in the 1993 repair discussed in following sections.

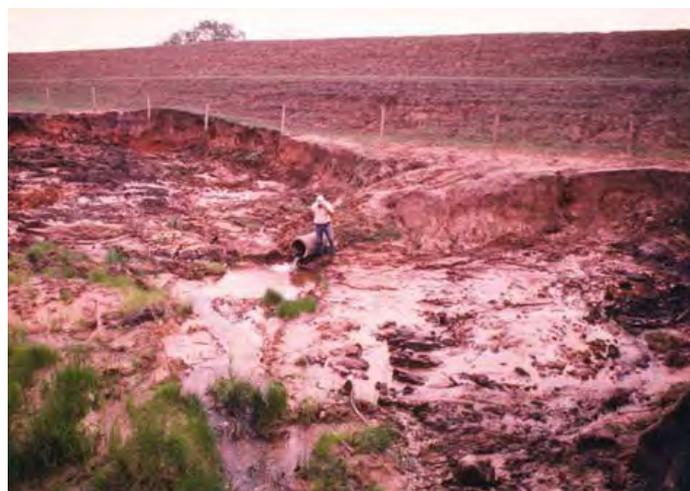
Figure 3.—Sloughing of downstream area near plunge pool.

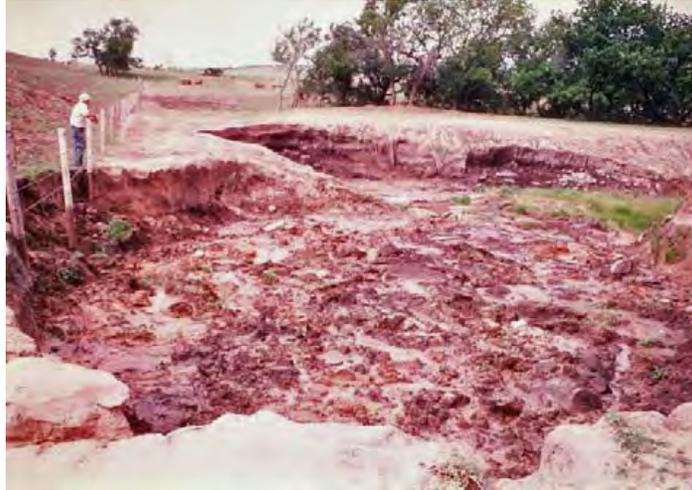
Figure 4.—Sloughing of downstream area observed in May 1979.

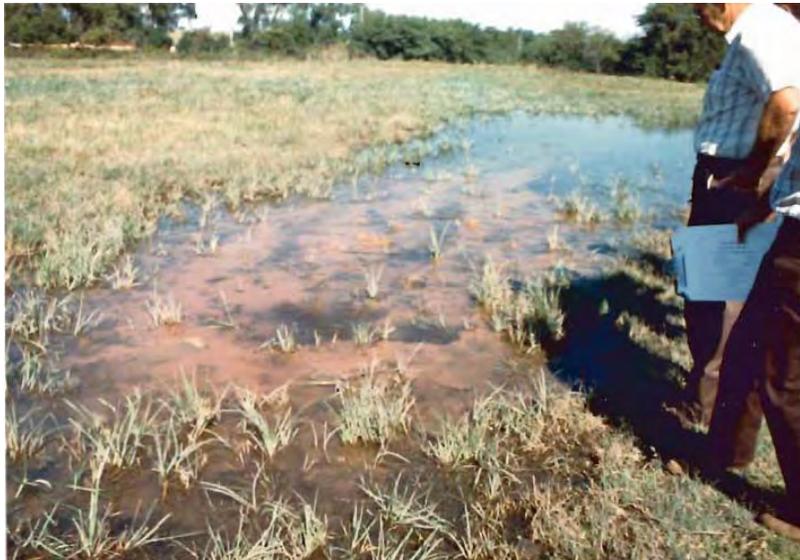
Figure 5.—Seepage occurring downstream from embankment in September 1987.

Subsidence was observed in the upstream berm, which aligned with a concentrated seepage area downstream from the embankment. Figure 5 shows seepage observed downstream from the embankment in September 1987.

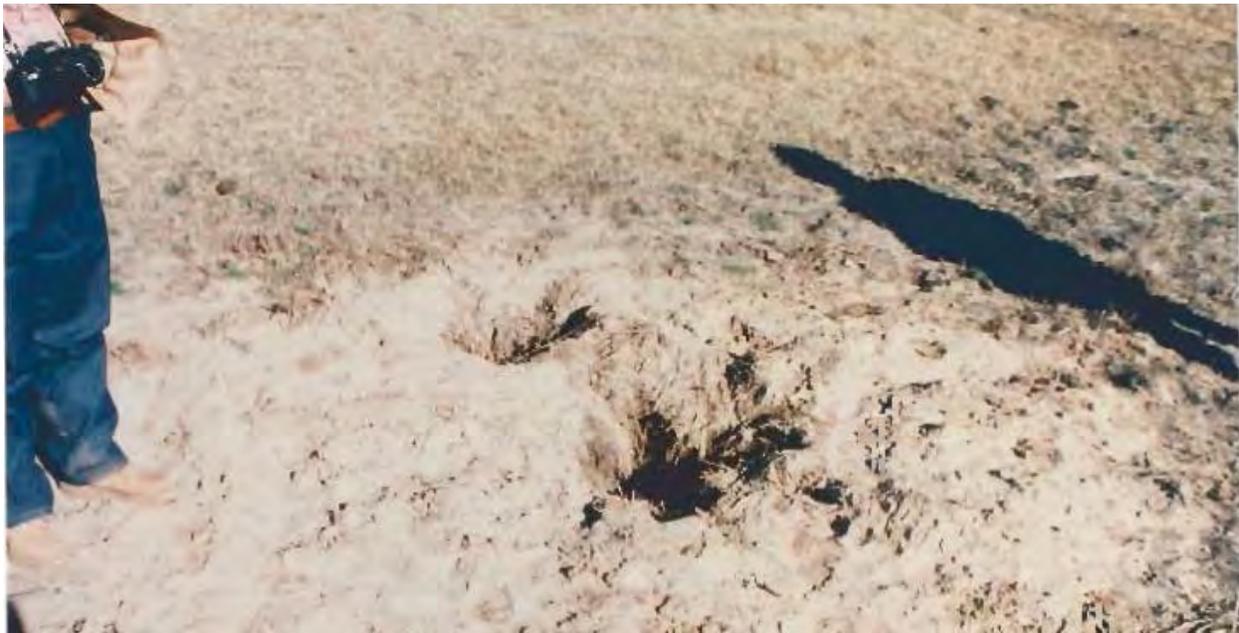
Figure 6.—Tunnel outlet downstream from Sta. 5+50, March 8, 1988.

An engineering report was prepared in August 1988. The report attributed the excessive seepage to preferential flow paths developing through the gypsiferous foundation soils (figure 6). It was determined that development of flow paths occurred from dissolution of the soluble salts in the foundation. The report recommended a cutoff barrier extending downward to at least elevation 1246 (about 6 ft below the zone of lost circulation in the 1988 investigation), a foundation drain, and repair of the sinkholes.

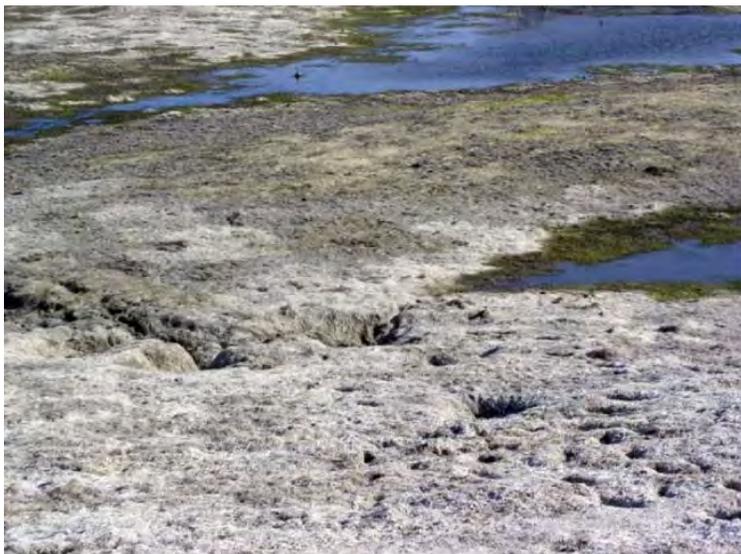
Figure 9.—Sinkholes in reservoir bottom.

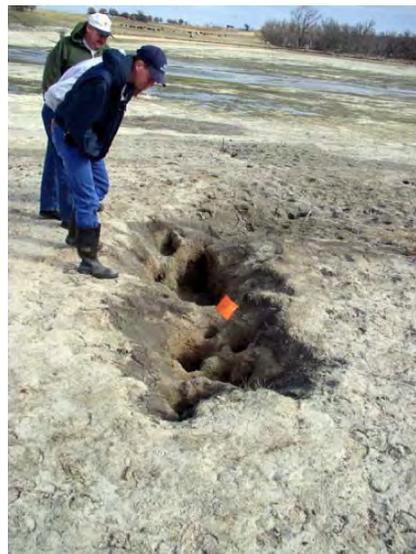
Figure 10.—Large sinkhole in reservoir.

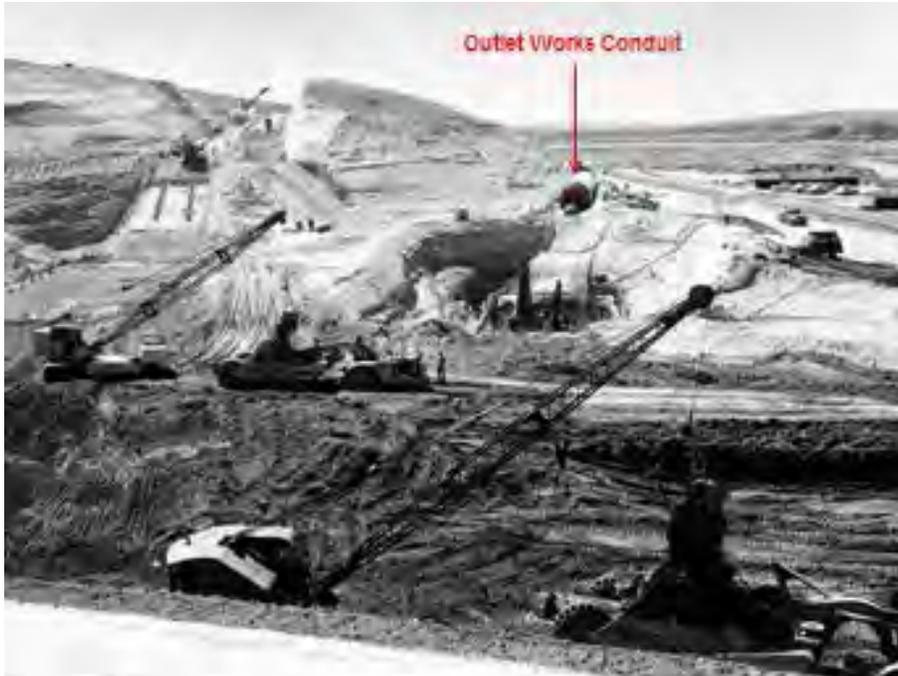
Figure 3.—Construction photo showing outlet works notched into firm Ogallala Formation.

The outlet works and spillway are conduits located near each other at the right abutment of the dam. Both were reportedly founded primarily on competent Ogallala Formation (figure 3). As was typical for 1960's era Reclamation dams, both conduits feature cutoff collars and no filter envelopes, although the horizontal drainage blanket extends over the outlet works conduit and partially up the abutments.

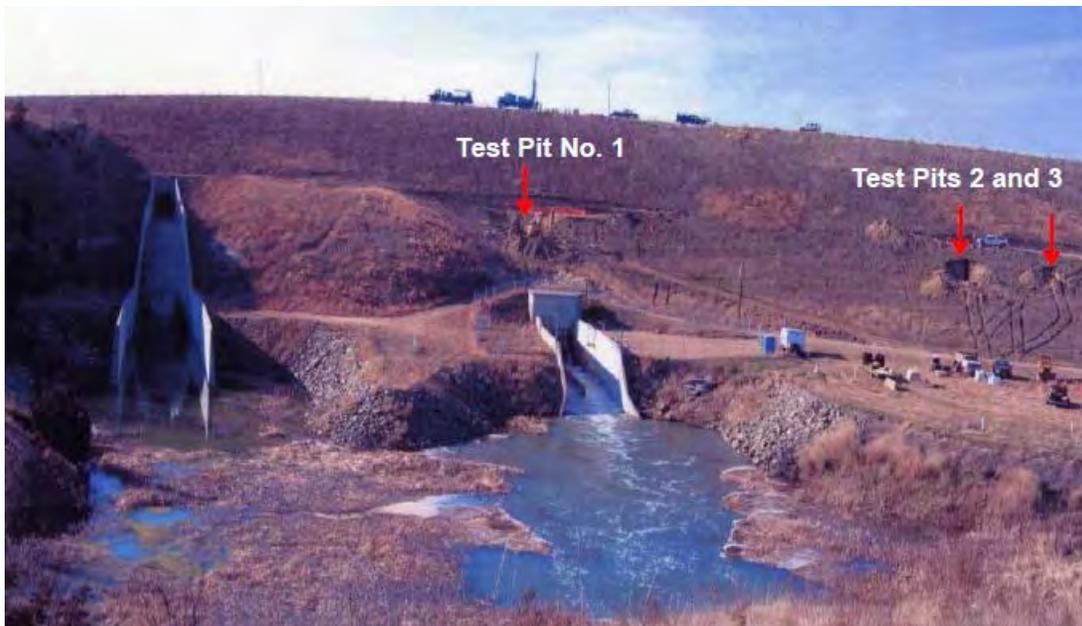
Figure 4.—Photo showing locations of observed cracking in the embankment.

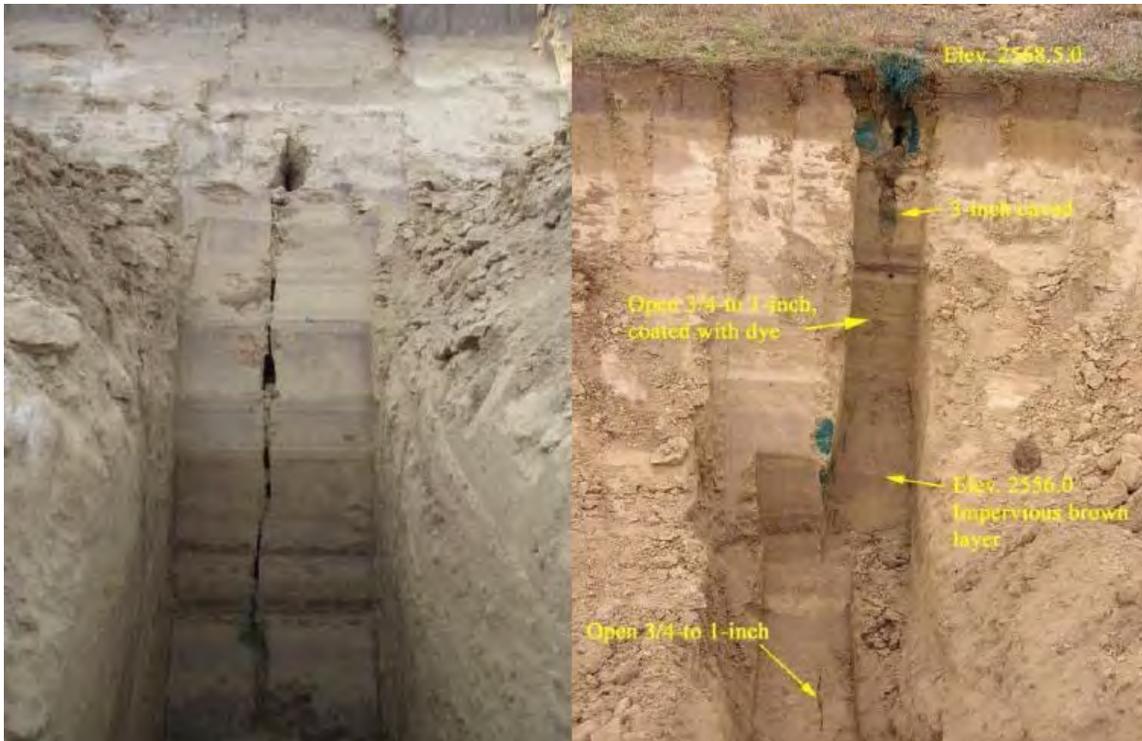
Figure 5.—Representative cracking in the embankment observed in test pit #2. Dye was poured into the sinkholes to aid in tracing the cracks. Cracks were typically 1/4 to 1 in wide.

interim risk reduction measures included stockpiling sand and gravel materials for use as potential emergency filters, 24-hr monitoring, and lowering the reservoir by approximately 20 ft to the dead pool elevation. Figure 5 shows the typical cracking observed.

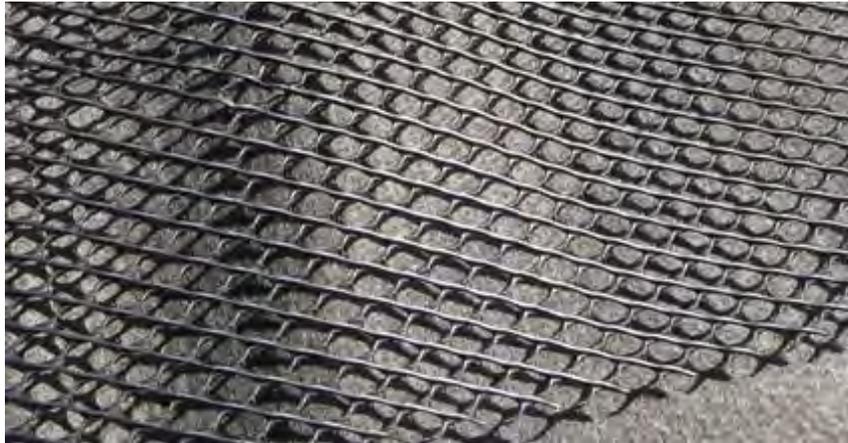
Figure 8.—Geo-net composite – 5-mm biaxial HDPE geo-net, 16 ounces per square yard (oz/yd^2) geotextile bottom layer, 6 oz/yd^2 geotextile top layer (photo above does not show the top [downstream] geotextile).

The double-sided geo-net composite was installed over the entire excavated slope for the full length of the embankment. The material was anchored into a trench along the crest and then rolled down the excavated slope to the base of the excavation. Figure 8 below is a photo of the geo-net composite used in the modifications, and figure 9 shows the typical installation, rolling the panels from the dam crest.

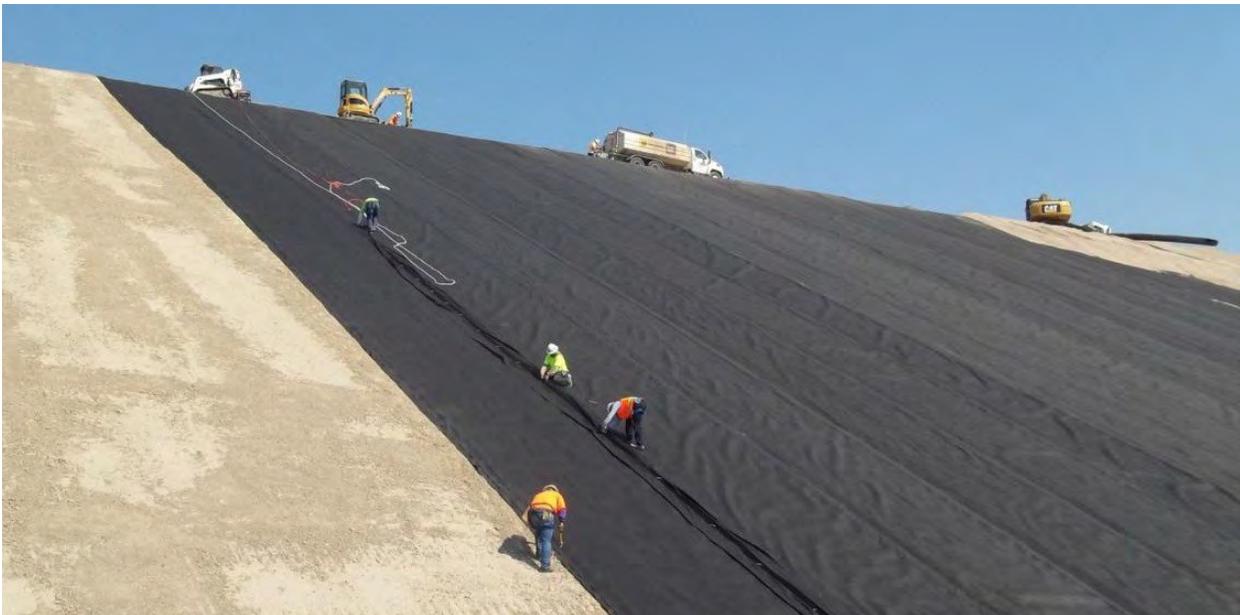
Figure 9.—Typical installation of geo-net composite on downstream face of embankment.

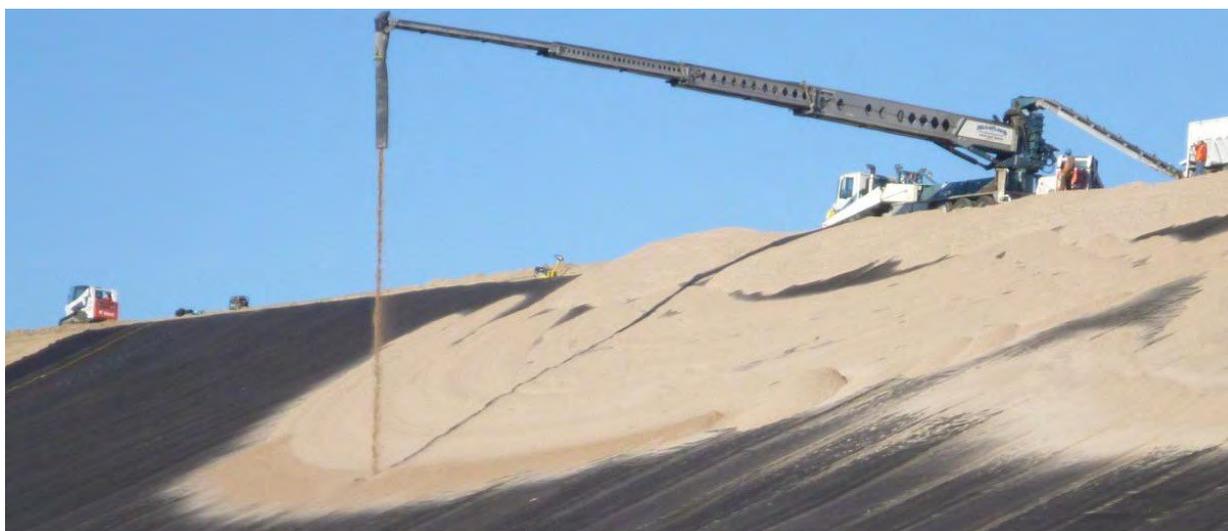
Figure 10.—Telebelt used from dam crest to protect geo-net composite.

In order to prevent degradation of the geo-net composite due to ultraviolet breakdown, it was specified that the geo-net be covered within 30 days of placement. This posed a unique problem due to the embankment construction sequence and large area of geo-net composite materials to be covered. Ultimately, the contractor used a 6-in layer of sand to protect the exposed geo-net. A telebelt conveyor system was used to ensure coverage of the entire exposed composite as shown on figure 10.

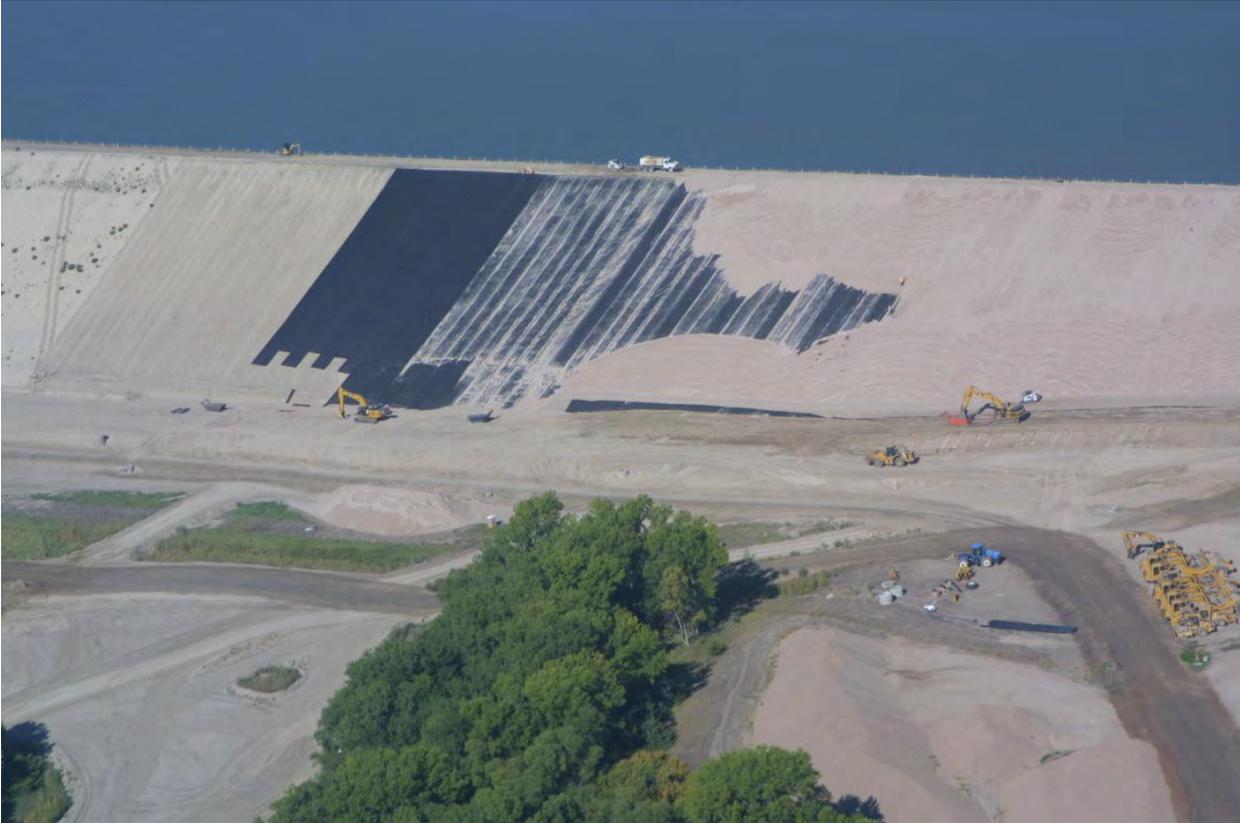
Figure 11.—Aerial photo of Red Willow Dam showing geo-net installation and protection with sand.

The use of geo-net composite materials in Reclamation dams is not common practice. Red Willow Dam is the first Reclamation dam to use the geo-net composites as identified. Federal guidelines prohibit the use of geosynthetics as a primary filter/drain. For this reason, a two-stage filter/drain was constructed below elevation 2615 to serve as the primary filter/drain. The use of a geo-net composite as the primary filter/drain above elevation 2615 is unconventional, but due to the low likelihood of the reservoir exceeding this elevation, the designers decided there was very little risk in not continuing the chimney filter/drain above this elevation. Because the drain materials were imported from a long distance, stopping the two-stage filter at this elevation also had an economic benefit for the project – by limiting quantities, a cost savings was achieved. A total of 70,000 square yards of geo-net composite was installed of the downstream excavation as shown on figure 11 below.

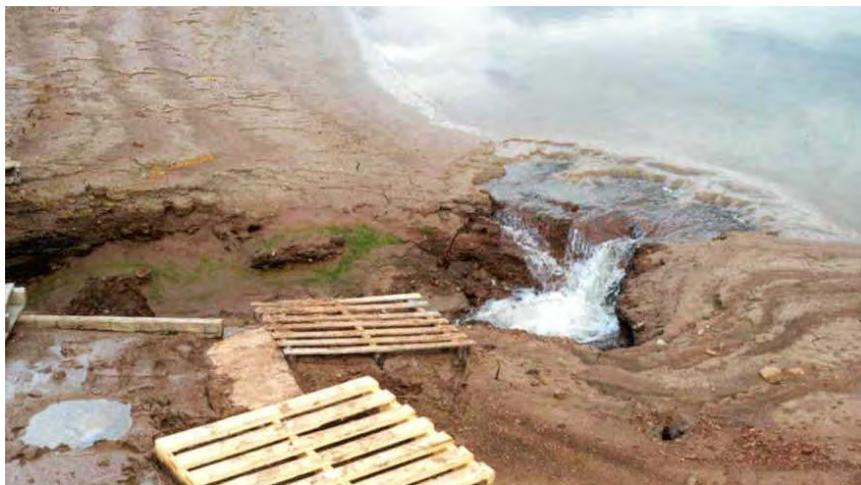
Figure 5.—Observed sinkhole at upstream left groin of Horsetooth Dam.

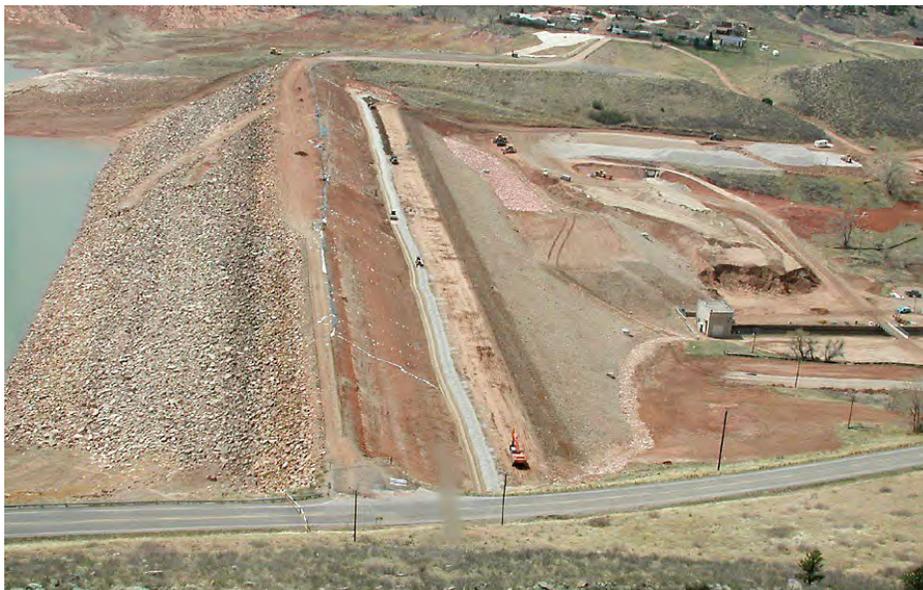
Figure 7.—Construction of downstream filter and berm at Horsetooth Dam.

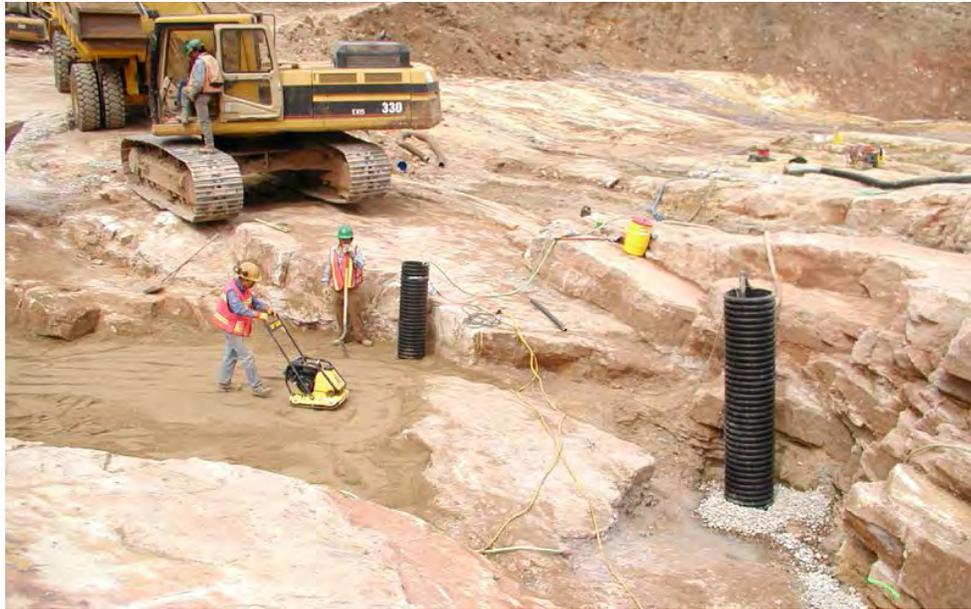
Figure 8.—Foundation cleanup and construction of downstream filter and berm at Spring Canyon Dam.

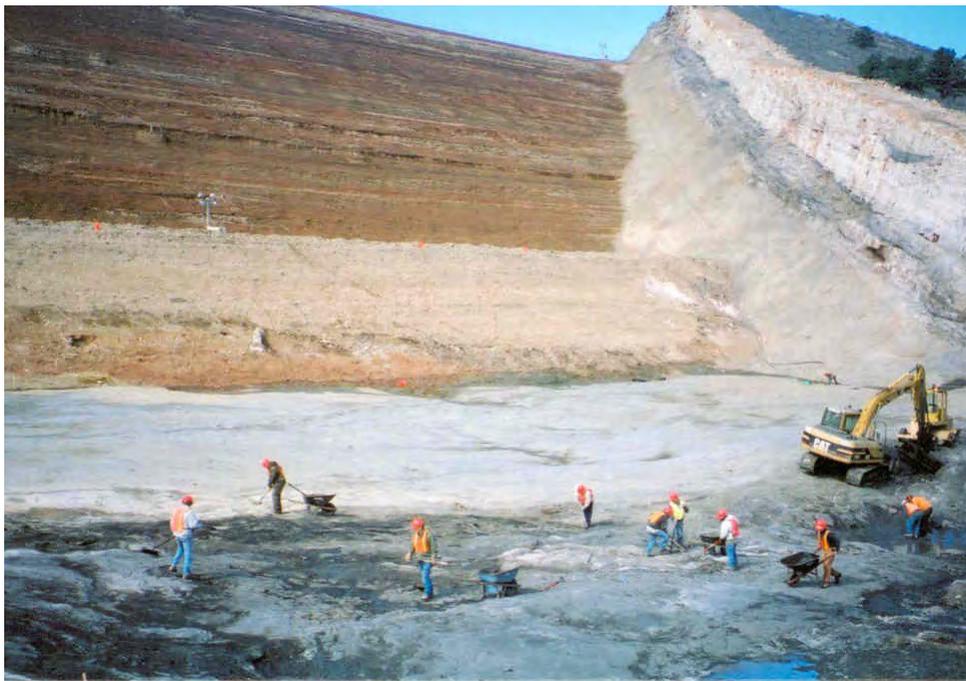
Figure 9.—Excavated downstream embankment and foundation at Soldier Canyon Dam.

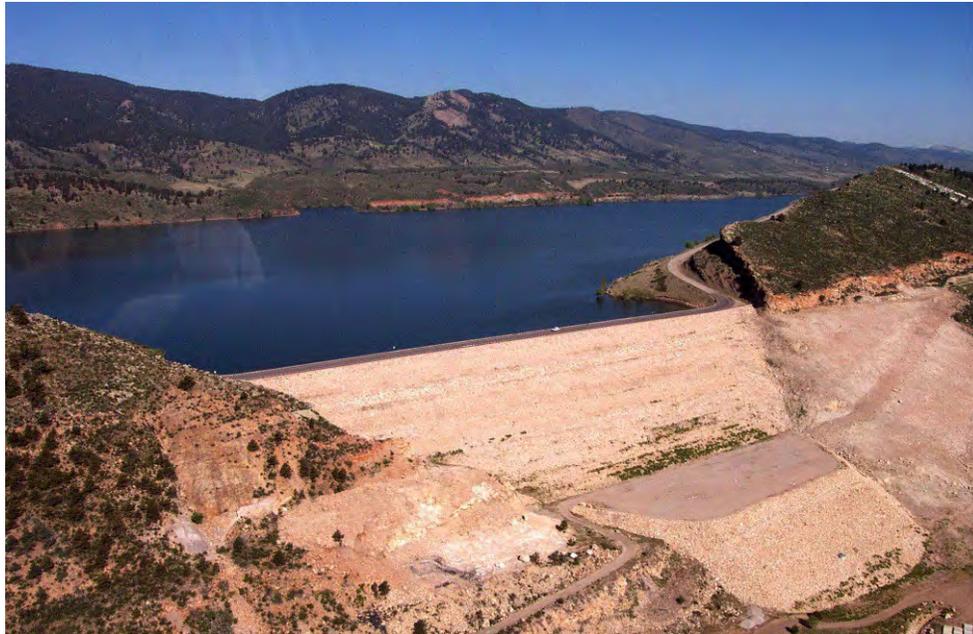
Figure 10.—Completed downstream modification at Dixon Canyon Dam.

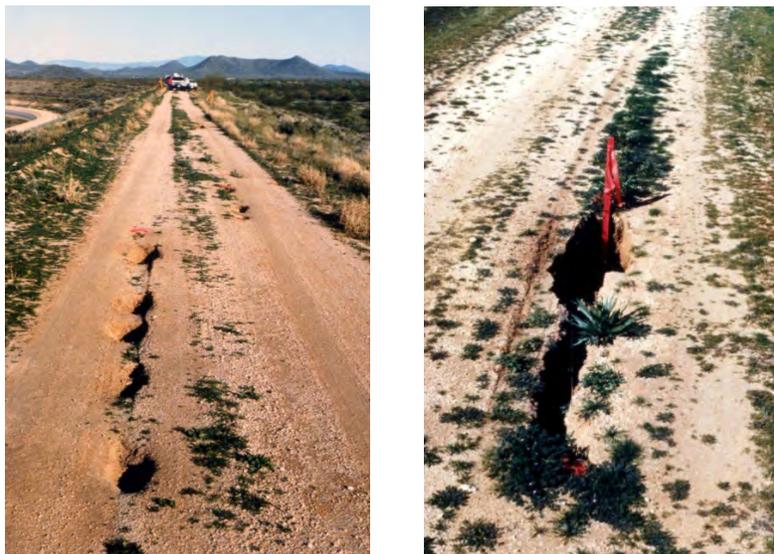
Figure 2.—Typical longitudinal cracking observed on crest of Reach 11 Dikes.

Over the life of the dikes, very significant transverse and horizontal cracking has been seen along the crest of the dikes, especially Dikes 1, 2, and 3. In addition, large sinkholes have formed along the alignment of these cracks, and erosion outlet tunnels have appeared on the slopes of the dikes. Figures 2 and 3 illustrate show the observed features. Typically, these features have been seen after significant rainfall events, which have temporarily stored up to 8 ft of water against the dikes, and the water was allowed to evaporate and/or infiltrate into the foundation. Field investigations have revealed that some of these cracks extended completely through the dike embankments. Laboratory testing of dike and foundation materials also revealed that approximately 40% of the soils tested were classified as D-1 dispersive soils. Vertical strains over 20% were seen in laboratory tests of foundation samples at the effective vertical overburden stress imposed on the soils by the embankment. According to research done on the prediction of field collapse of soils due to wetting, in the basin and range provinces of the Southwest, collapsible soil deposits are primarily wind deposited, weakly cemented silty sands, sandy silts, and clayey sands of low plasticity. The majority of the basin fill deposits under Dikes 1, 2, and 3 fit these soil types.

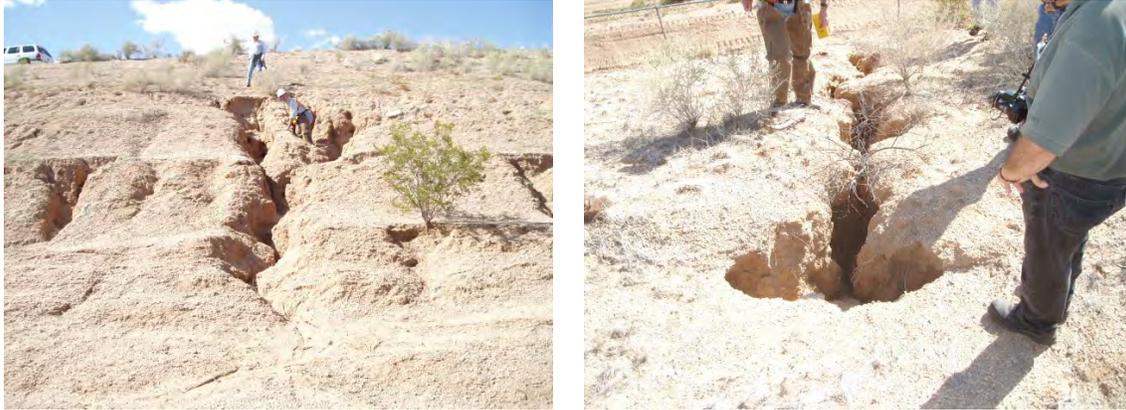
Figure 3.—Typical severe erosion of dispersive embankment soils comprising Reach 11 Dikes.

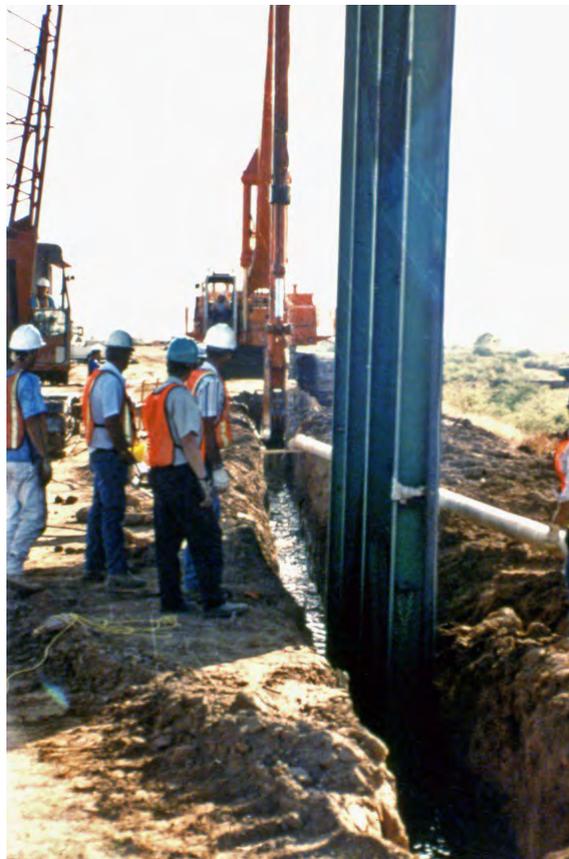
Figure 7.—Excavation of trench using biopolymer slurry. Steel frame was used to install the geomembrane panels.

Excavation and placement of filter zone materials was accomplished by the slurry trench method. A biodegradable slurry was selected to prevent contamination of the filter zone material with residual materials that would occur with conventional slurry (typically bentonite). A biodegradable slurry, such as a natural guar gum or a synthetic biopolymer, will break down naturally over time or can be chemically broken down using a weak chlorine solution and flushed out of the filter zone material, leaving a free-draining filter zone in place.

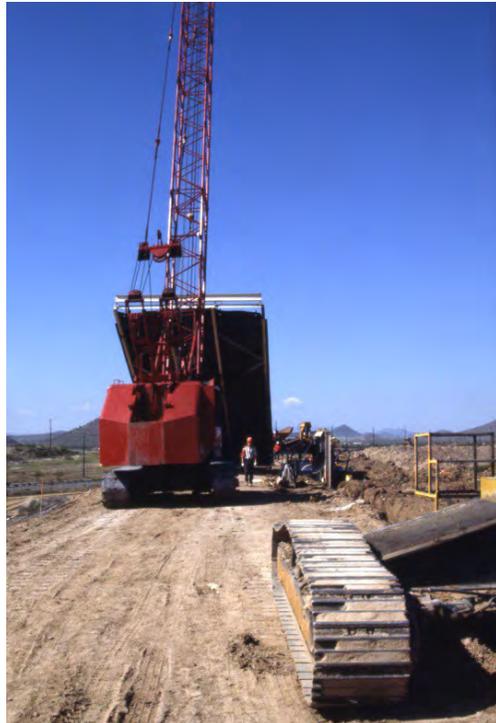
Figure 8.—Transport of geomembrane panel by crane using steel frame.

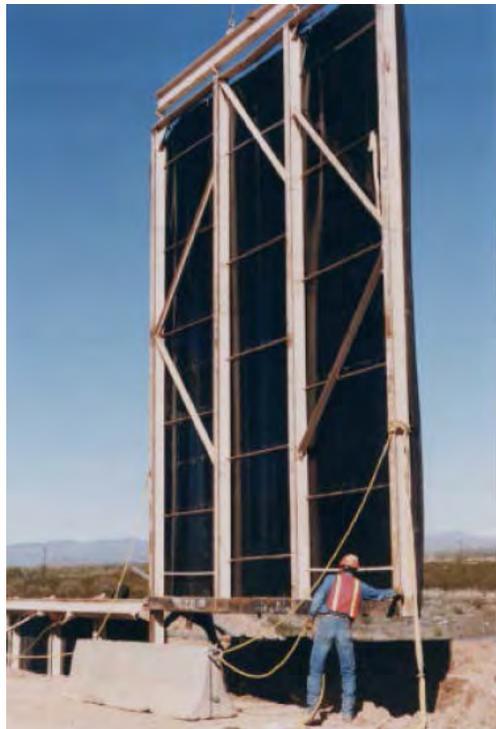
Figure 9.—Installation of geomembrane panel in the trench adjacent to previously placed panel.

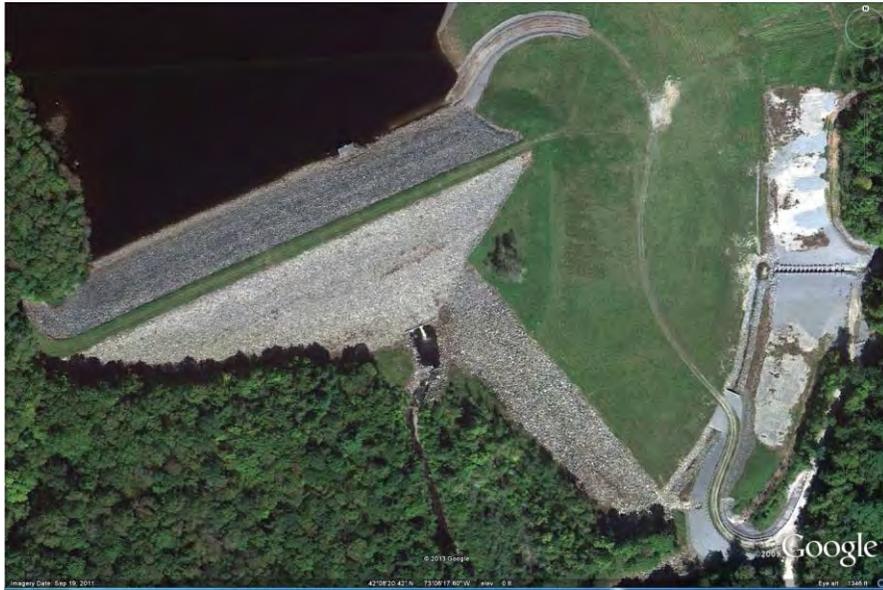
Figure 1.—Clam Lake Dam.

Clam Lake Dam is a 94-ft-high, 985 ft-long flood-retarding embankment constructed between 1974 and 1977 near Cold Spring, Massachusetts (figure 1). The embankment was constructed of broadly graded glacial till soil with low plasticity fines. The dam impounds a maximum storage of 3,840 acre-ft from a 10.5-mi² drainage area.
